Engineering
Science
Report
Neighborhoods
① Four Mile Run
② Potomac Watersfront
③ Potomac Central
④ Slaters Lane
⑤ Braddock

ABSTRACT

The purpose of this study was to inventory the cultural resources present, or potentially present, within the area of the Yard and to identify those resources that possess historical or archaeological significance. Where necessary, recommendations are made for further study and evaluation.

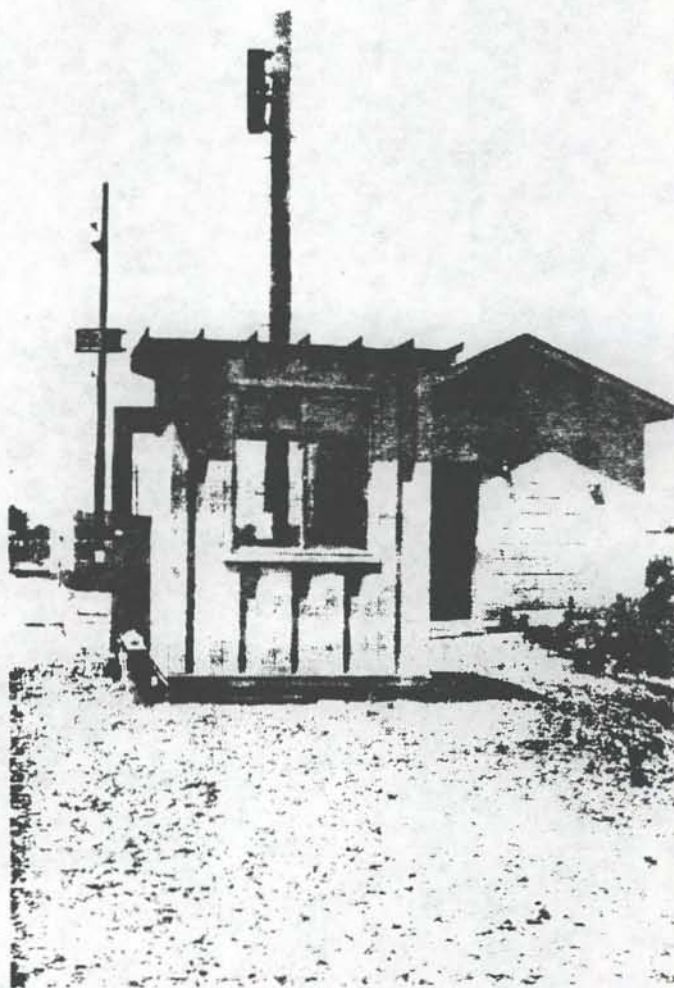
Number 34

This 6 foot square, flat roofed shed, of Butler metal panel construction, rests on a raised concrete platform and has a metal panel shed roof. There are two light sliding metal sash windows on the south and a metal door with fixed light on the north.

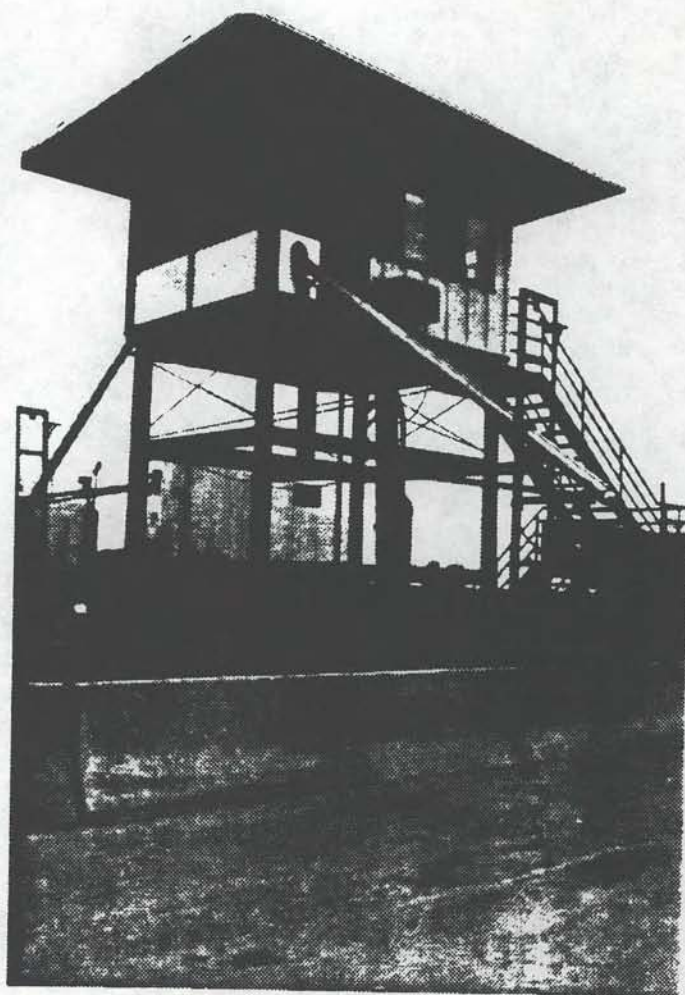
Number 35

This 20 foot by 10 foot tower, sheathed in conventional and Butler metal panels, is raised on an I-beam steel base. There are large fixed and sliding glass windows on the upper level. Steps provide access on the east side.

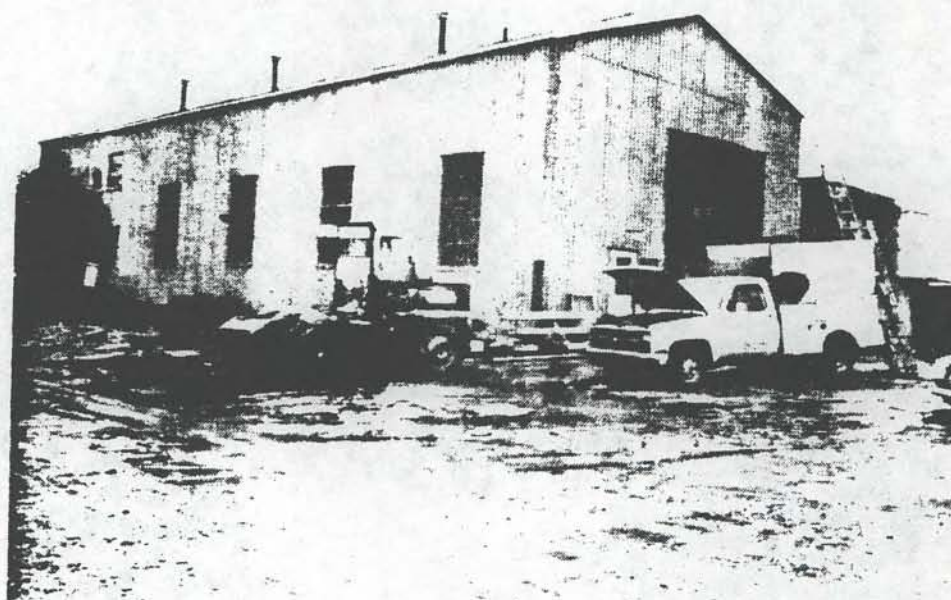
Number 37

This corrugated metal building, 20 feet by 100 feet, on a concrete slab, was probably part of the Yard's operations when it was built. Its metal gable roof runs on a roughly east-west axis. Rail car access is provided through doors on the east and west ends of the building. Twenty light awning windows are located in the front half of the building, with two tiers of smaller windows in the rear.

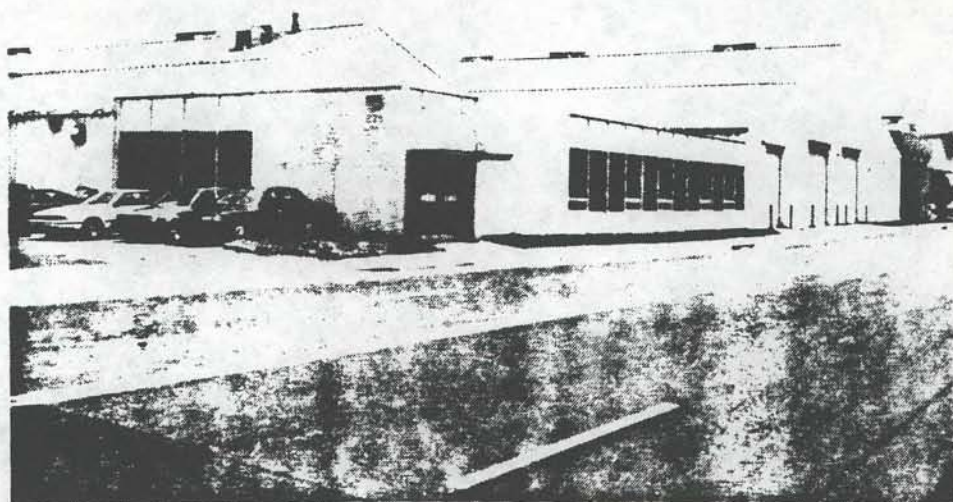
Number 38 (Parr Industrial Corporation) These two very large adjoining gable roofed warehouses sheathed in Butler metal siding form a single roughly L-shaped structure measuring about 250 feet by 175 feet. A brick and metal panel office addition is located at the junction of the two sections. There are a number of roll-up metal doors on the west and north elevations.

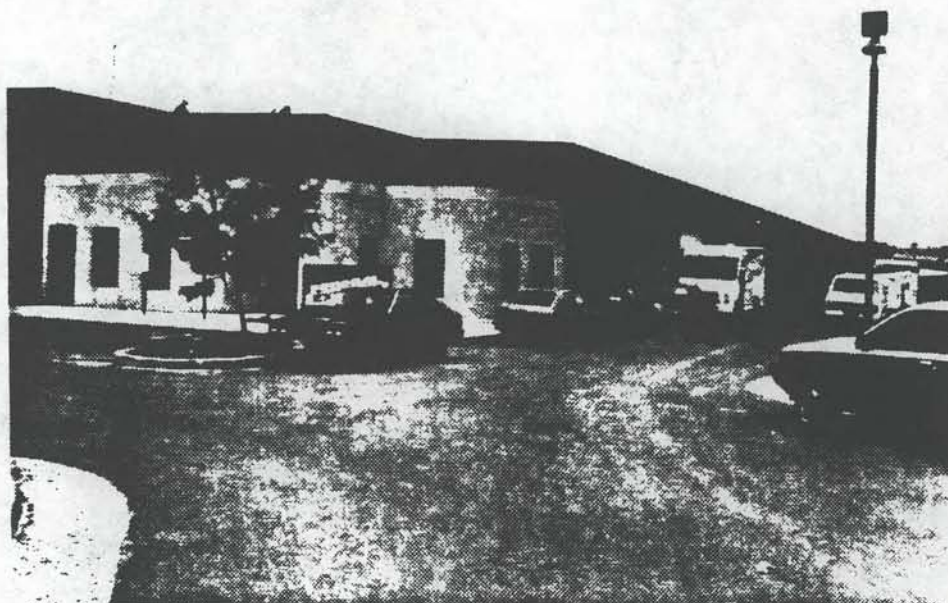
Number 39 (Federal Express Building)

This very large brick and metal panel warehouse probably measures about 250 feet on a side. Generally square in plan, the building has an irregular cutout in the southwest corner for a one story stucco-finished concrete office addition (also irregular in plan). The roofs of both parts are flat. Glass doors and large single light fixed pane windows face south in the office addition. There are numerous truck bays on the west and south elevations.

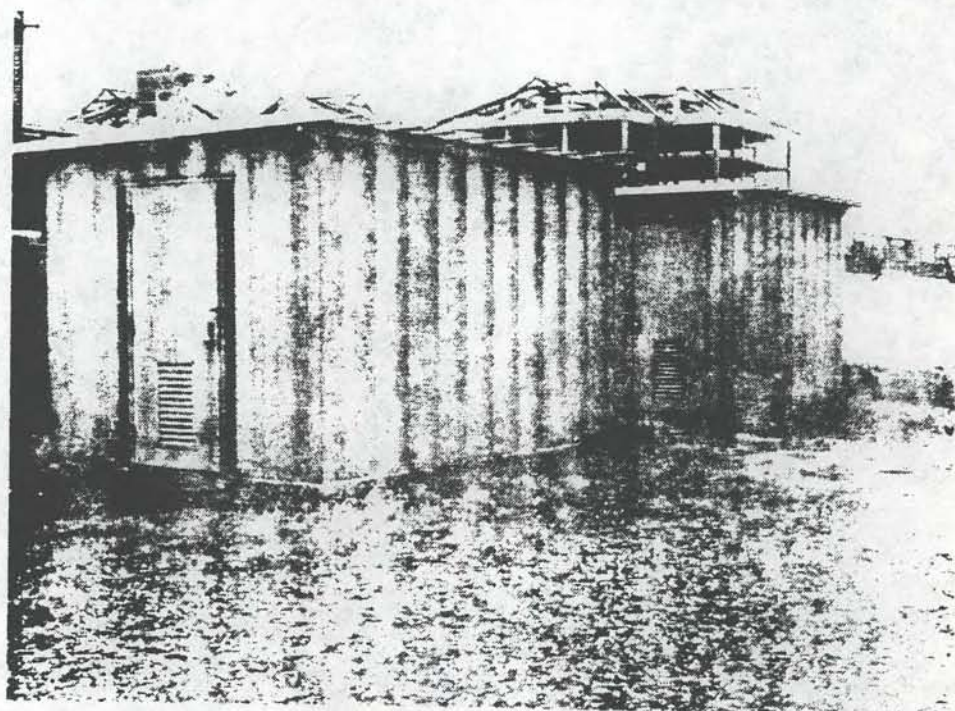
Number 41

One of these 6 foot by 8 foot sheds, of Butler metal siding with concrete slab foundations and flat roofs, apparently serves as a signal shed, the other as a frame case.
