PROPERTY CONDITION ASSESSMENT

LADREY HIGH-RISE APARTMENTS - PROPERTY CONDITION ASSESSMENT
300 WYTHE STREET
ALEXANDRIA, VIRGINIA

ECS PROJECT NO. 46:11503

SEPTEMBER 11, 2025

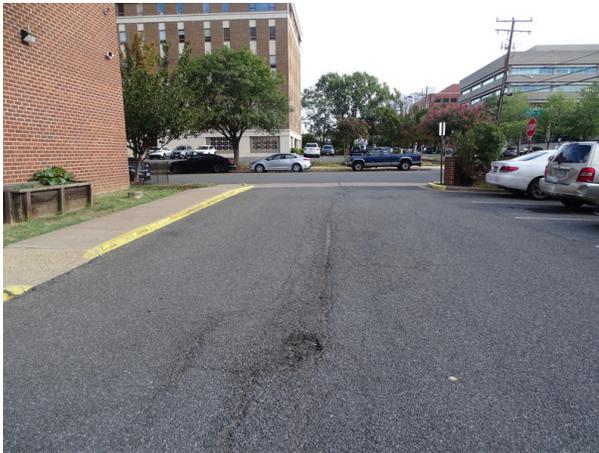
Asphalt pavement in drive lanes and parking spaces - Note cracks.

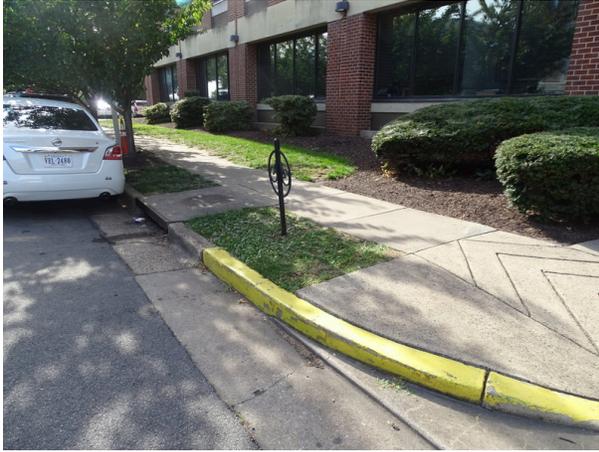
Concrete curb - Note settled.

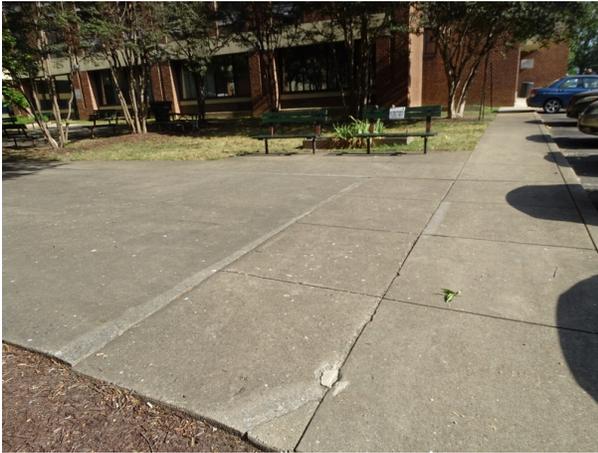
The north, south, and east sides of the building have concrete sidewalks. Regularly spaced control joints were observed. The concrete sidewalk observed crack and settled in several locations. We recommend that the settled and cracked sections of concrete sidewalks be replaced as needed.

Concrete sidewalk - Note settled.

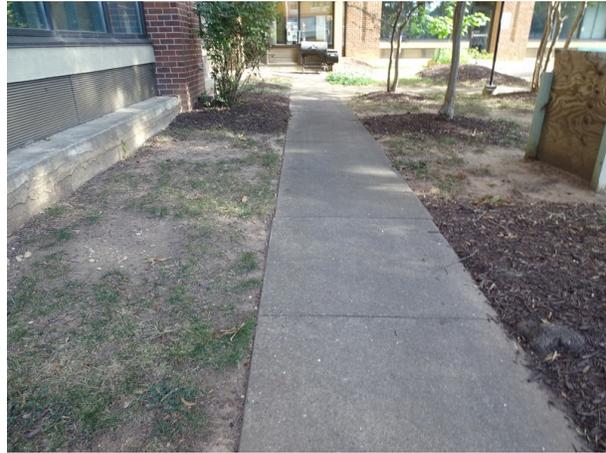
Concrete sidewalk - Note settled.

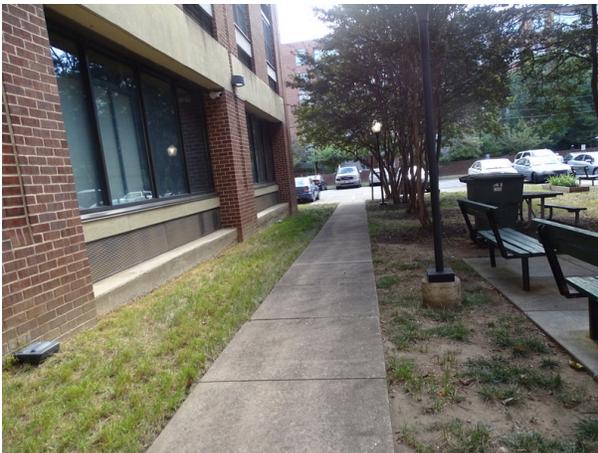
Concrete sidewalk - Note settled.

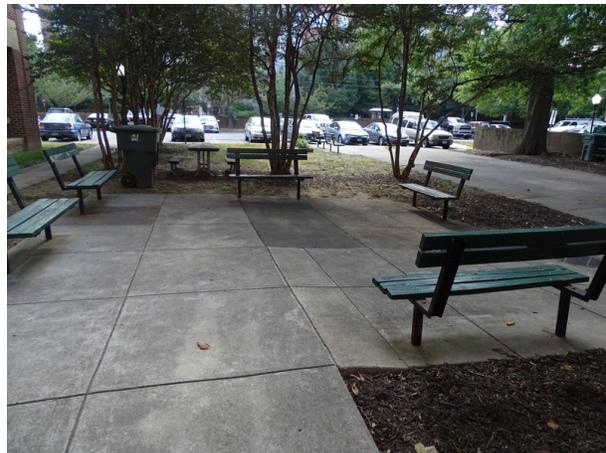
Concrete sidewalk - Note settled.

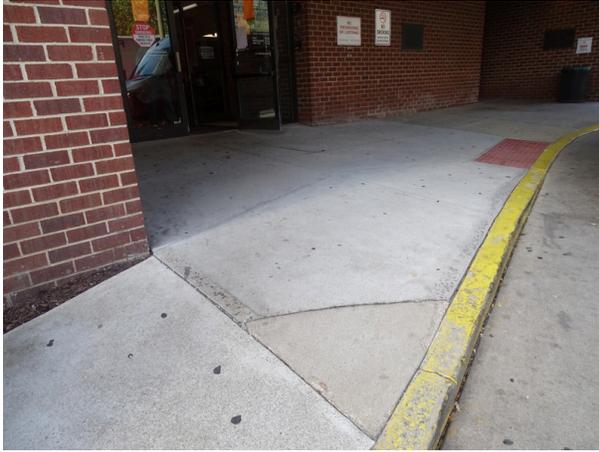
Concrete sidewalk - Note settled.

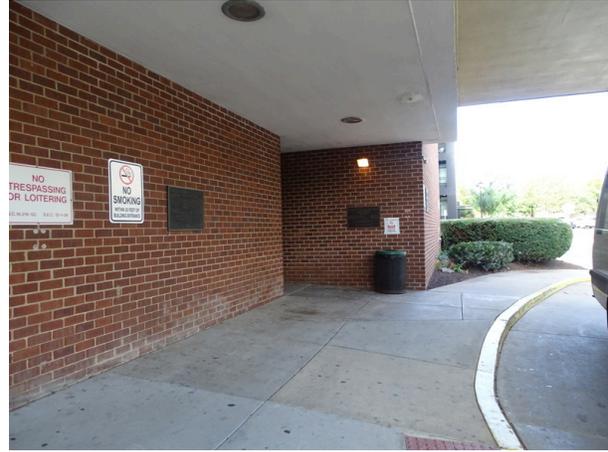
Concrete sidewalk - Note settled.

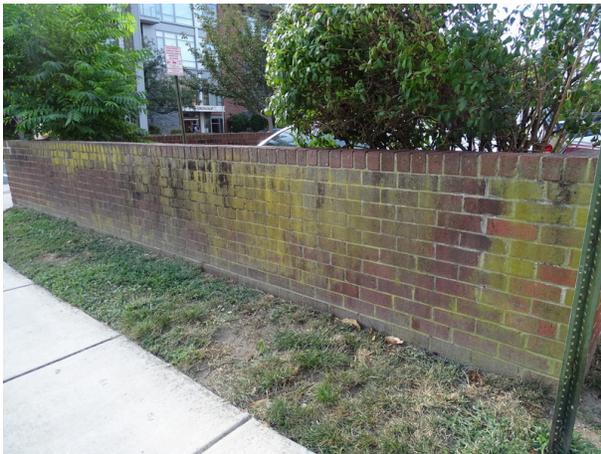
We observed the walls on the east and south sides of the site. Deteriorated mortar joints and cracks were noted. We recommend providing an allowance for replacing the mortar joints.

Typical wall - Note stains and mortar joint condition.

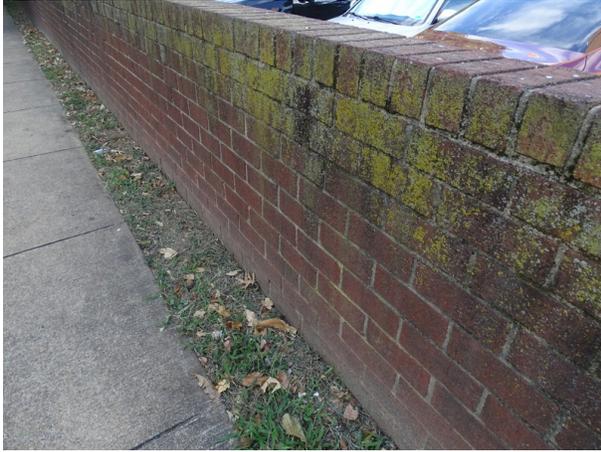
Typical wall - Note stains and mortar joint condition.

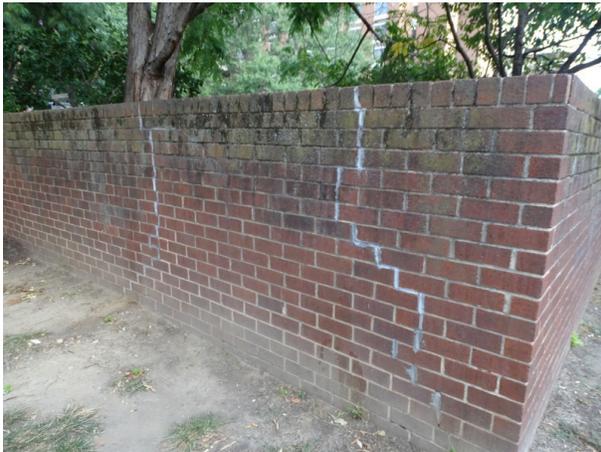
Typical wall - Note stains and mortar joint condition.

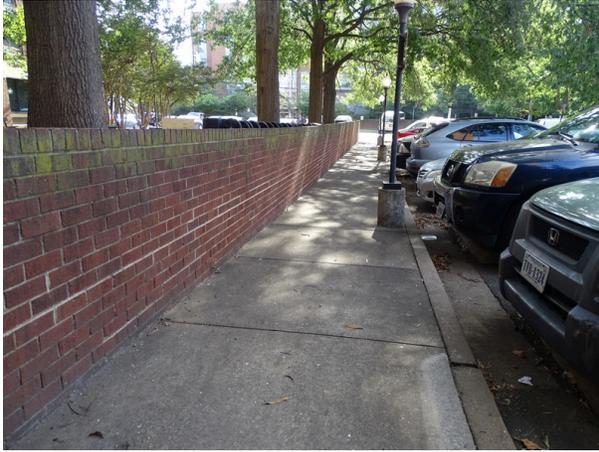
Typical wall - Note stains and mortar joint condition.

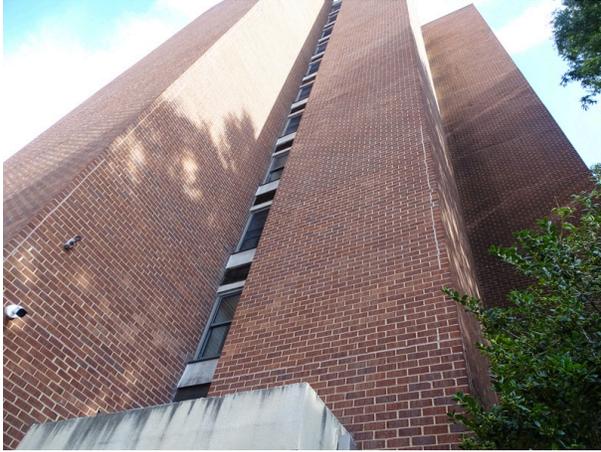
Exterior wall finishes at south side - Note mortar joint condition.

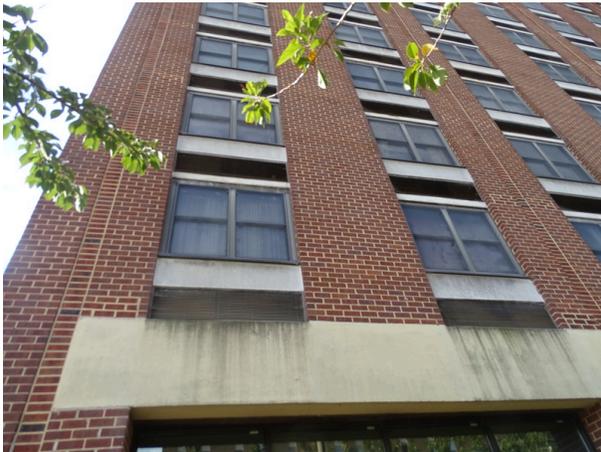
Exterior wall finishes at north side - Note stains.

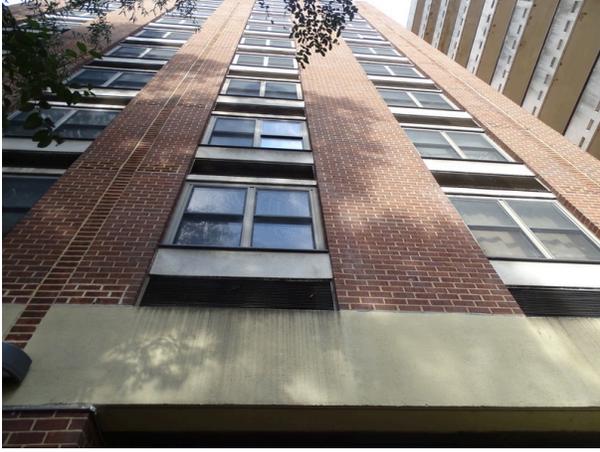
Exterior wall finishes at north side - Note stains.

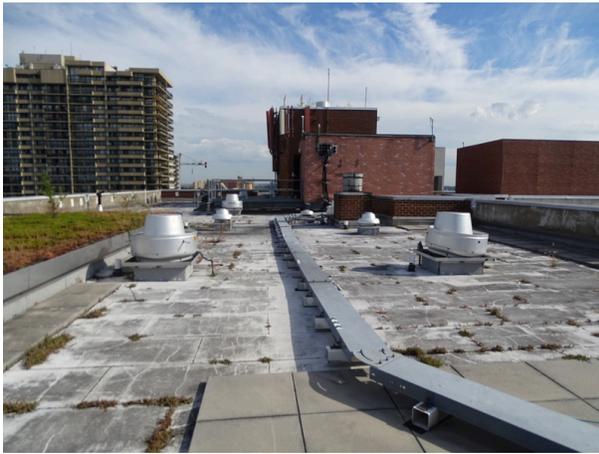
The roofing system is a low-sloped Inverted Roof Membrane Assembly (IRMA), consisting of a modified bitumen membrane located beneath insulation and concrete pavers, which serve to protect the membrane from direct exposure. The roof exhibits signs of deterioration, including vegetation growth. Based on the observed conditions, the roofing system appears to be at or near the end of its expected useful life. We recommend providing an allowance for full replacement of the IRMA roofing system.

IRMA Roofing System – Cracks and vegetation were observed.

Cost Recommendation	EUL	EFF AGE	RUL	Year	Cost
REPLACE IRMA ROOFING SYSTEM	20	19	1	1	\$250,000
REPLACE GREEN ROOFING SYSTEM	20	19	1	1	\$48,000
Total					\$298,000

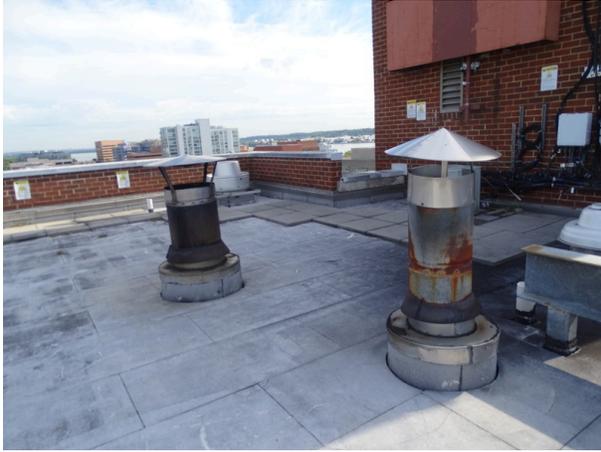
IRMA Roofing System – Note cracks and vegetation were observed.

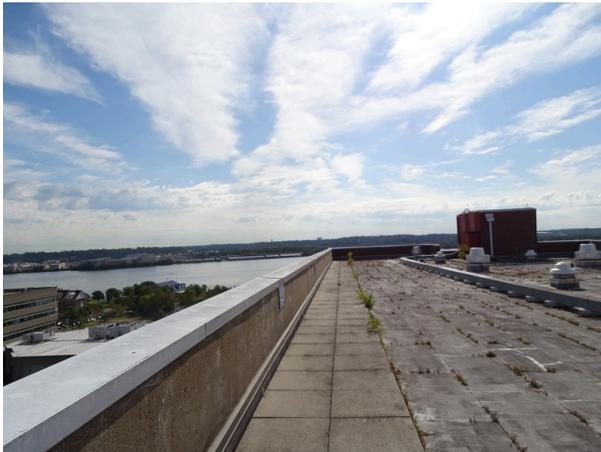
IRMA Roofing System – Note cracks and vegetation were observed.

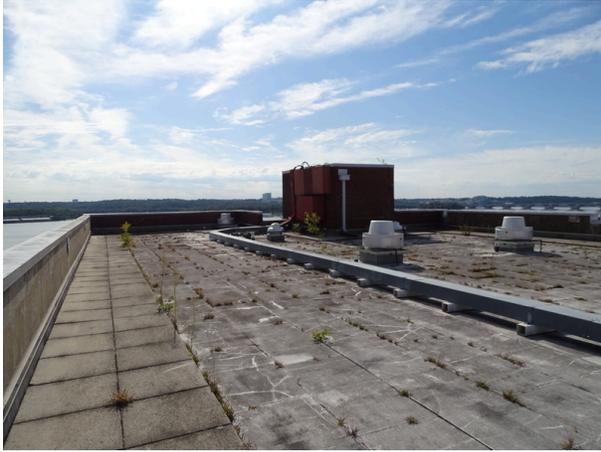
IRMA Roofing System – Note cracks and vegetation were observed.

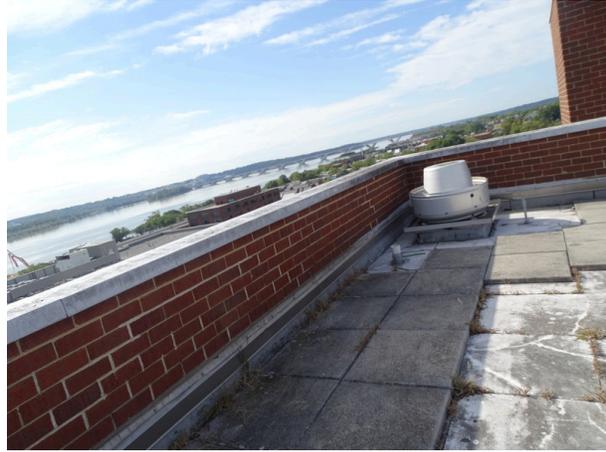
The parapet walls were observed to be in generally good condition. We recommend that the parapets be monitored on an annual basis as a maintenance item.

Typical parapet wall.

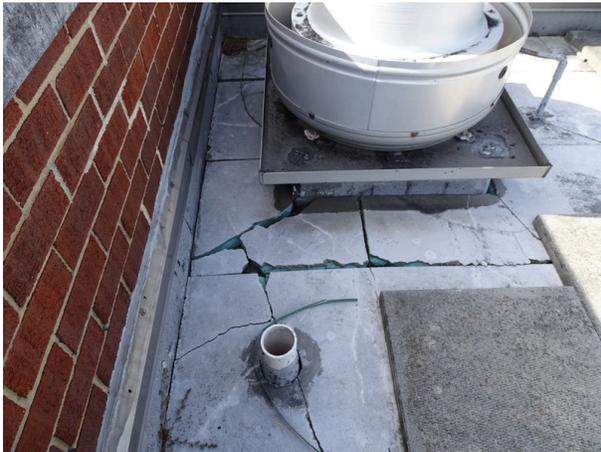
IRMA Roofing System – Note cracks were observed.

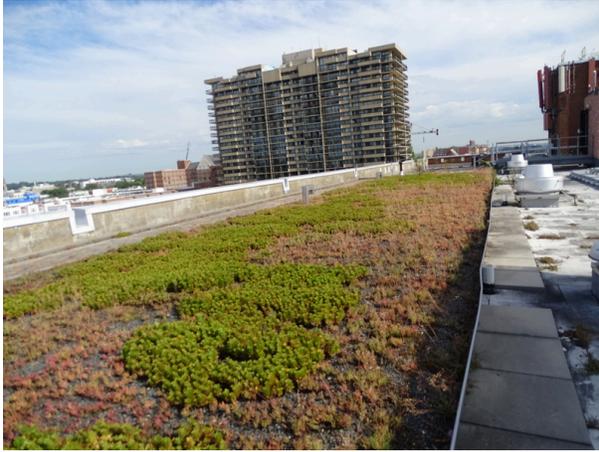
Green Roofing System.

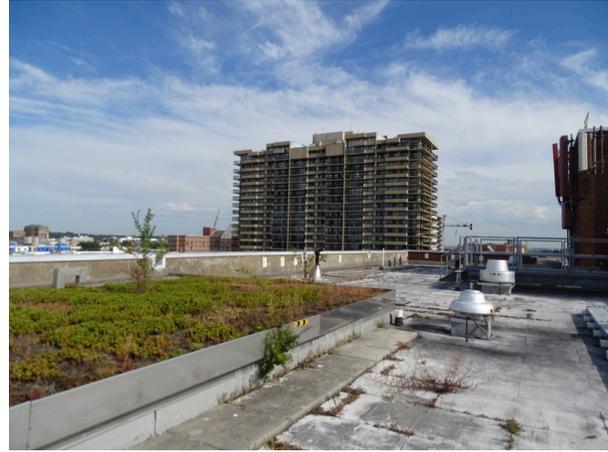
Green Roofing System.

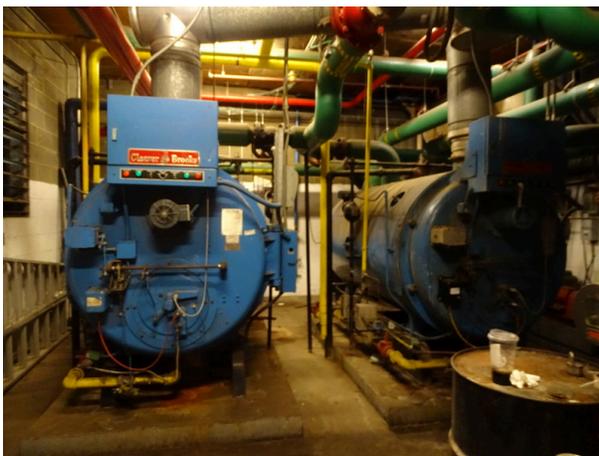
The natural gas boilers are located in the utility room. The boilers were manufactured by Cleaver Brooks in 1977. The boilers were observed to be in fair condition. The expected useful life of a boiler is 30 years with proper maintenance. We recommend that the boilers be replaced.

Boiler manufactured by Cleaver Brooks.

Cost Recommendation	EUL	EFF AGE	RUL	Year	Cost
REPLACE BOILERS	-	-	-	1	\$200,000
Total					\$200,000

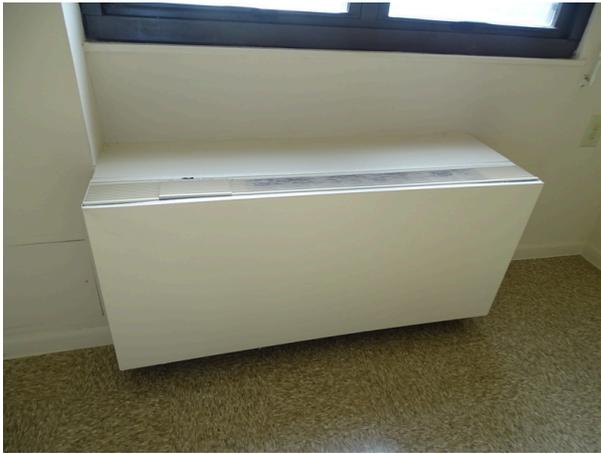
Terminal units include fan coil units serving the apartment units and common areas. These units were typically manufactured by different manufacturers and were observed to be in fair condition. We recommend providing an allowance to replace the fan coil units over the term.

Typical fan coil unit in apartment.

Cost Recommendation	EUL	EFF AGE	RUL	Year	Cost
PROVIDE ALLOWANCE TO REPLACE FAN COIL UNITS AND ASSOCIATED PIPING	-	-	-	1	\$150,000
				2	\$150,000
				3	\$150,000
				4	\$150,000
				5	\$150,000
				6	\$150,000
				7	\$150,000
				8	\$150,000
				9	\$150,000
				10	\$150,000
Total					\$1,500,000

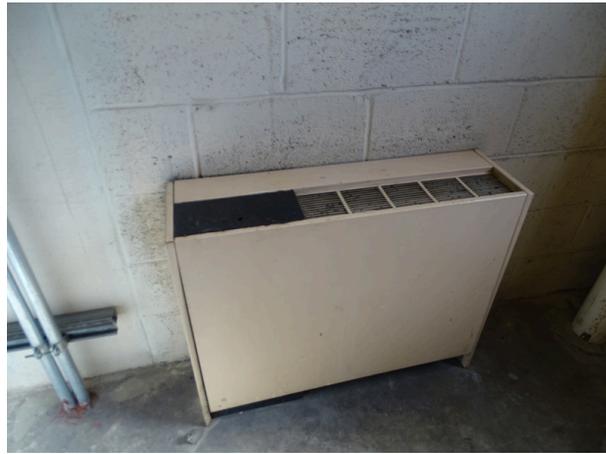
Fan coil unit in walkways and stairwell.

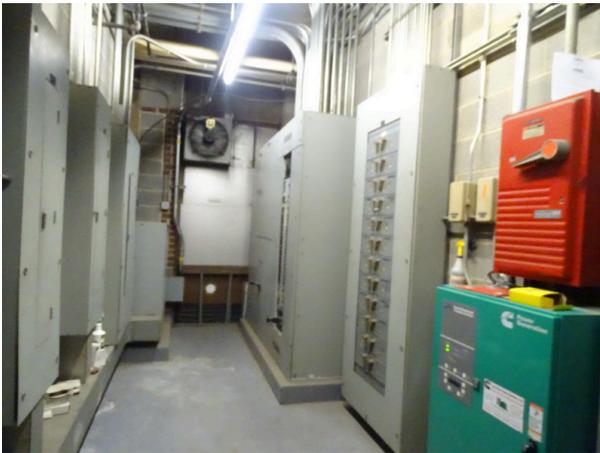
The switchgear was manufactured by Federal Pacific. Federal Pacific was sold in 1988 and since the end of manufacturing of circuit breakers under the Federal Pacific Electric (FPE) brand, compatible Stab-Lok® type breakers have appeared under names such as "American", "Federal Pioneer", "Challenger", "Federal Pacific Reliance Electric", and "Federal Pioneer Limited" (Canada). Some of the Stab-Lok® type breakers have been known to short out and cause fires. Replacement breakers for Federal Pacific panels are typically expensive and not readily available. Due to age of the equipment and the difficulty of getting replacement parts, we recommend that the Federal Pacific panels be replaced.

Main service disconnect.

Cost Recommendation	EUL	EFF AGE	RUL	Year	Cost
REPLACE MAIN SWITCHGEAR	-	-	-	1	\$100,000
Total					\$100,000

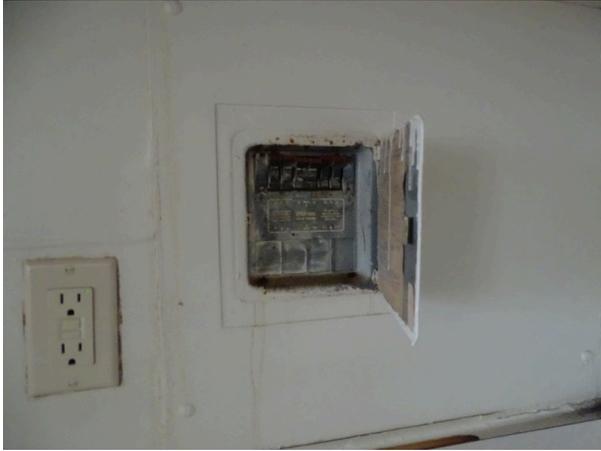
Electrical panels.

Cost Recommendation	EUL	EFF AGE	RUL	Year	Cost
REPLACE CIRCUIT BREAKER PANELS	-	-	-	1	\$125,000
				2	\$125,000
Total					\$250,000

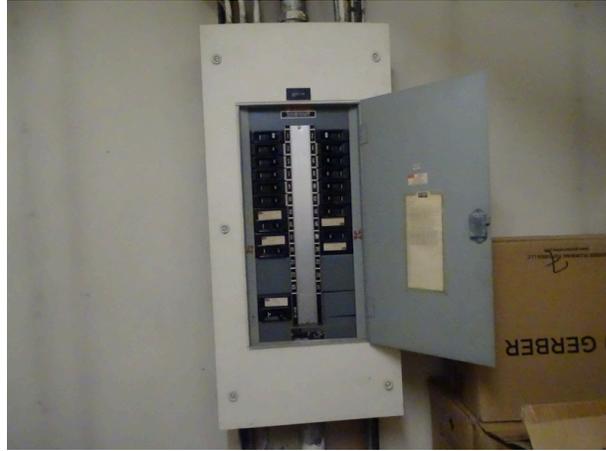
Electrical panels.

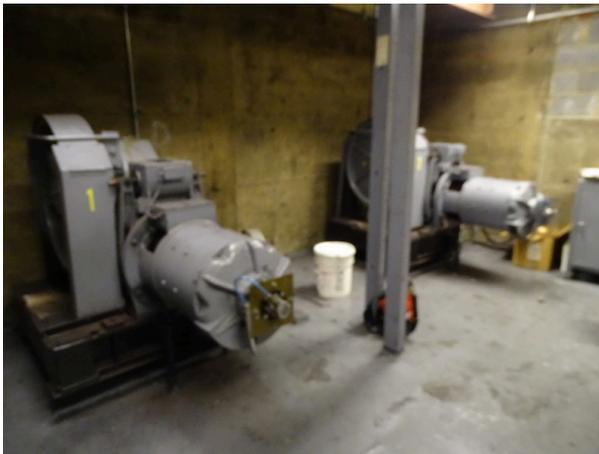
The building is served by two passenger elevators. The elevators were manufactured by Otis. The expected useful life of the elevator controls is 30 to 40 years with proper maintenance. We recommend providing an allowance to modernize the elevators.

Elevator machine room.

Cost Recommendation	EUL	EFF AGE	RUL	Year	Cost
MODERNIZED THE ELEVATORS	-	-	-	1	\$350,000
				2	\$350,000
Total					\$700,000

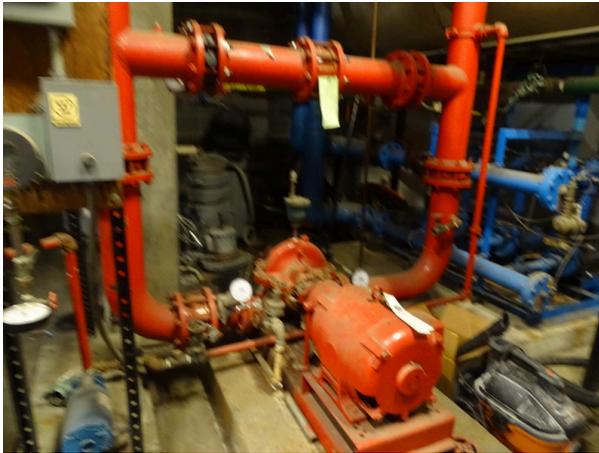
Fire suppression system is located in the utility room.

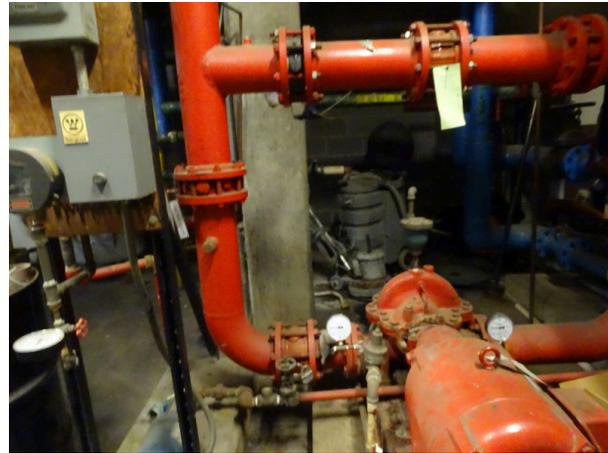
Fire suppression system is located in the utility room.

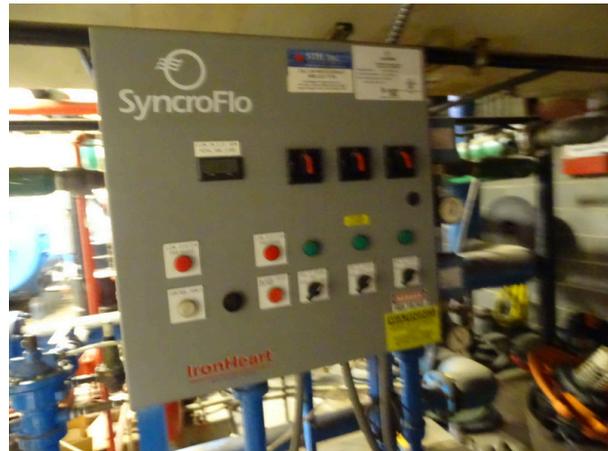
The sprinkler pump is located in the utility room. The sprinkler pump was manufactured by SyncroFlo IronHeart Pump Control Panel. The expected useful life of a sprinkler pump is 20 years with proper maintenance. We recommend that the sprinkler pump be replaced.

Booster pump control.

Cost Recommendation	EUL	EFF AGE	RUL	Year	Cost
REPLACE SPRINKLER PUMP	-	-	-	1	\$15,000
Total					\$15,000

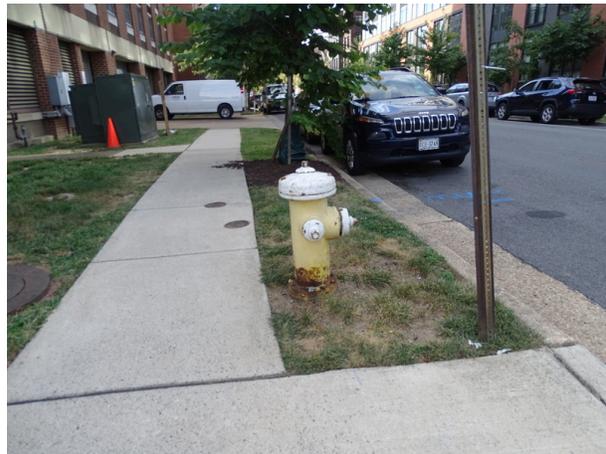
Fire hydrants are located around the site. The fire hydrants were observed to be in good condition.

Fire hydrant.

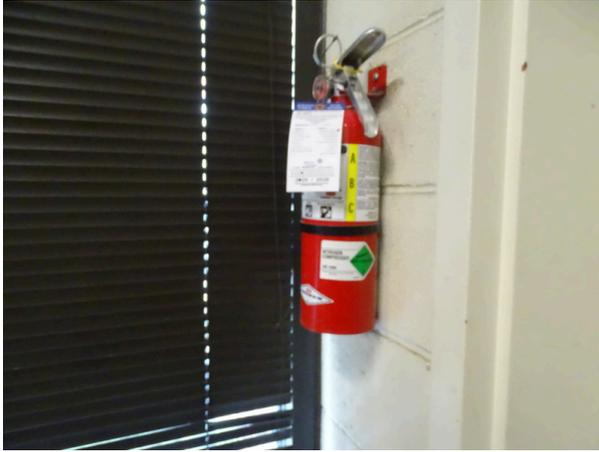
Fire extinguishers were observed throughout the interior spaces. The fire extinguishers were observed to have recent inspection tags issued by Johnson Control Fire Safety Inspections company. These devices are required to be inspected annually. Replacement of the fire extinguishers is considered routine maintenance.

Fire extinguishers.

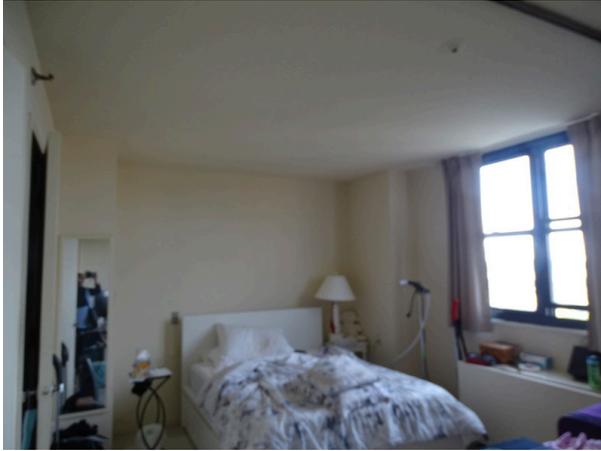
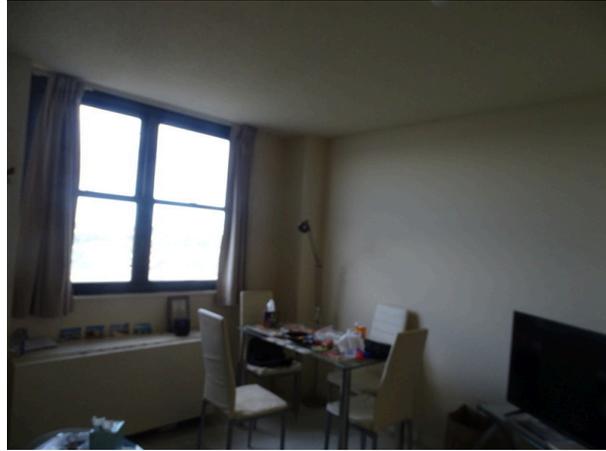
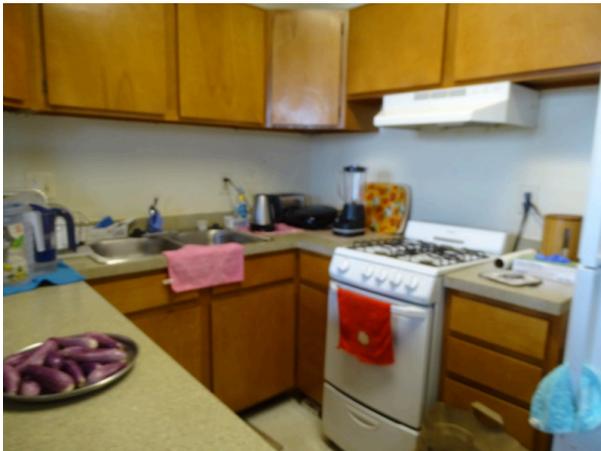
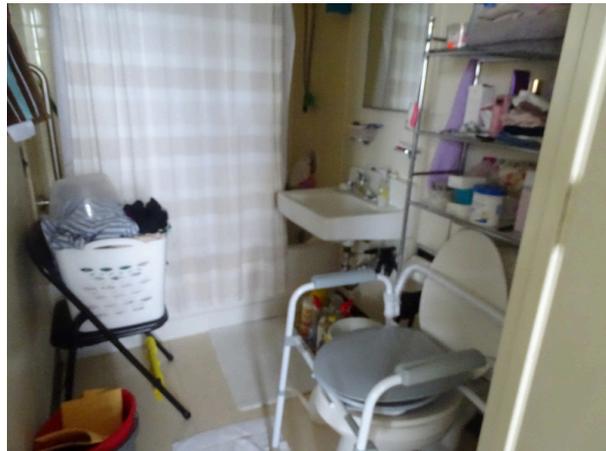
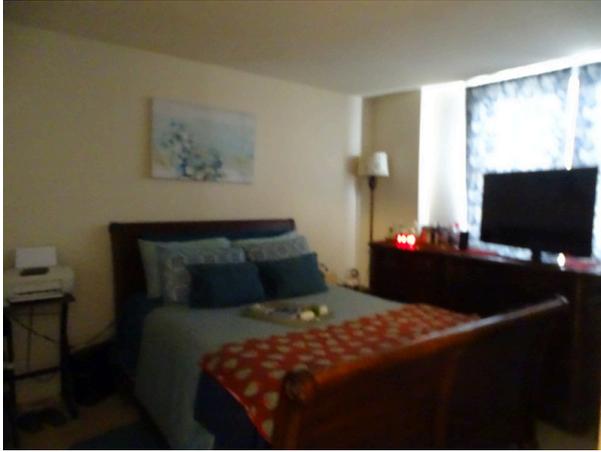
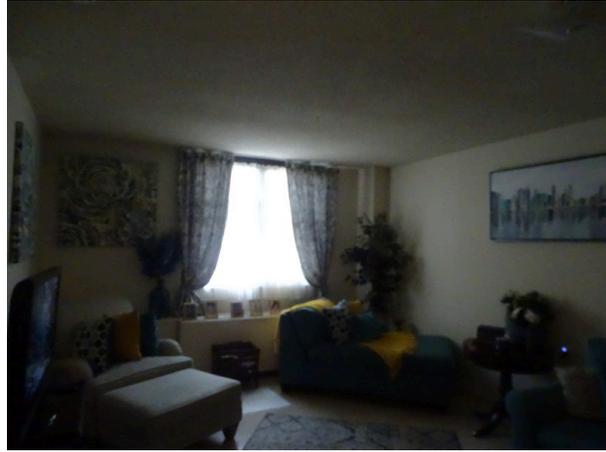
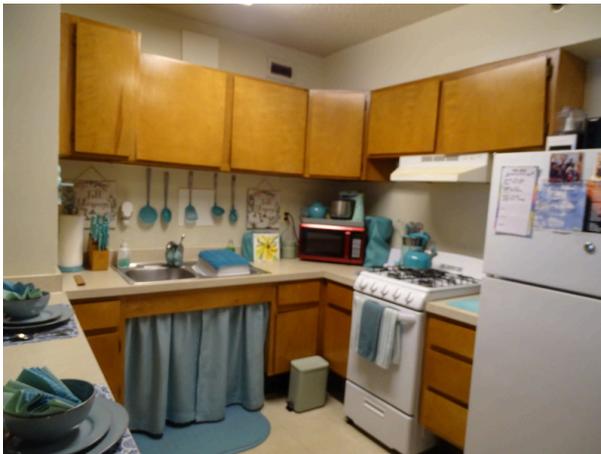
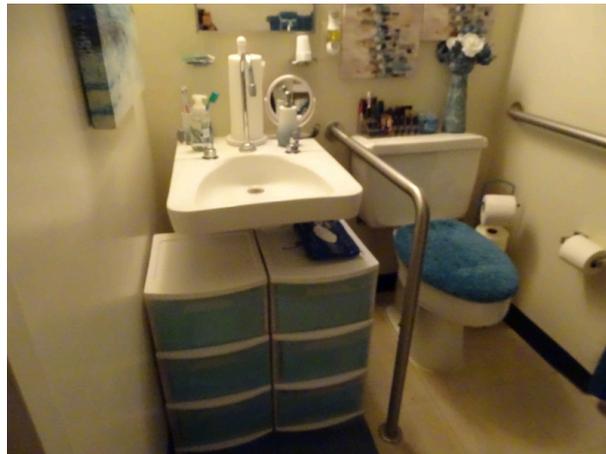
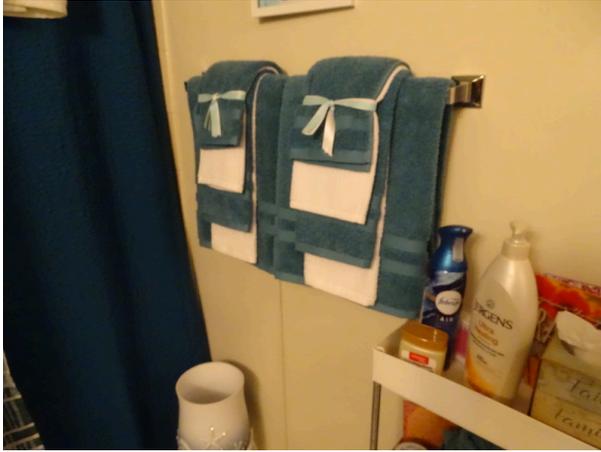
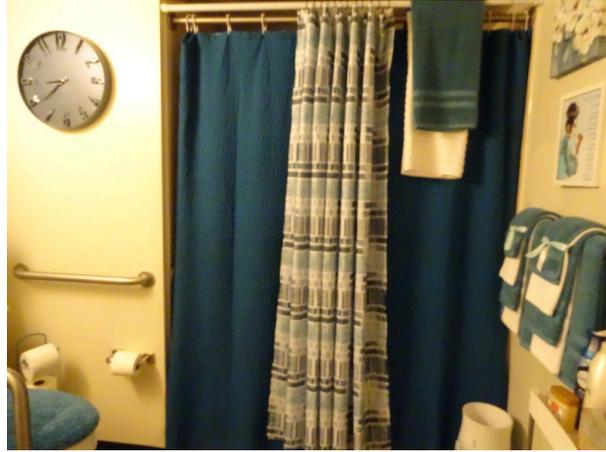
The interior of apartments generally includes a vinyl flooring area in the entrance, kitchen, bathrooms, and carpet or vinyl flooring in the bedrooms. The kitchens and bathrooms have typical wood cabinets and laminate counters. The appliances manufacturer and age varied by apartment. The finishes were observed to be in generally fair condition. We recommend that the apartment finishes be replaced as needed.

Cost Recommendation	EUL	EFF AGE	RUL	Year	Cost
PAINT APARTMENTS AS NEEDED	-	-	-	1	\$17,600
				3	\$17,600
				5	\$17,600
				7	\$17,600
				9	\$17,600
REPLACE FLOORING IN APARTMENTS AS NEEDED	-	-	-	1	\$26,400
				3	\$26,400
				5	\$26,400
				7	\$26,400
				9	\$26,400
REPLACE CABINETS AND COUNTERS AS NEEDED	-	-	-	1	\$35,200
				3	\$35,200
				5	\$35,200
				7	\$35,200
				9	\$35,200
REPLACE APPLIANCES AS NEEDED	-	-	-	1	\$35,200
				3	\$35,200
				5	\$35,200
				7	\$35,200
				9	\$35,200
Total					\$572,000

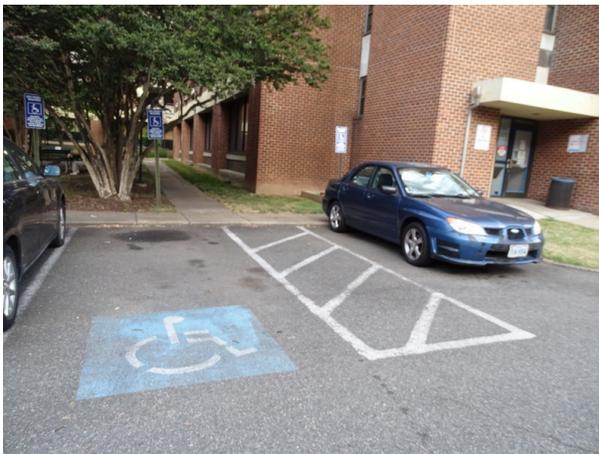
Accessible parking.

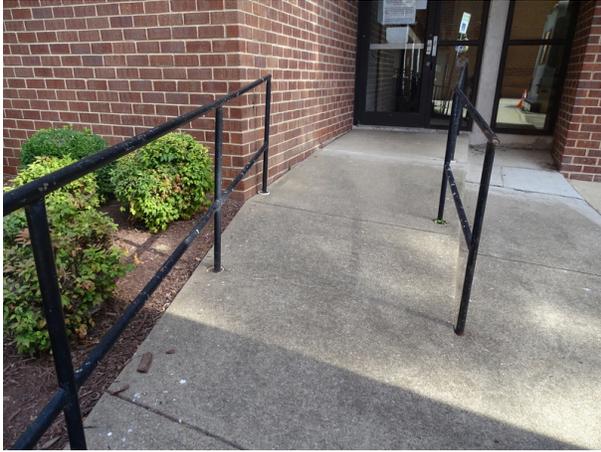
Accessible ramp.

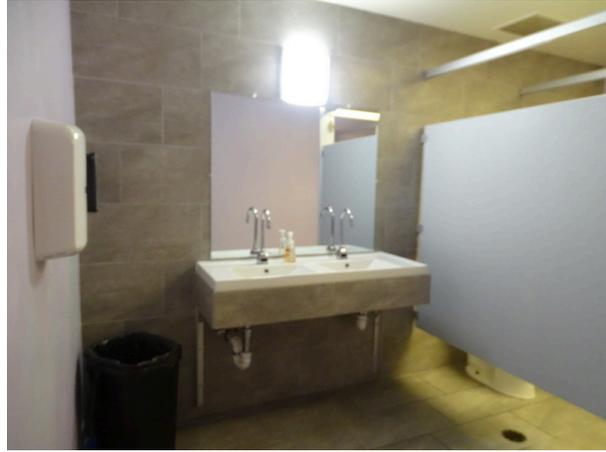
Accessible stall - Note exposed pipe.

Cost Recommendation	EUL	EFF AGE	RUL	Year	Cost
INSTALL TRUNCATED DOMES AT CURB RAMPS	-	-	-	Immediate	\$2,400
INSULATE EXPOSED PIPES UNDER SINKS	-	-	-	1	\$17,600
PROVIDE VAN ACCESSIBLE SPACES	-	-	-	Immediate	\$500
Total					\$20,500

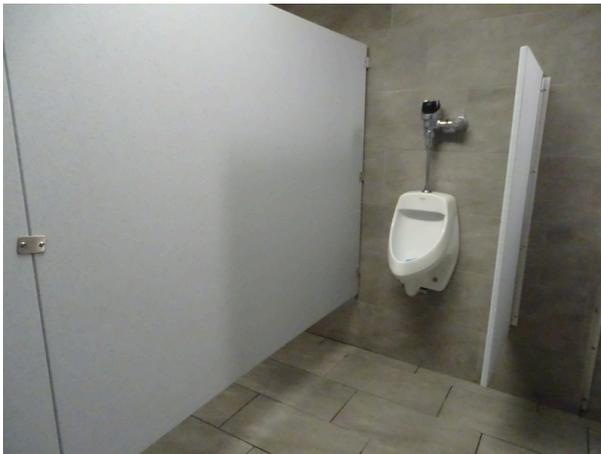
Accessible stall.

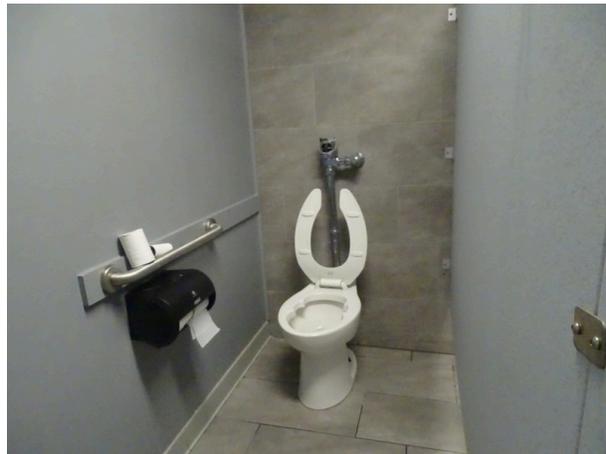
Accessible stall.

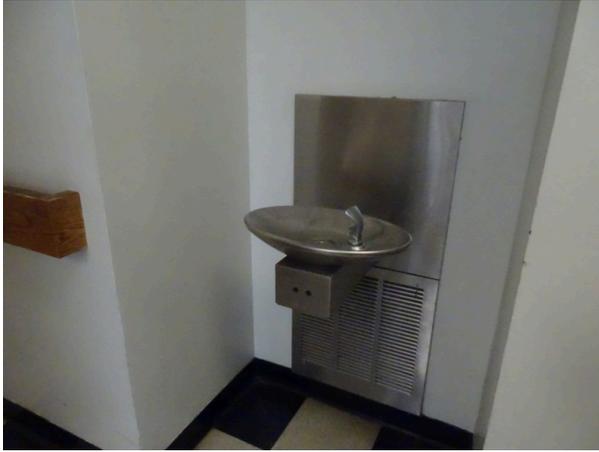
Water fountain.

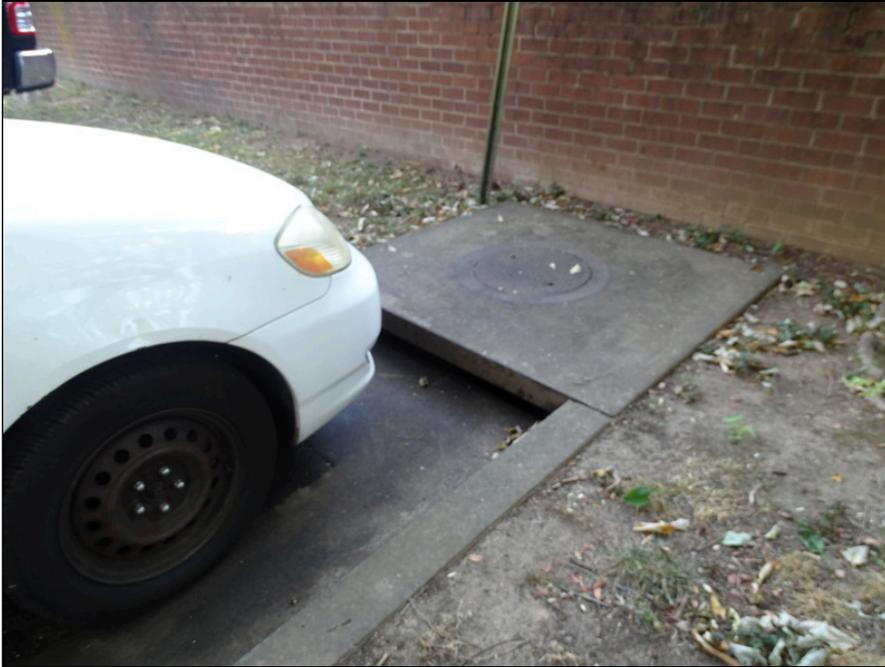
1 - Typical drop inlet.

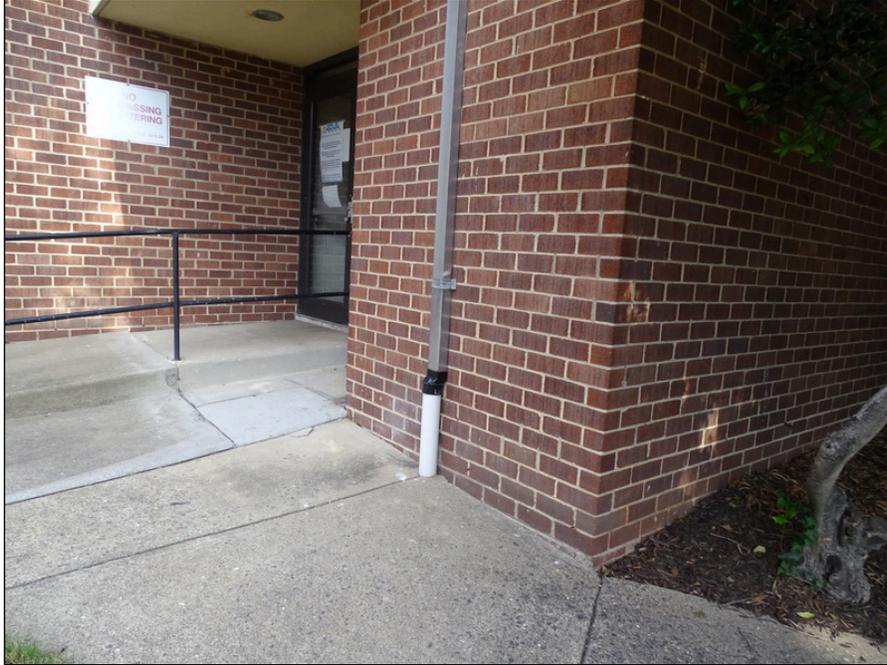
3 - Typical drop downspout.

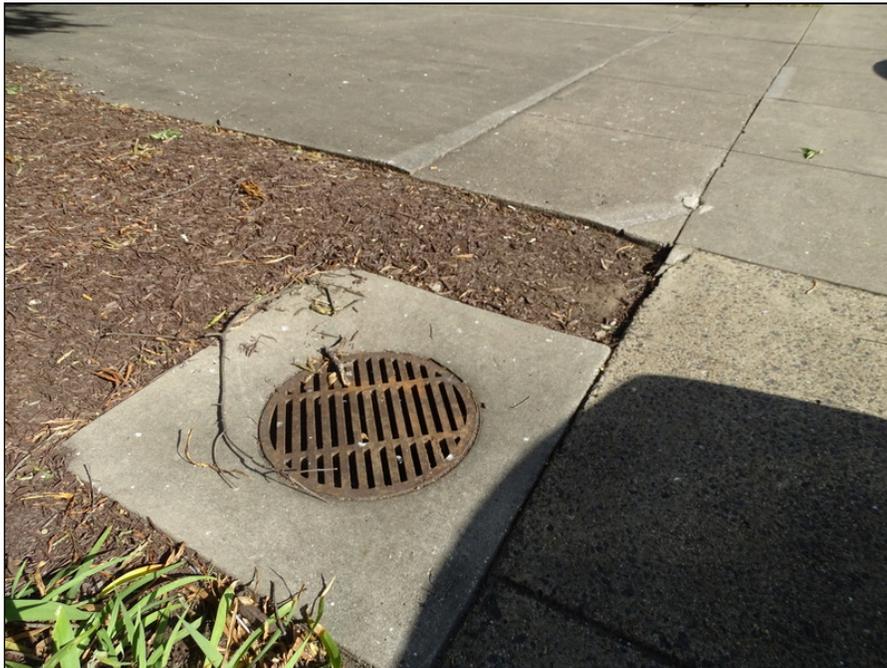
4 - Typical drop inlet.

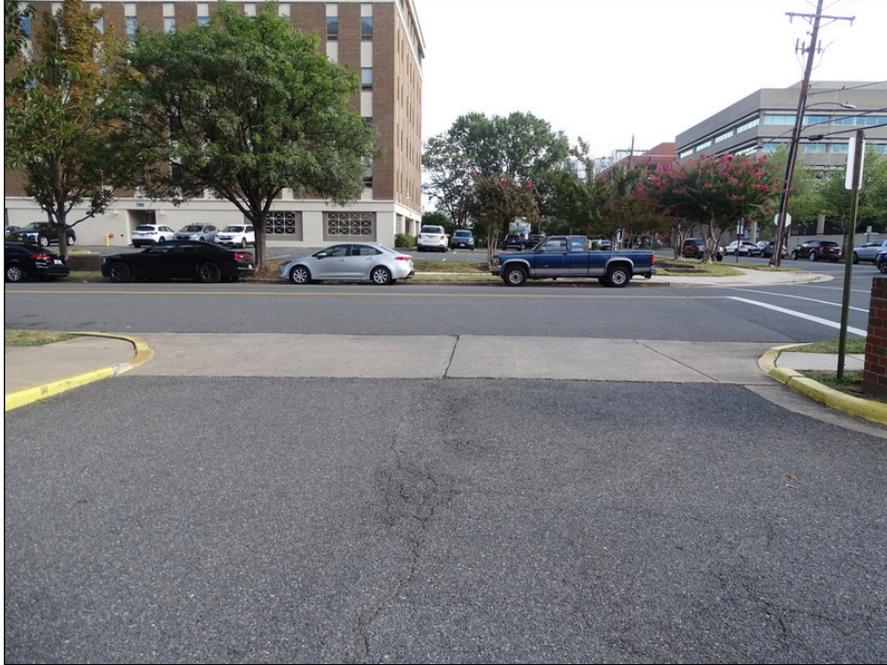
5 - Entrance apron on north side of site.

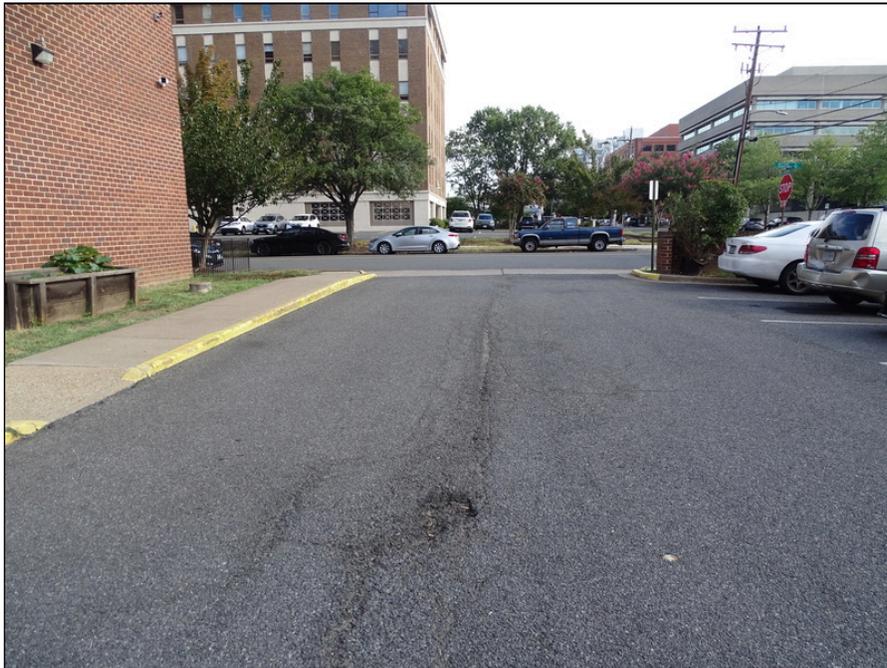
6 - Asphalt pavement in drive lanes and parking spaces - Note cracks.

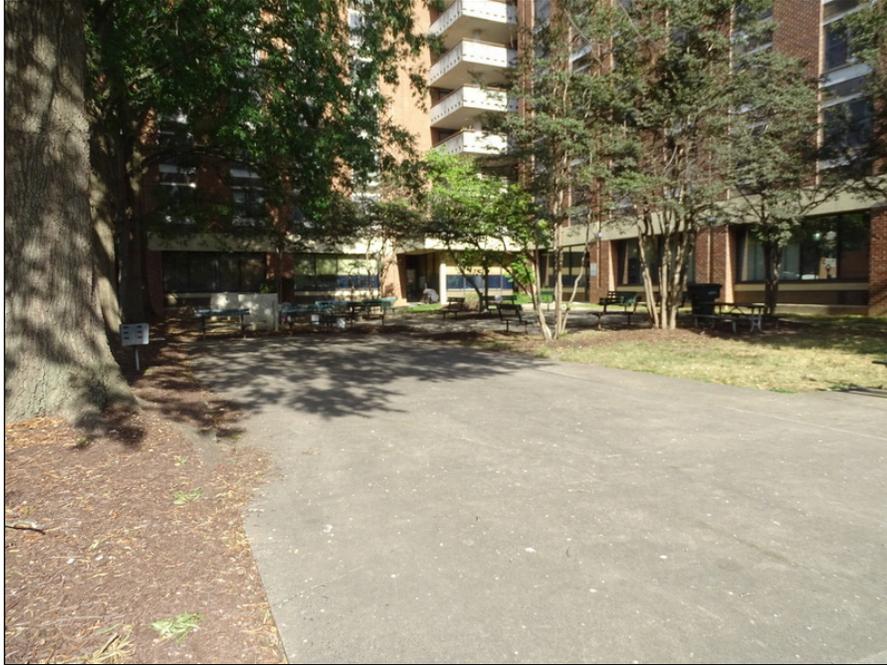
9 - Concrete pavement.

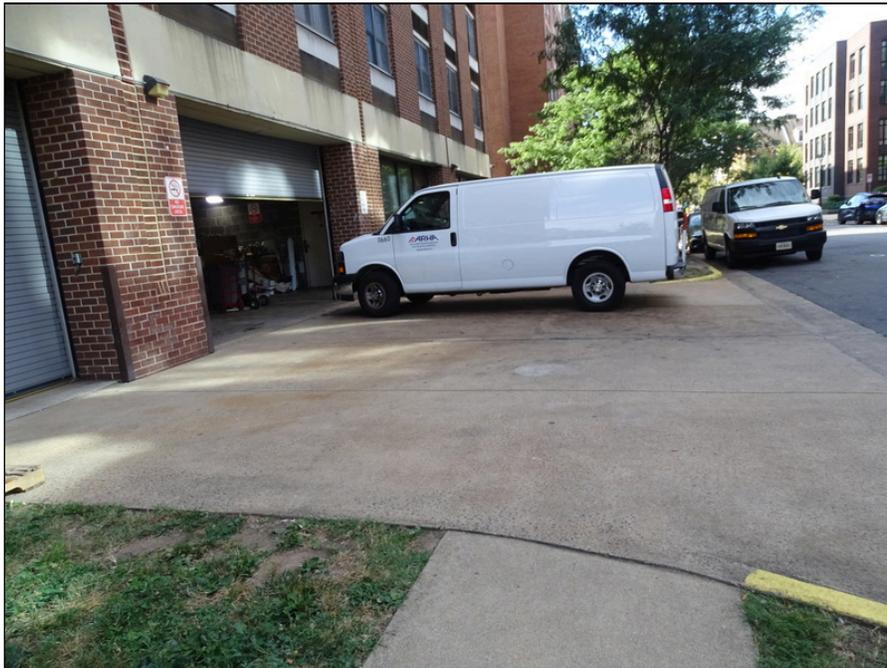
10 - Concrete pavement.

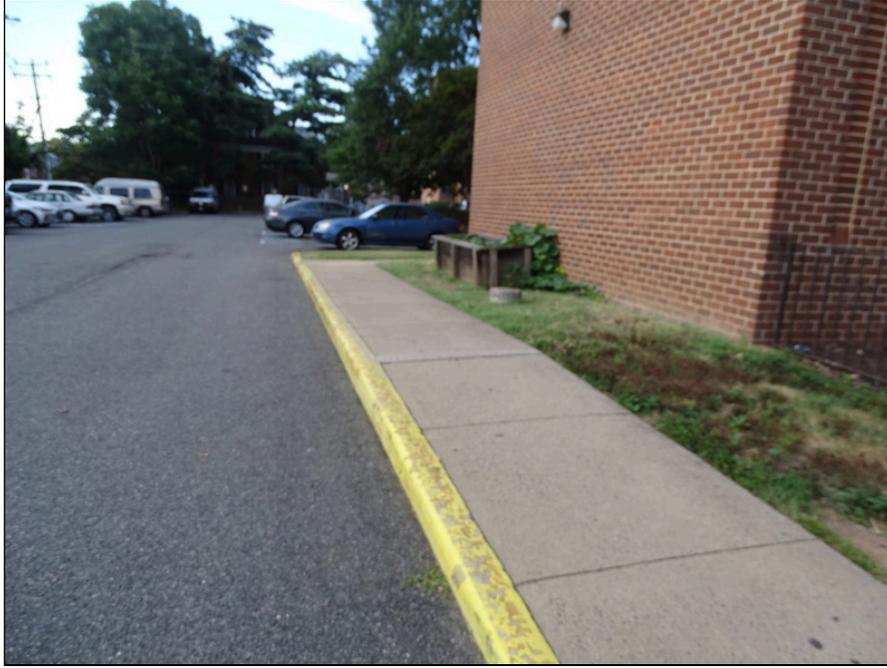
11 - Concrete curb.

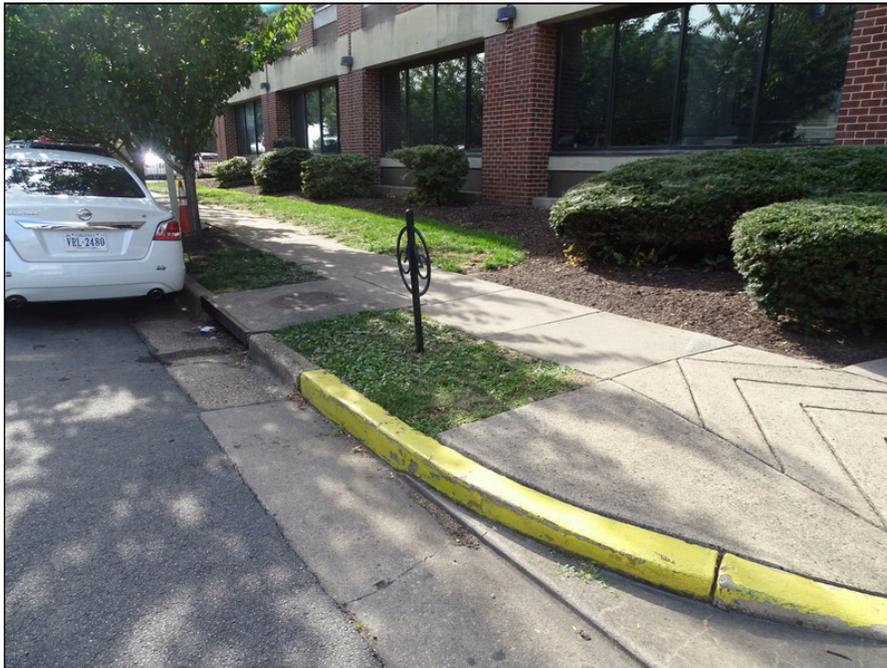
12 - Concrete curb - Note settled.

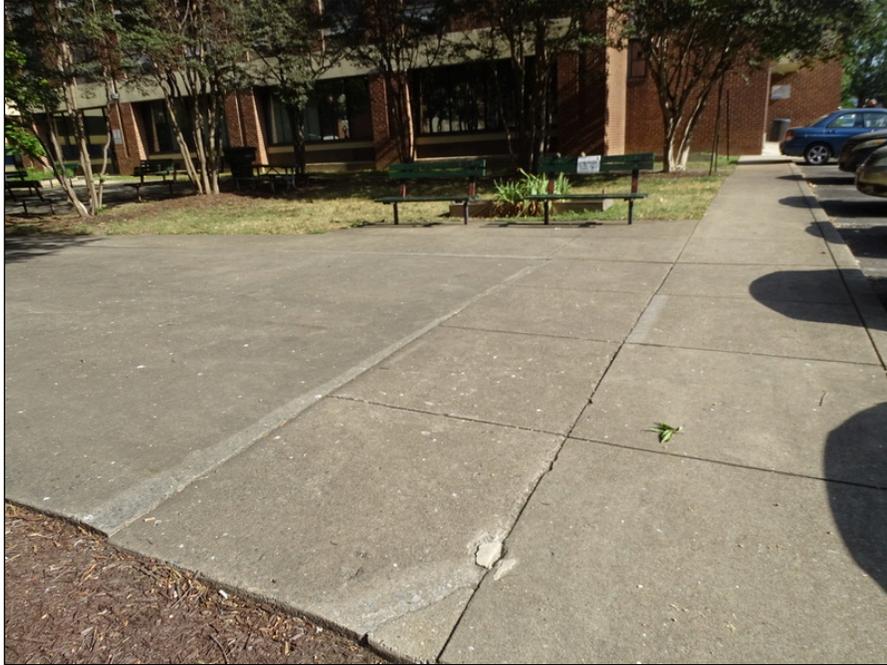
13 - Concrete sidewalk - Note settled.

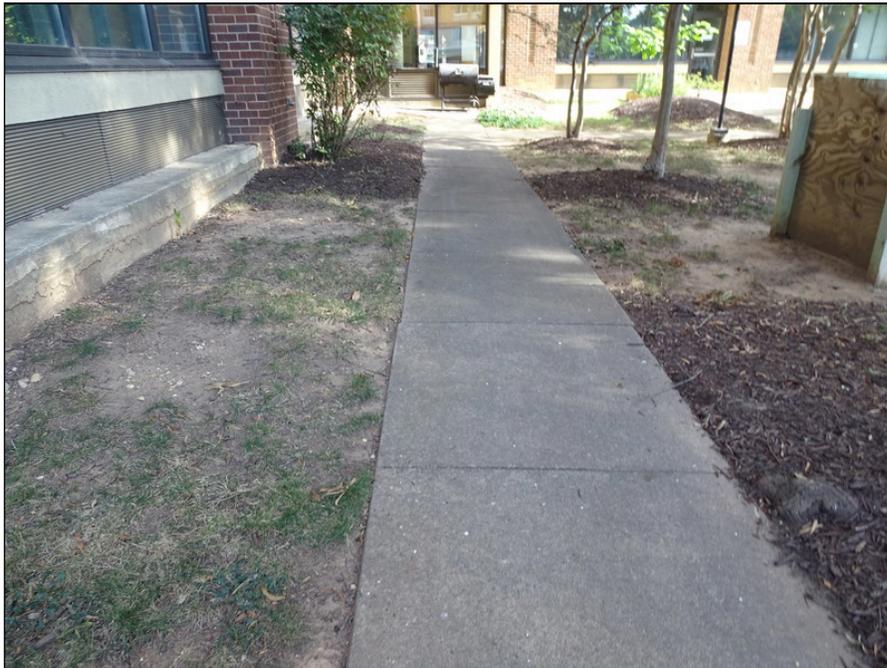
14 - Concrete sidewalk - Note settled.

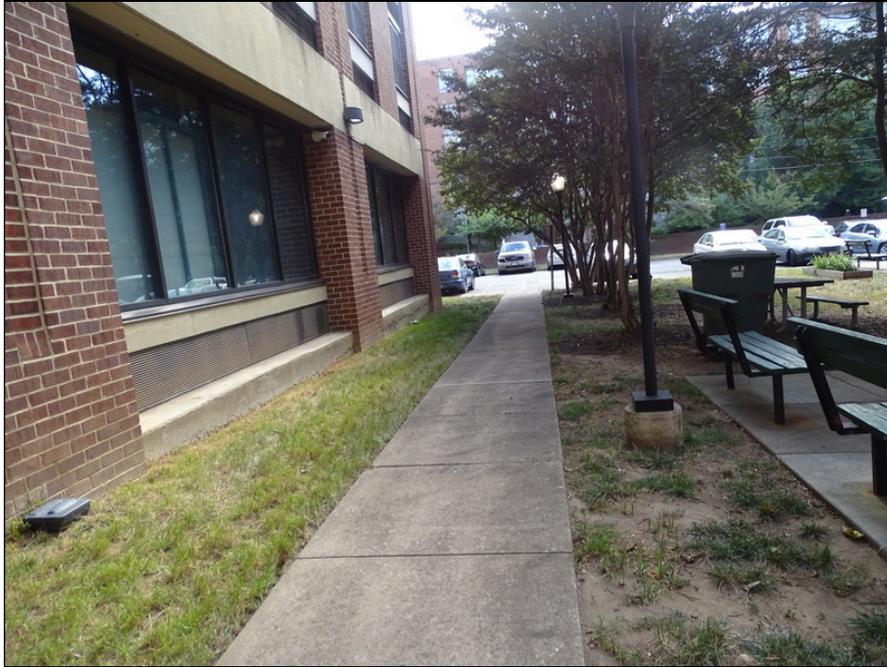
15 - Concrete sidewalk - Note settled.
