PROPERTY CONDITION ASSESSMENT

LADREY HIGH-RISE APARTMENTS - PROPERTY CONDITION ASSESSMENT
300 WYTHE STREET
ALEXANDRIA, VIRGINIA

ECS PROJECT NO. 46:11503

SEPTEMBER 11, 2025

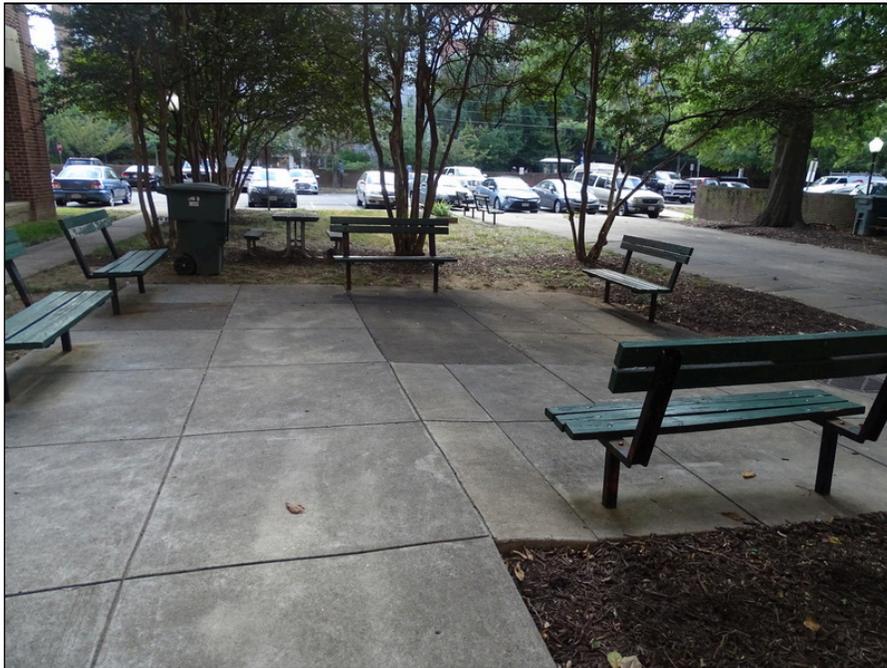
16 - Concrete sidewalk - Note settled.

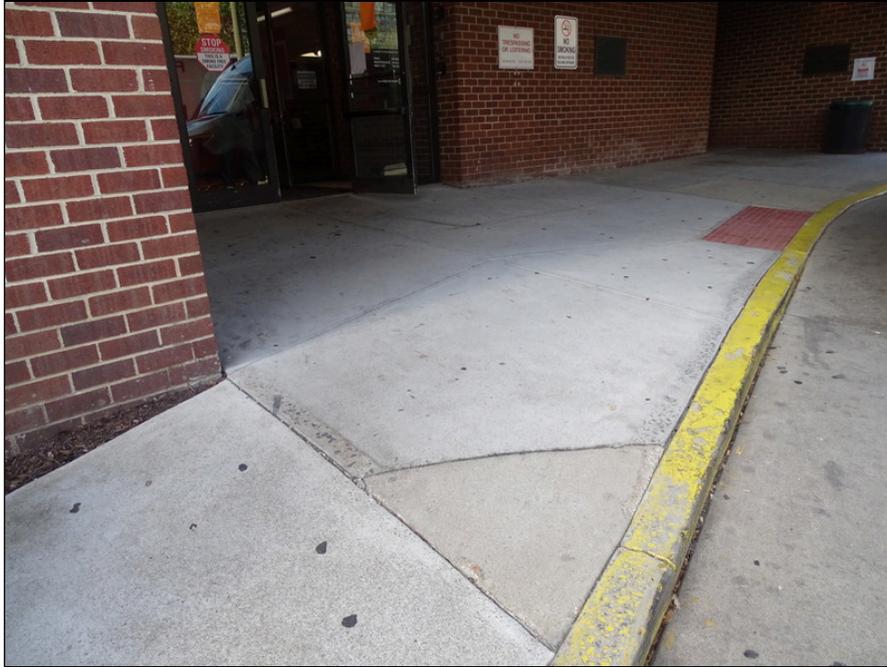
17 - Concrete sidewalk - Note settled.

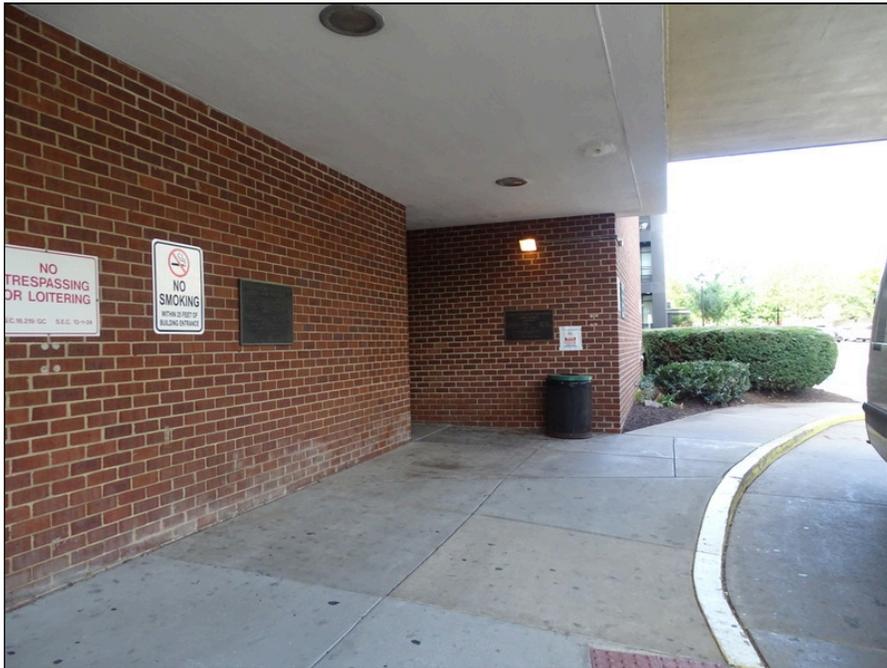
18 - Concrete sidewalk - Note settled.

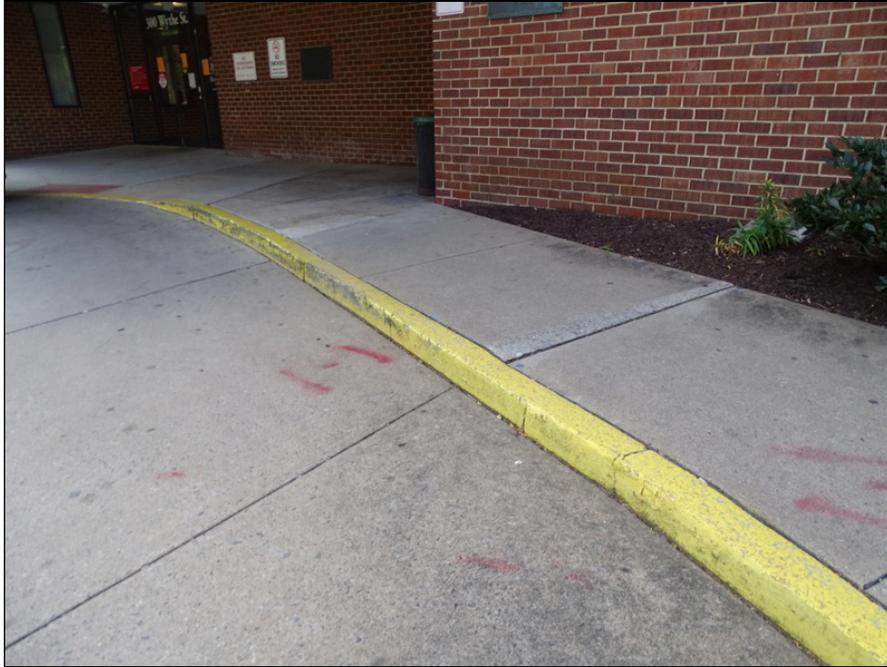
19 - Concrete sidewalk - Note settled.

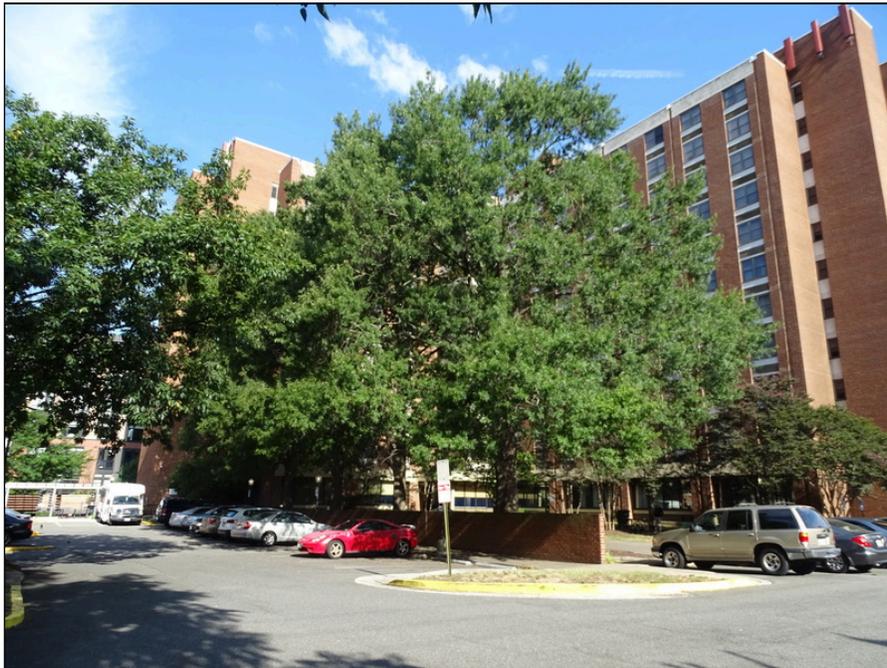
20 - Typical landscaping at east side.

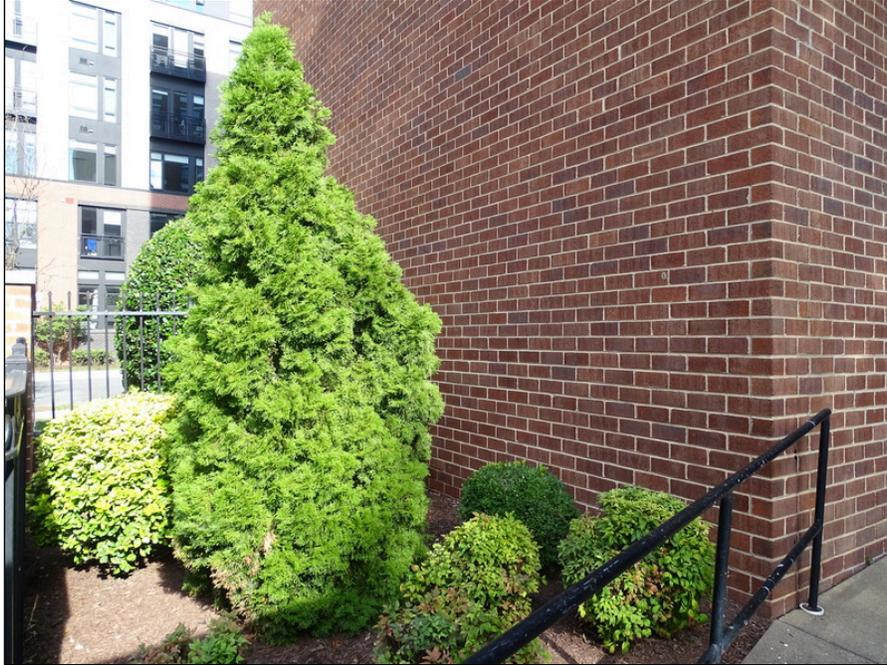
21 - Typical landscaping at south side.

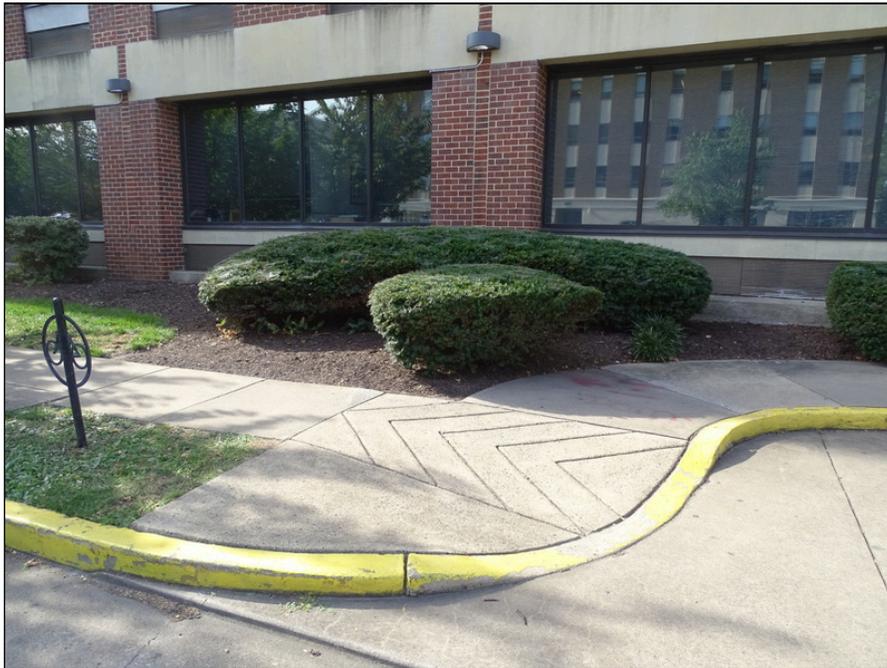
22 - Typical landscaping at north side.

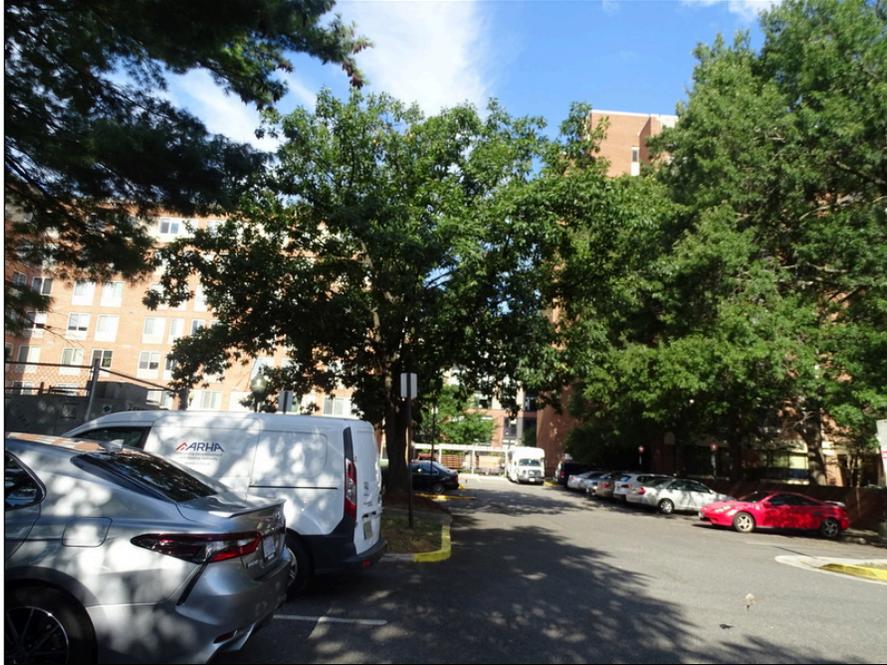
23 - Typical landscaping at south side.

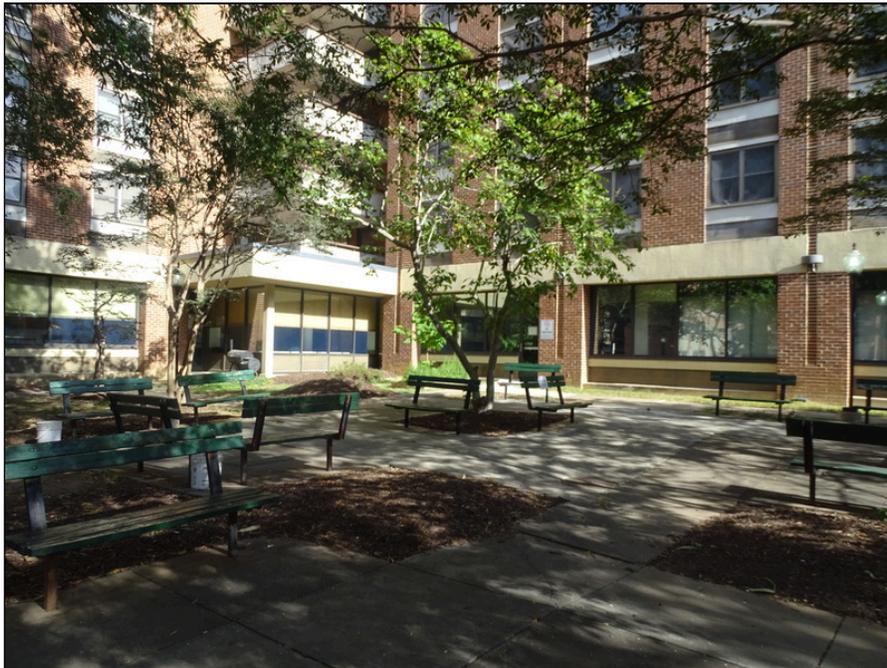
24 - Typical landscaping at south side.

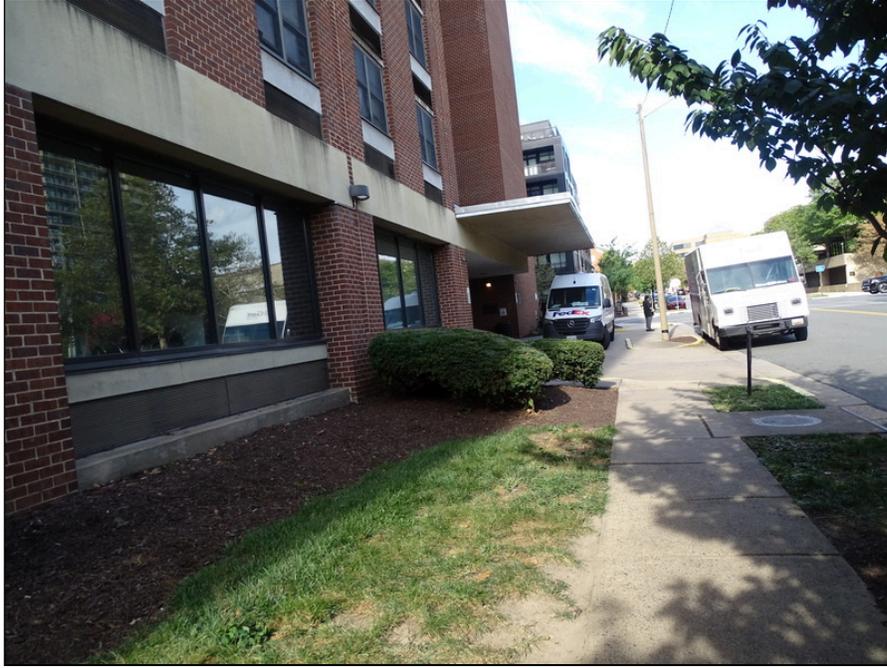
25 - Typical landscaping at north side.

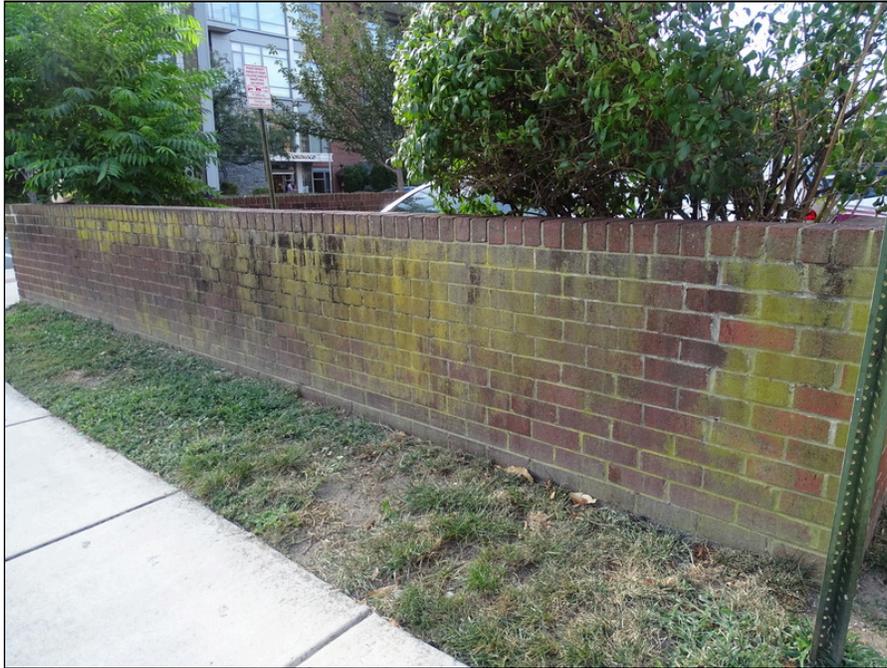
26 - Typical wall - Note stains and mortar joint condition.

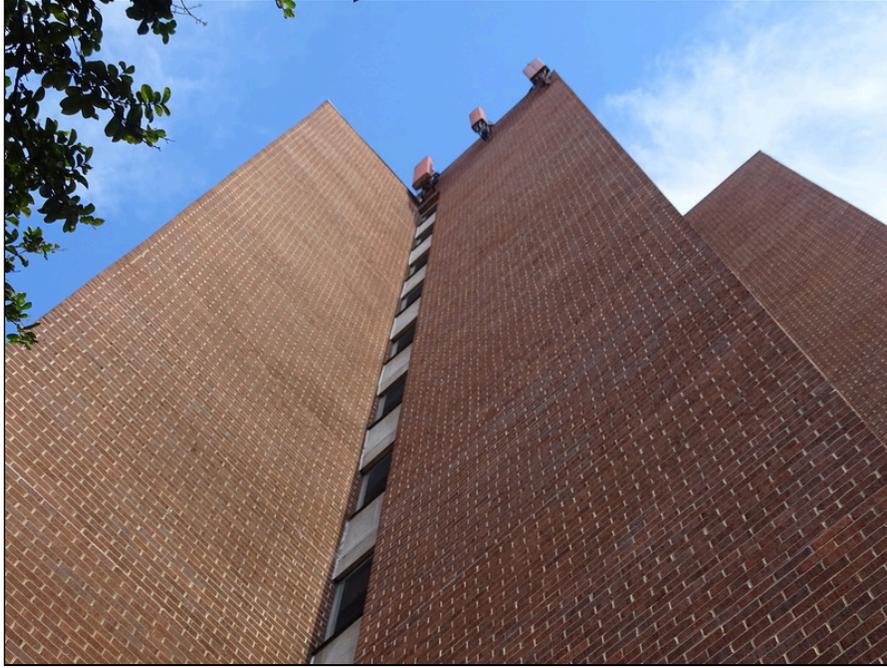
35 - Exterior wall finishes at south side.

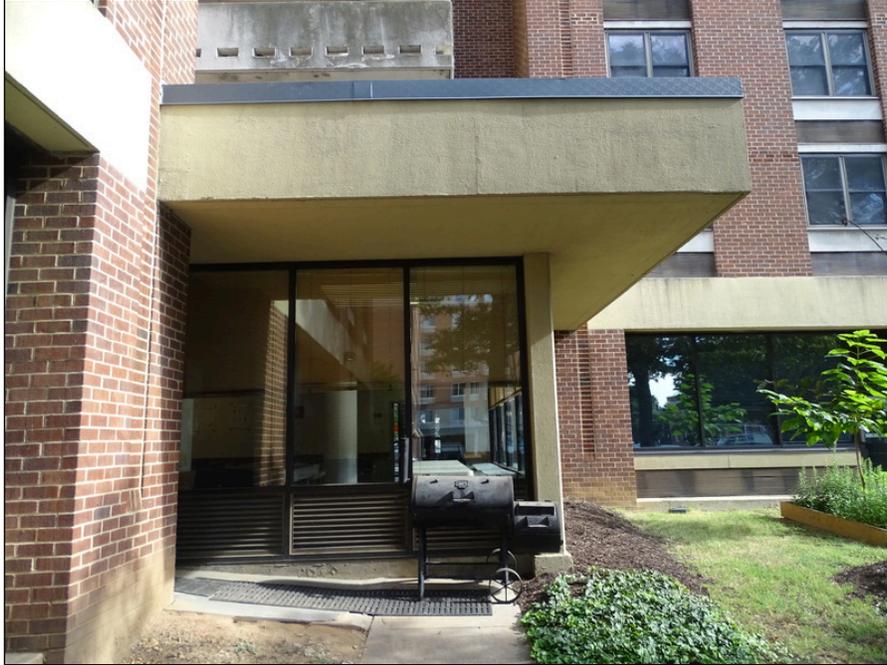
45 - Storefront entrance.

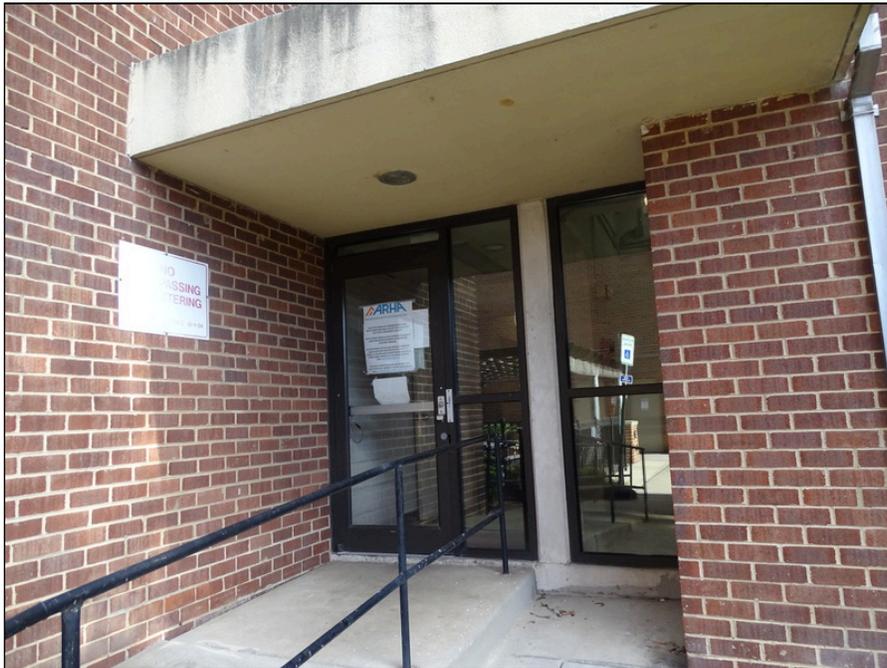
46 - Storefront entrance.

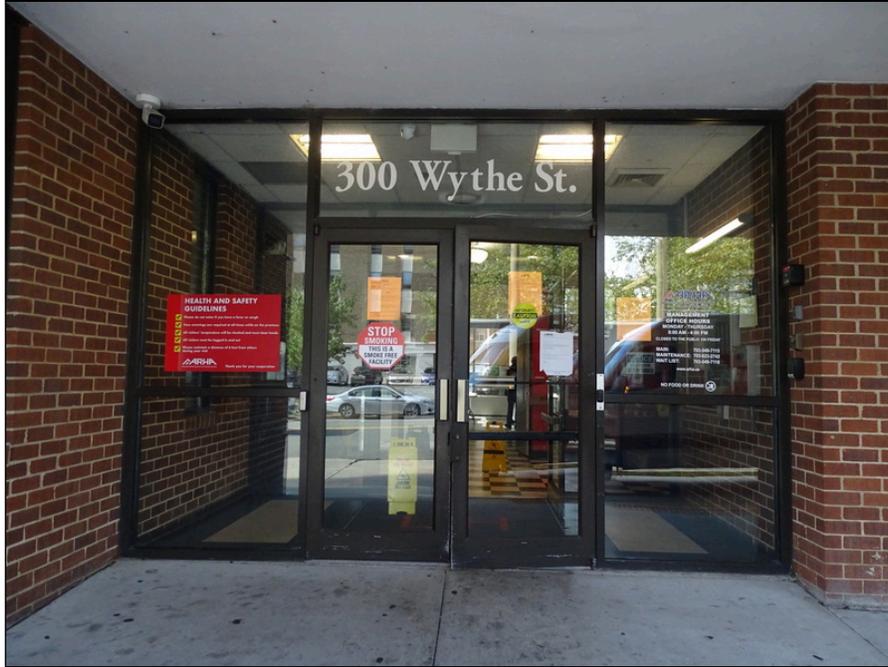
47 - Storefront entrance.

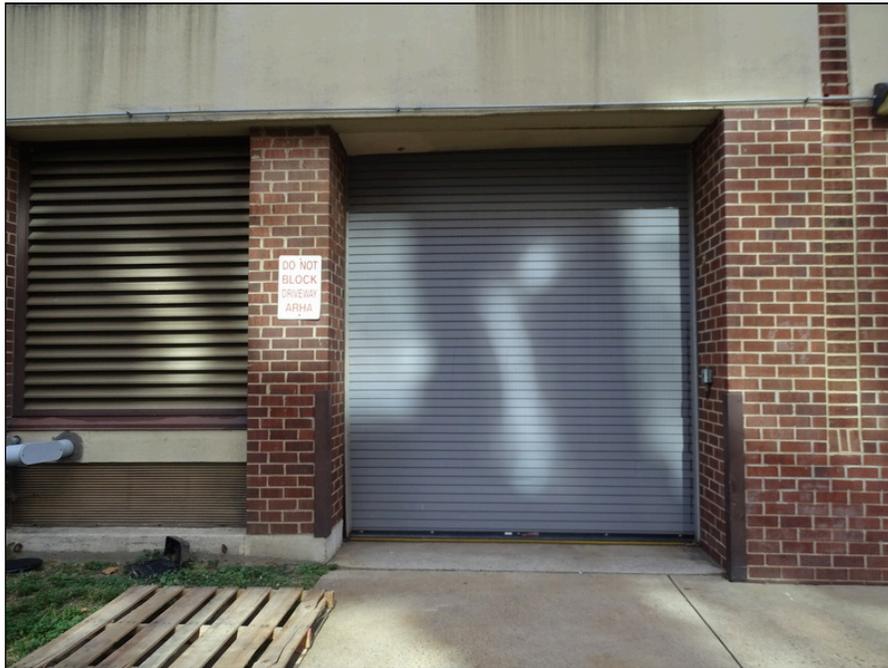
48 - Overhead doors.

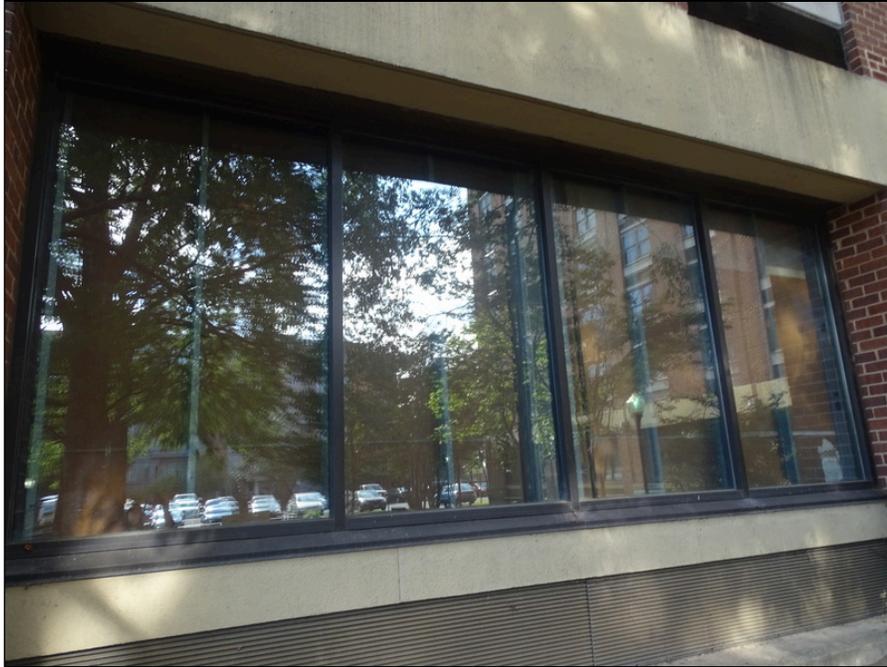
49 - Exterior windows at south side.

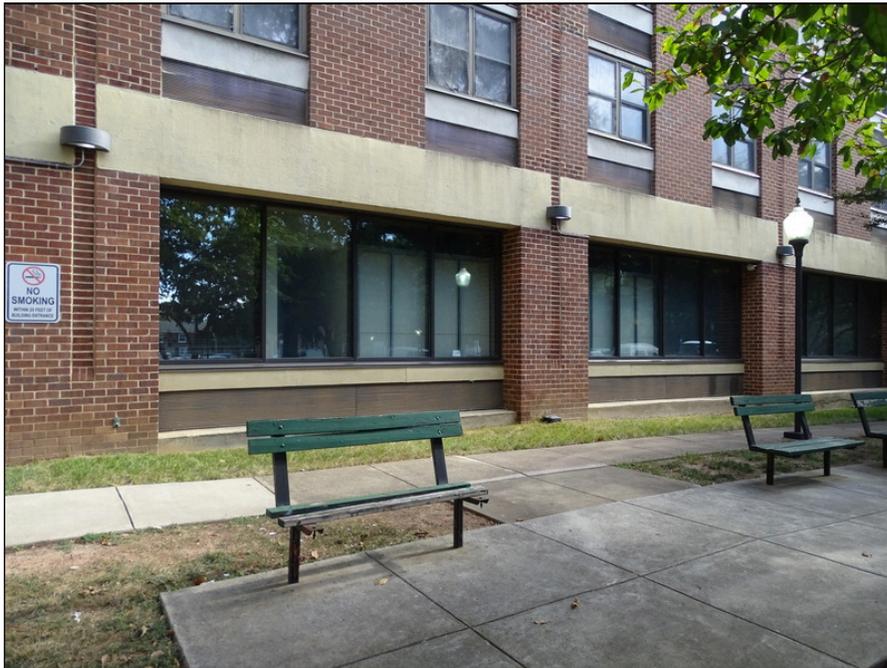
50 - Exterior windows at south side.

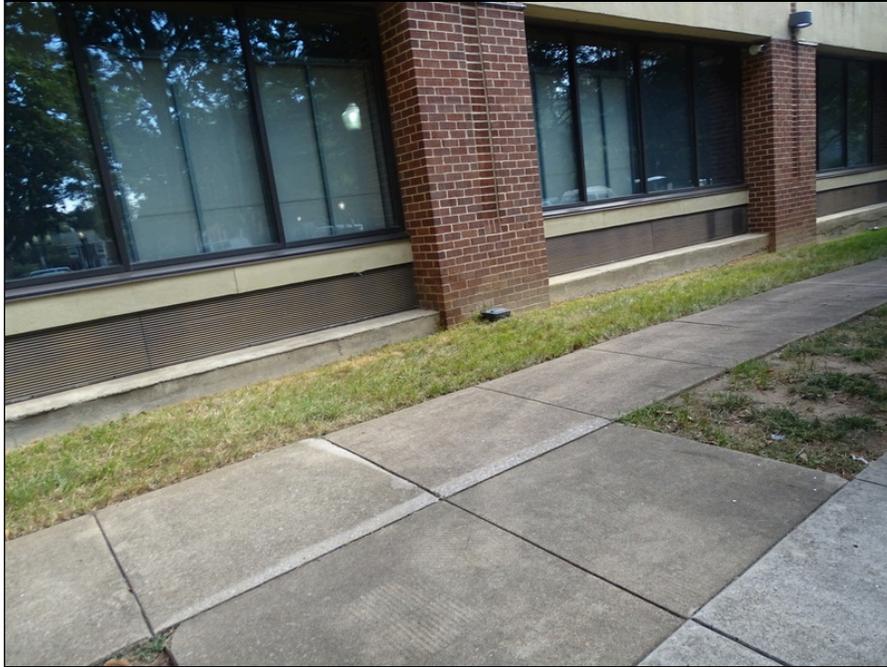
51 - Exterior windows at south side.

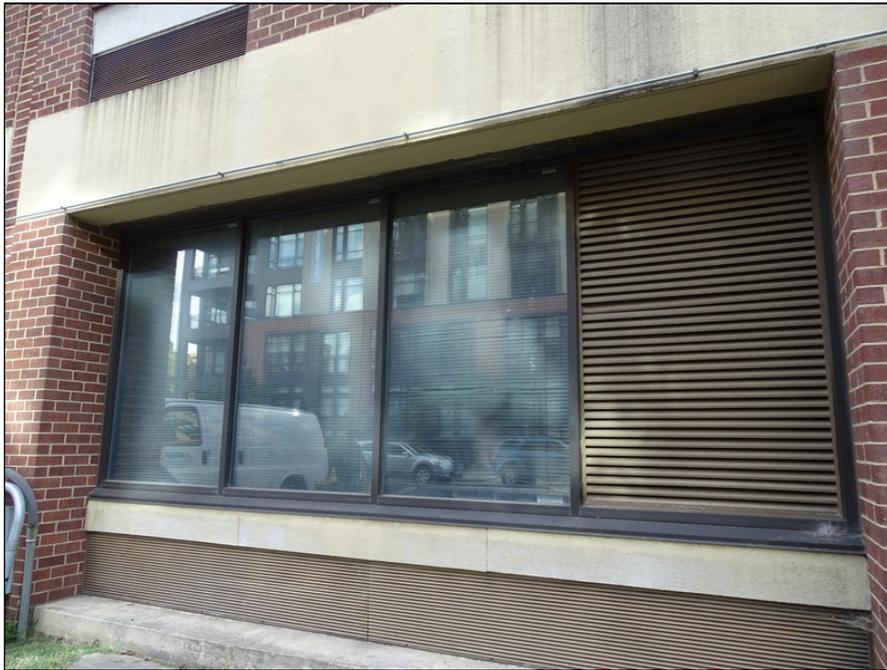
52 - Exterior windows at west side.

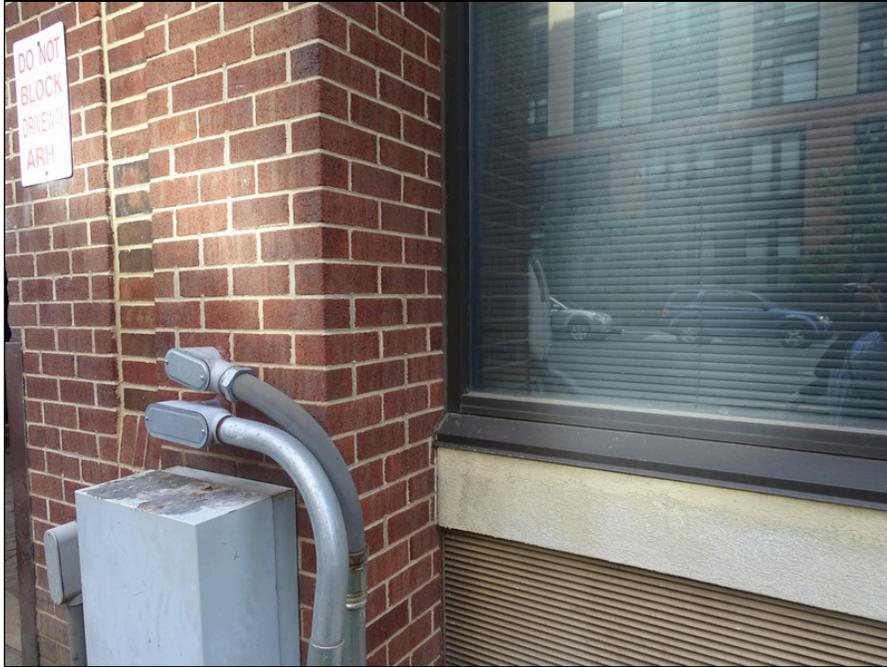
53 - Exterior windows at west side.

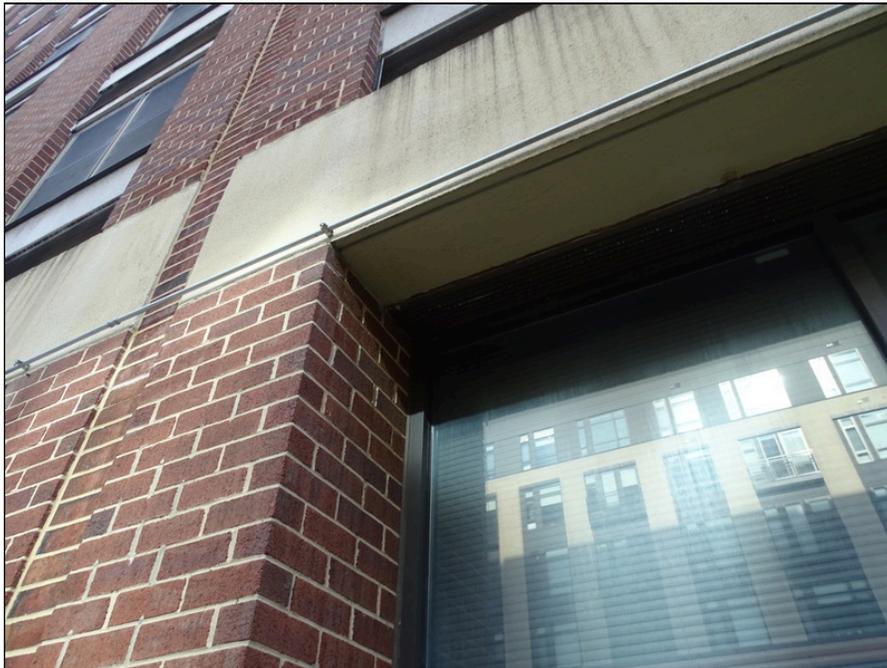
54 - Exterior windows at west side.

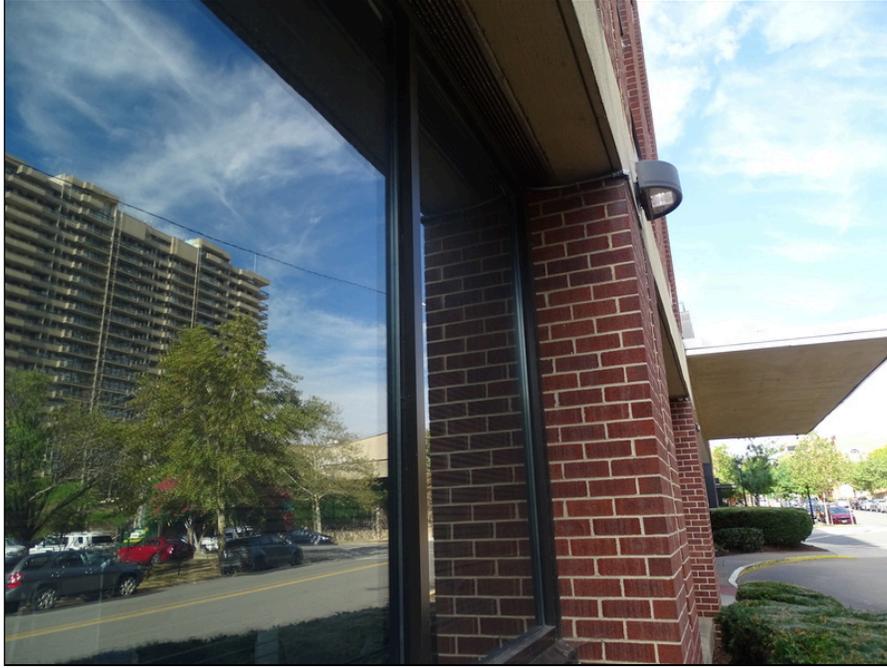
55 - Exterior windows at west side.

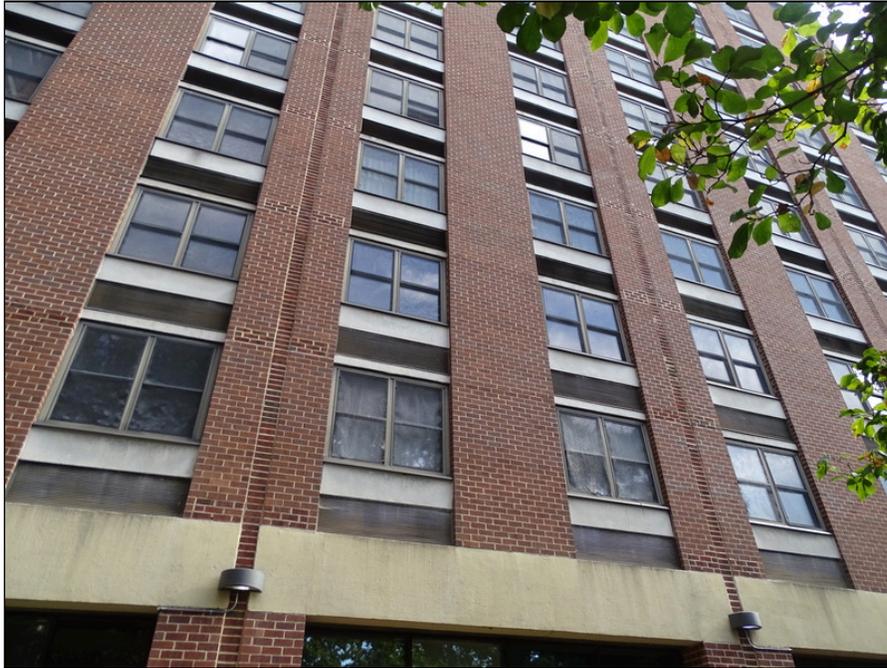
56 - Exterior windows at north side.

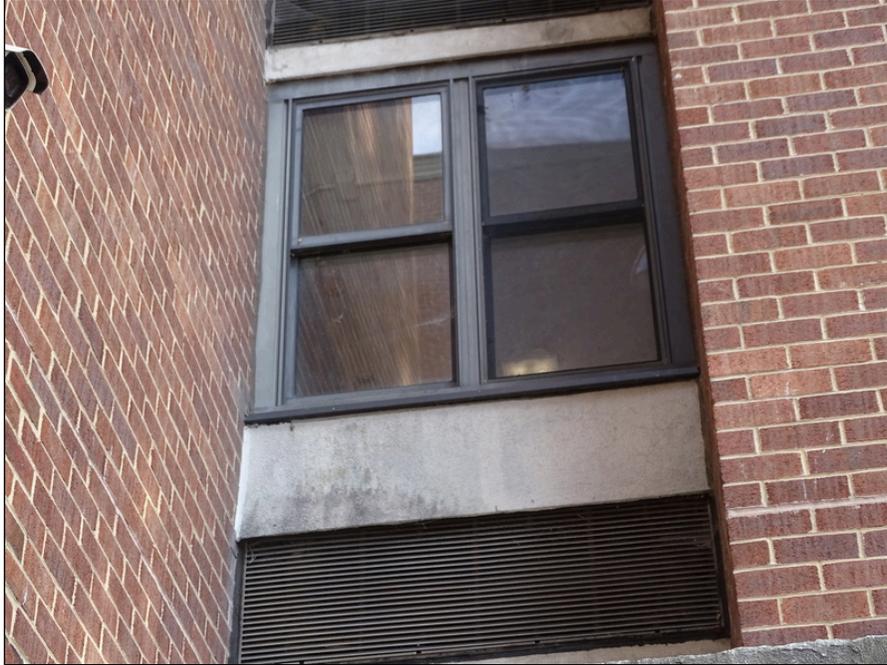
57 - Exterior windows at north side.

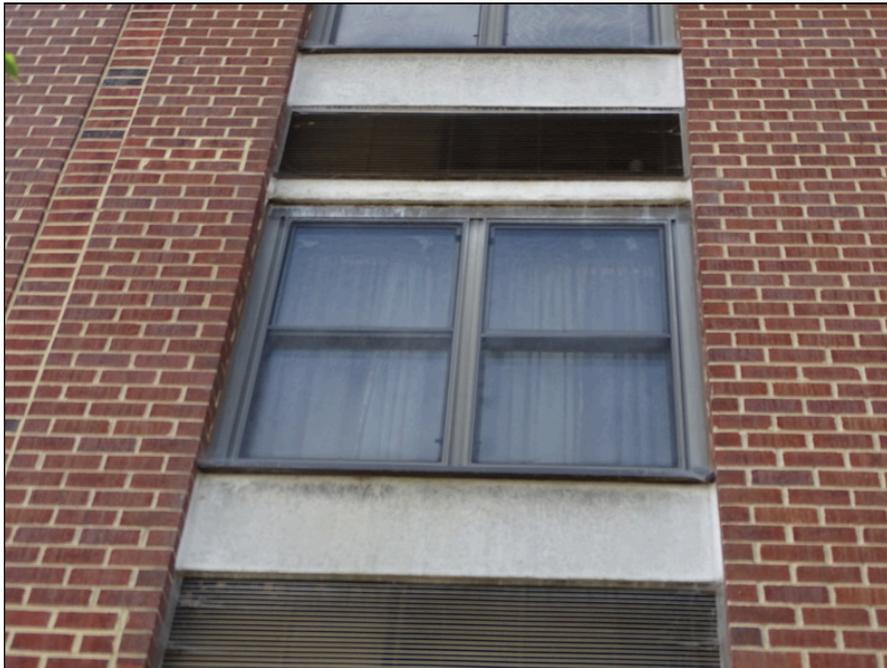
58 - Exterior windows at north side.

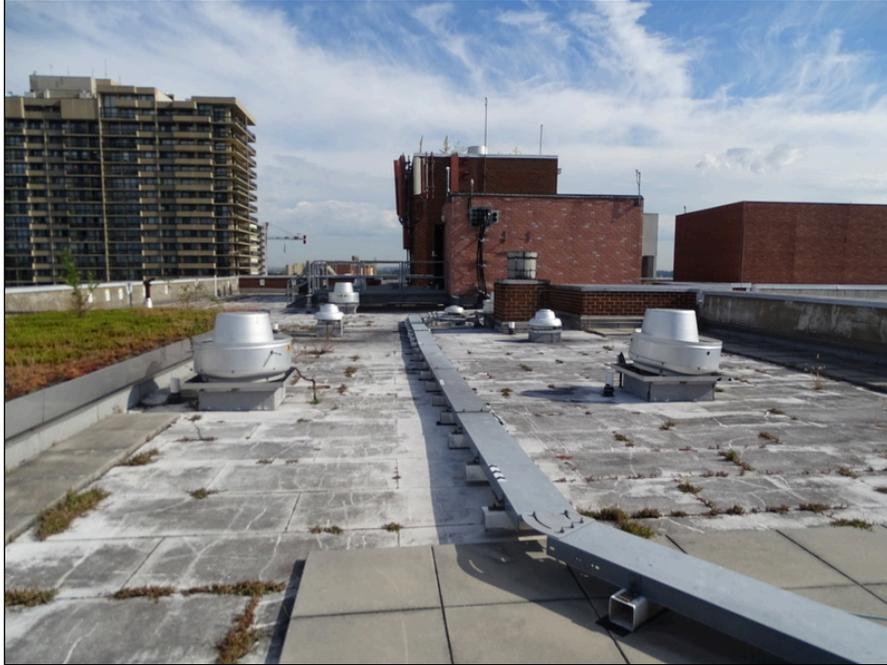
59 - IRMA Roofing System – Cracks and vegetation were observed.

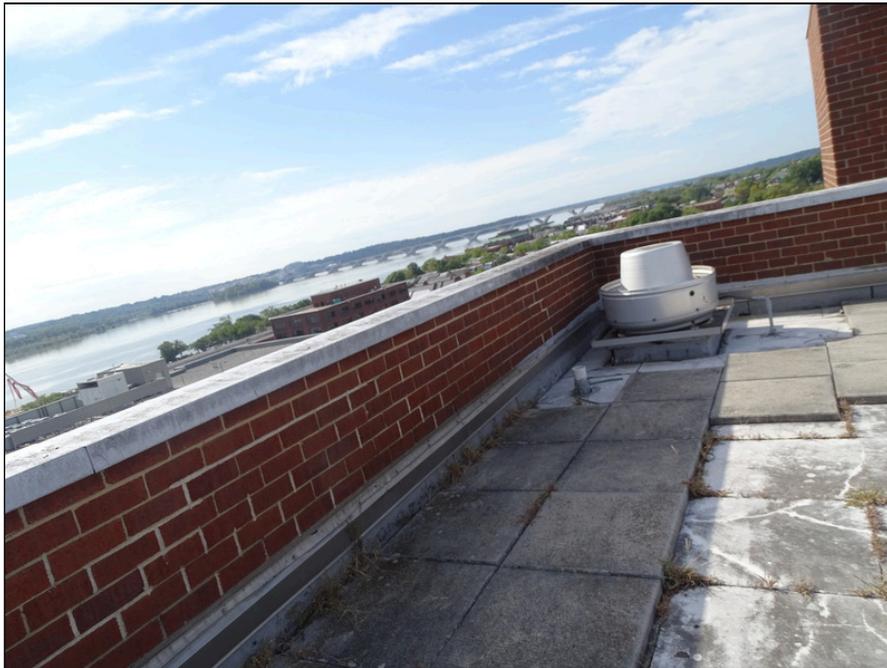
68 - Typical parapet wall.

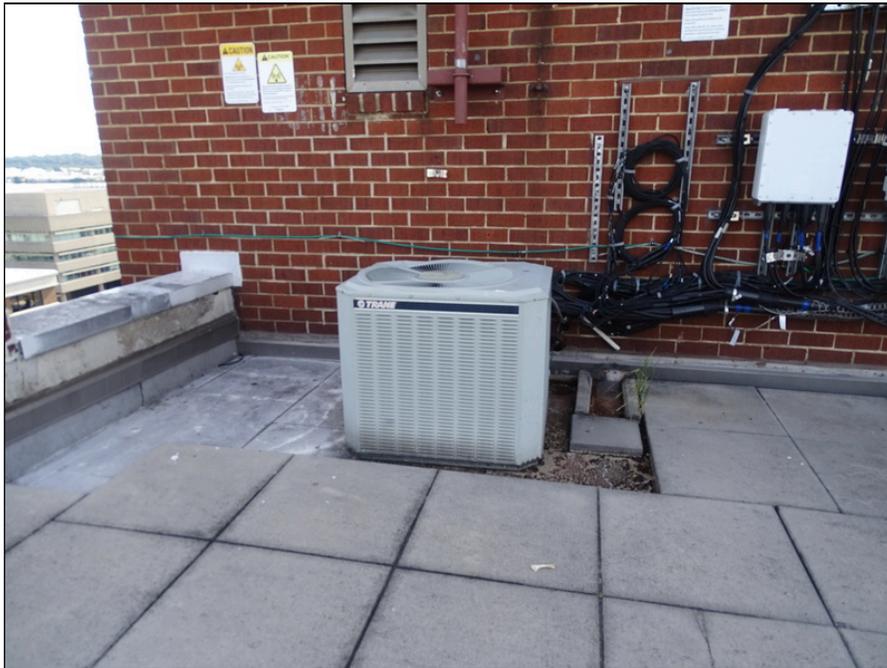
70 - IRMA Roofing System.

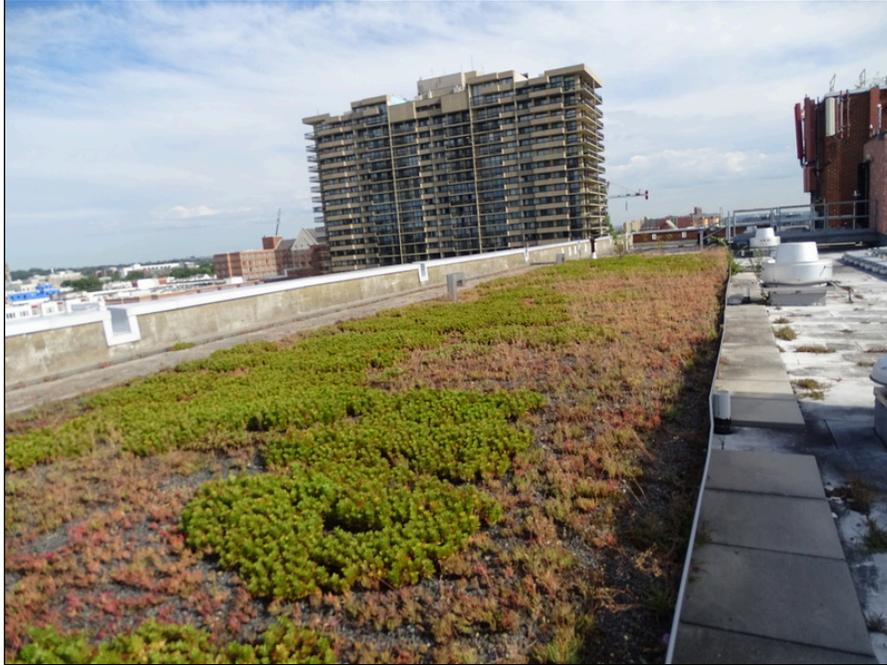
71 - Green Roofing System.

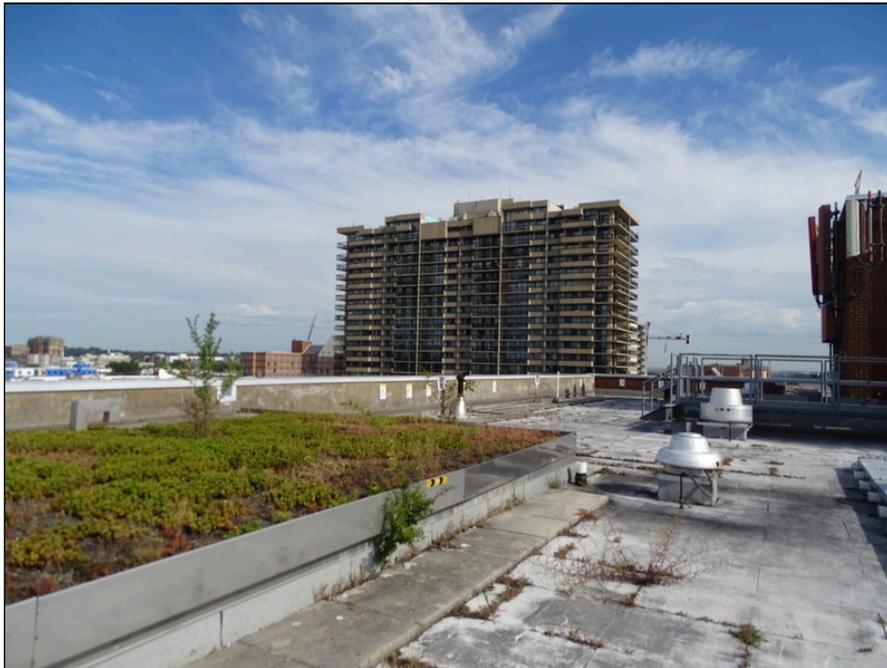
72 - Green Roofing System.

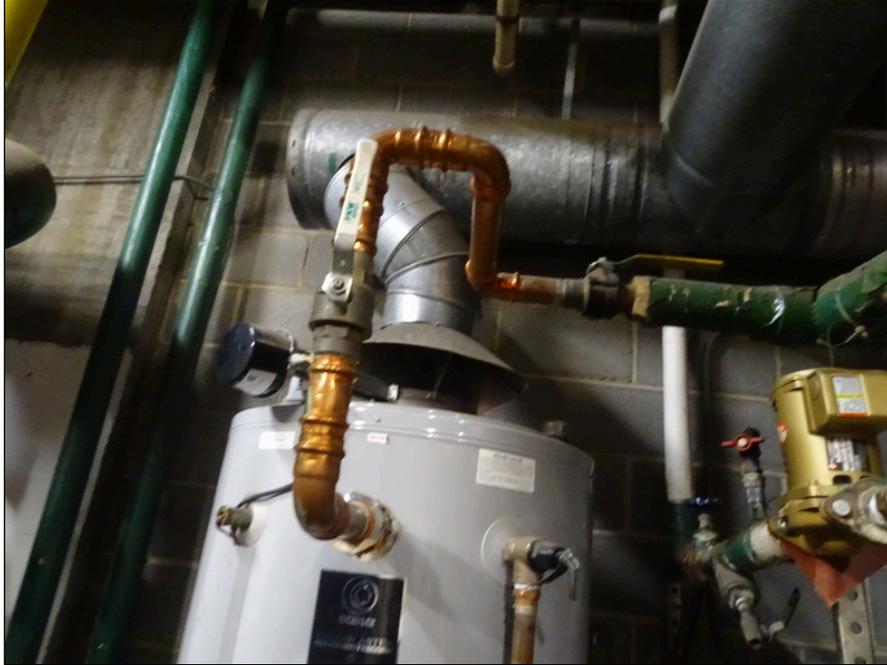
73 - Typical water piping.

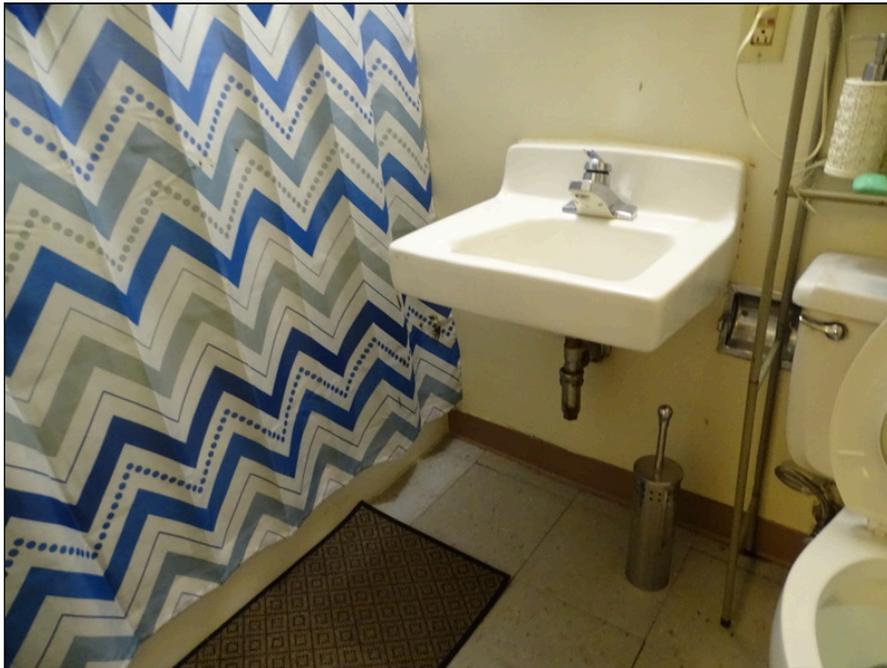
74 - Typical waste piping.

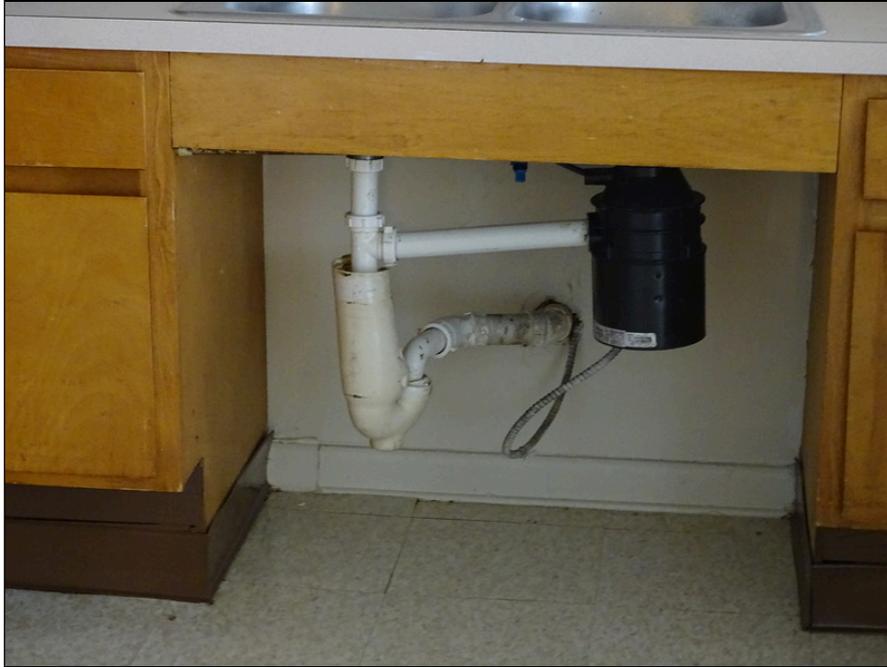
75 - Typical waste piping.

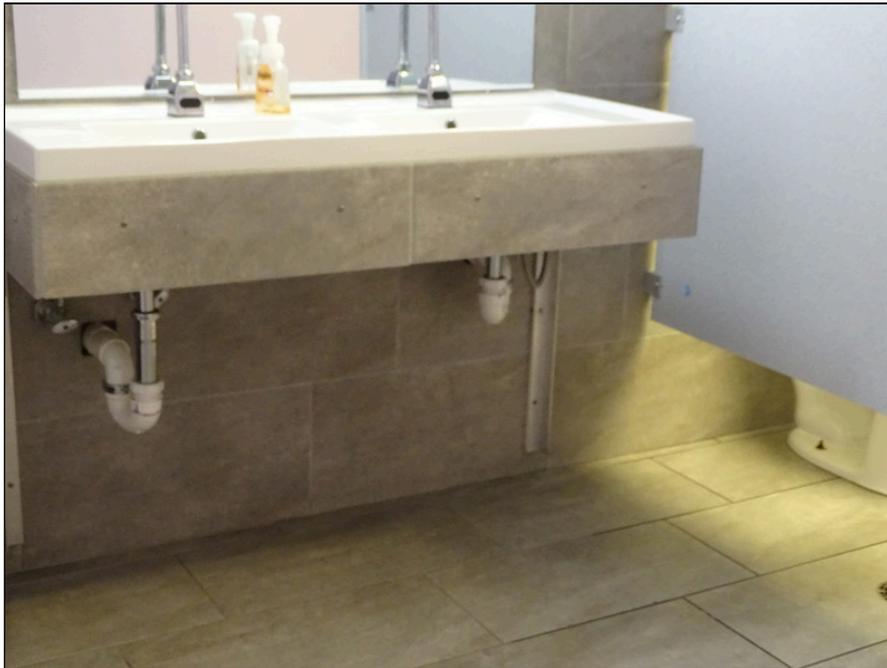
76 - Typical waste piping.

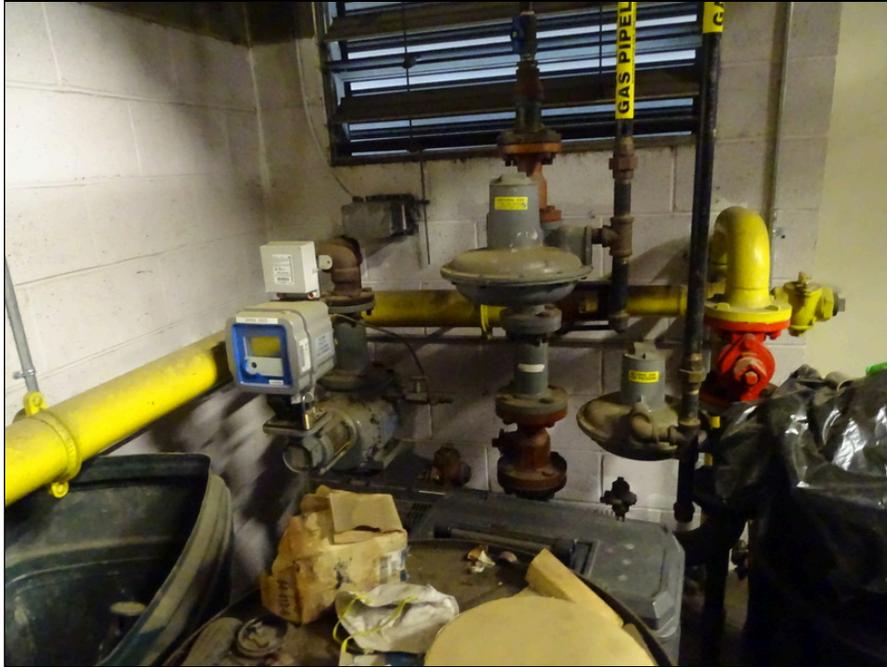
77 - Natural gas entrance.

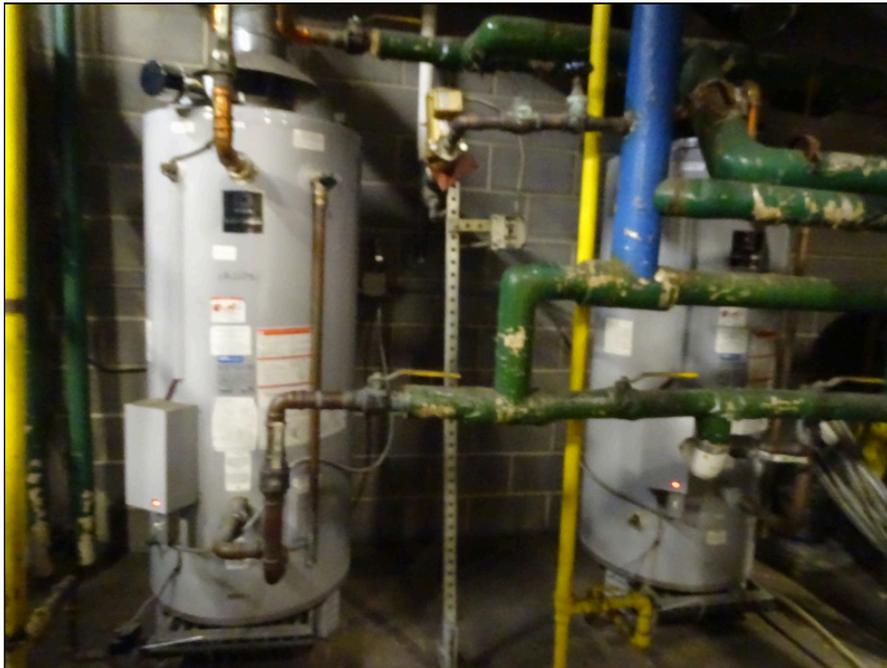
78 - Typical gas water heater.

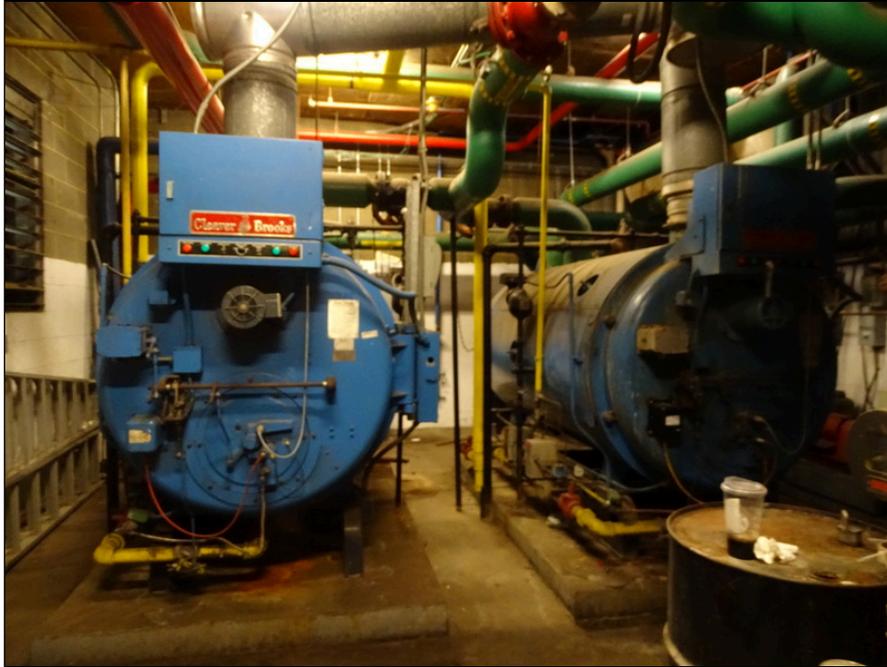
79 - Boiler manufactured by Cleaver Brooks.
