PROPERTY CONDITION ASSESSMENT

LADREY HIGH-RISE APARTMENTS - PROPERTY CONDITION ASSESSMENT
300 WYTHE STREET
ALEXANDRIA, VIRGINIA

ECS PROJECT NO. 46:11503

SEPTEMBER 11, 2025

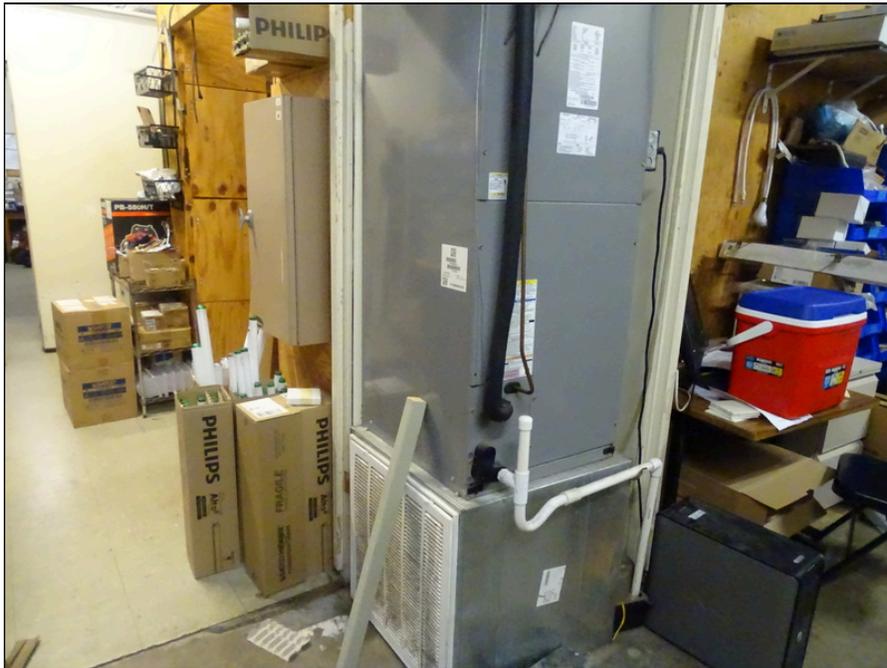
80 - Typical air handler.

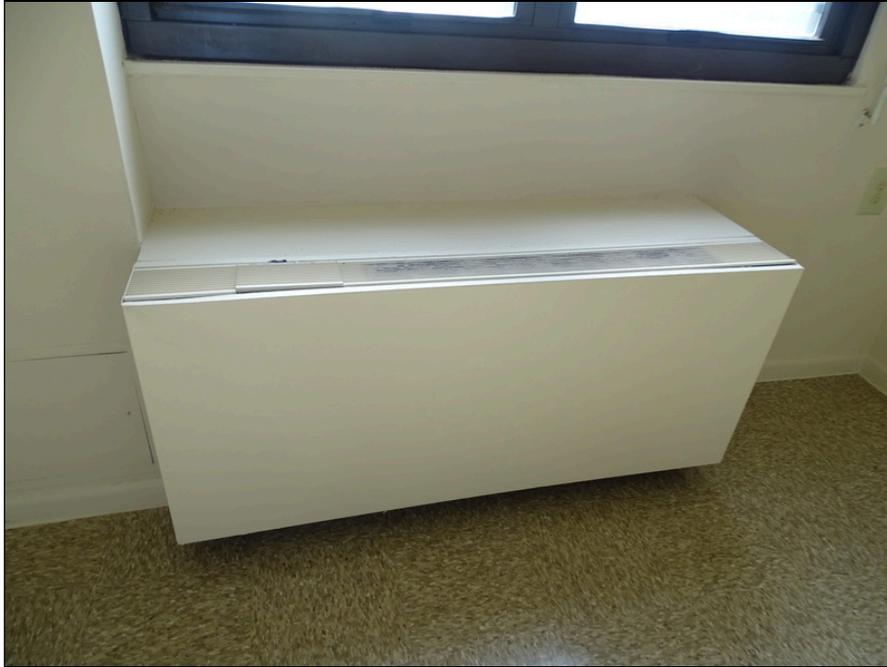
81 - Typical fan coil unit in apartment.

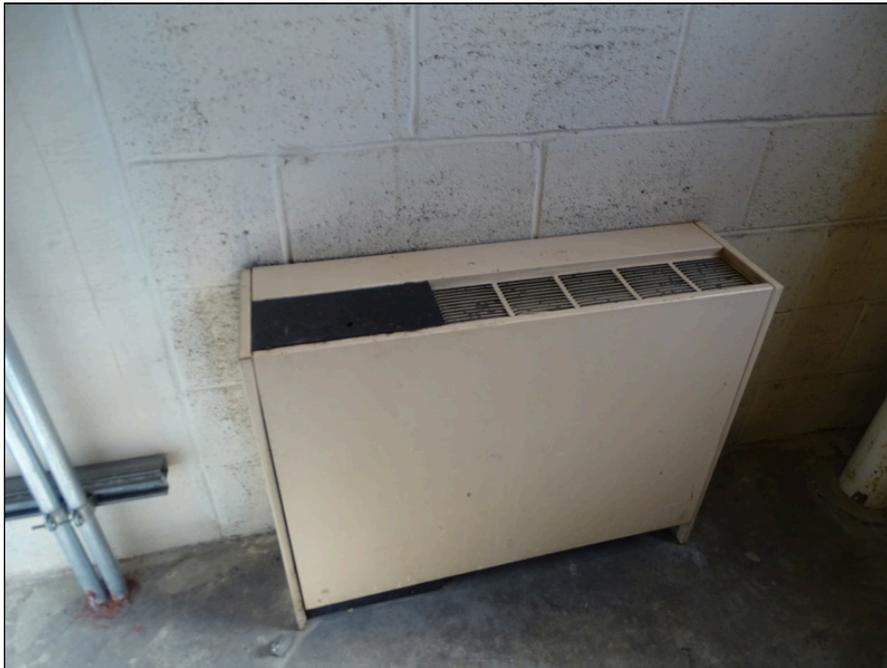
82 - Fan coil unit in walkways and stairwell.

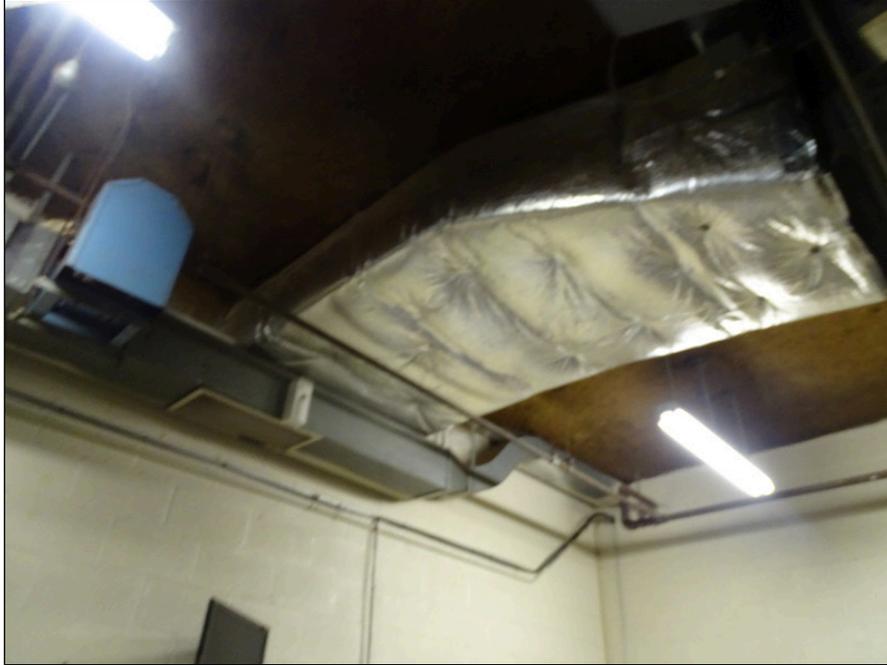
83 - Typical duct work.

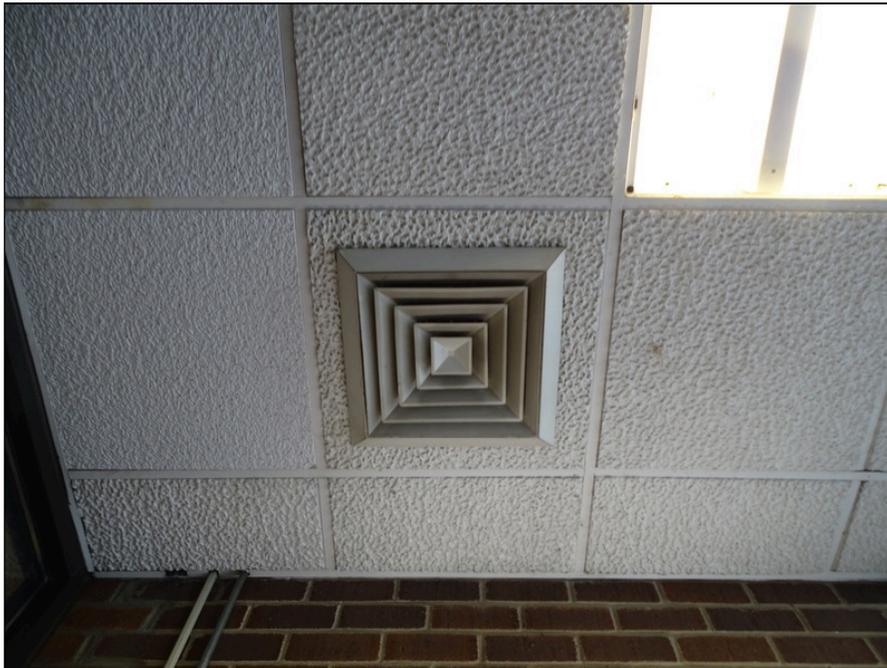
84 - Air vent supply in ceiling.

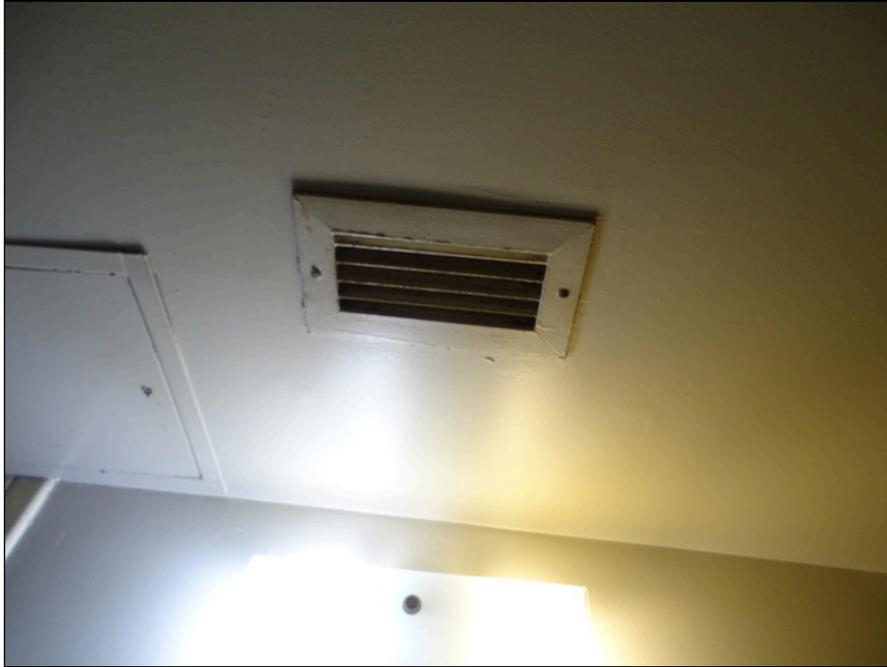
85 - Air vent supply in ceiling.

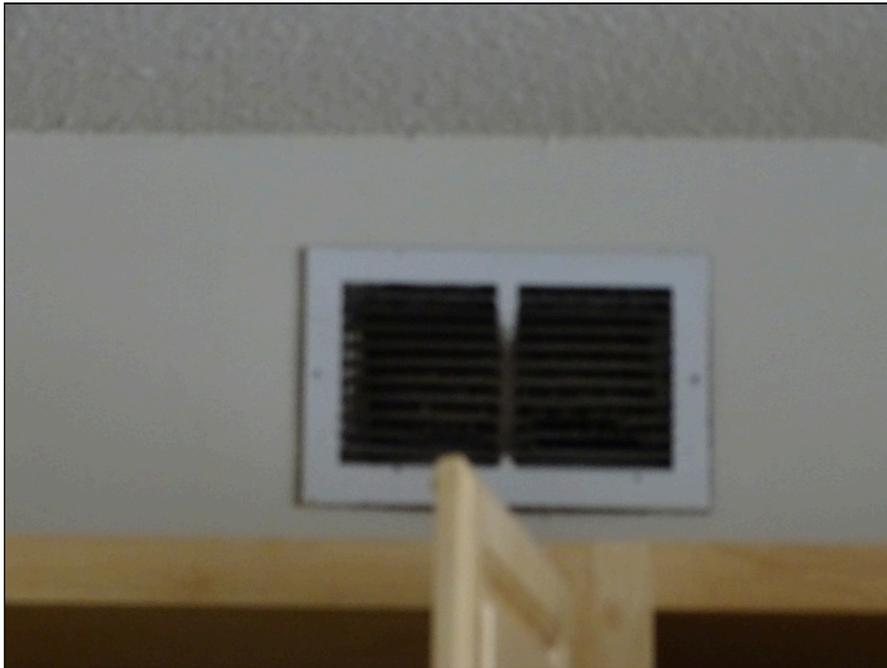
86 - Air vent supply in wall.

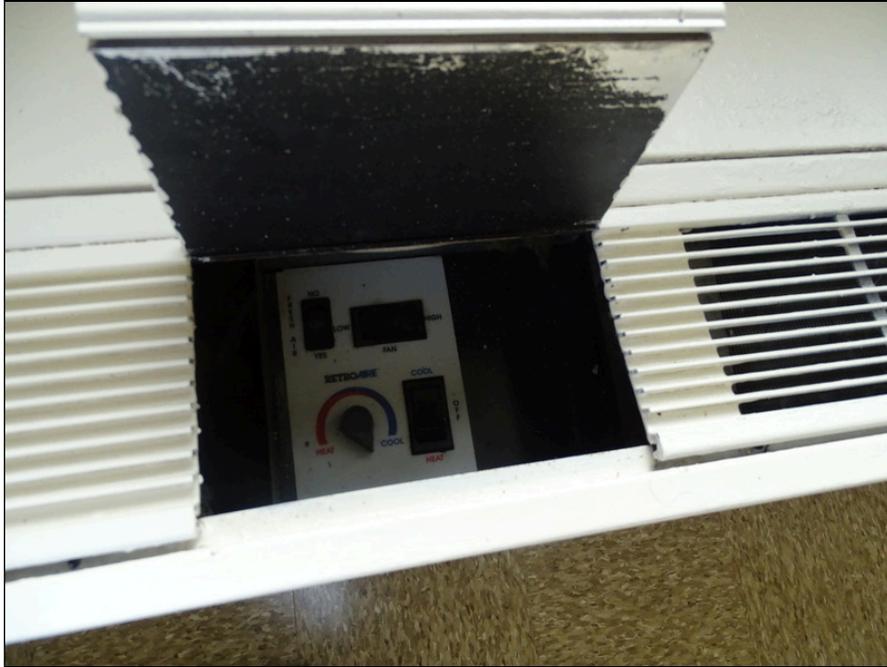
87 - Fan coil unit control system.

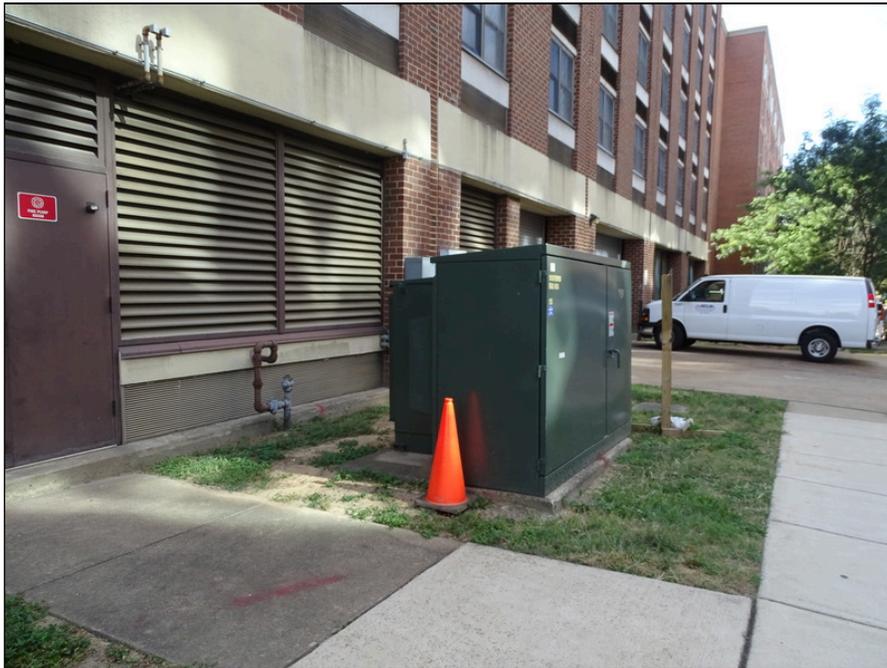
90 - Transformer located at west of the site.

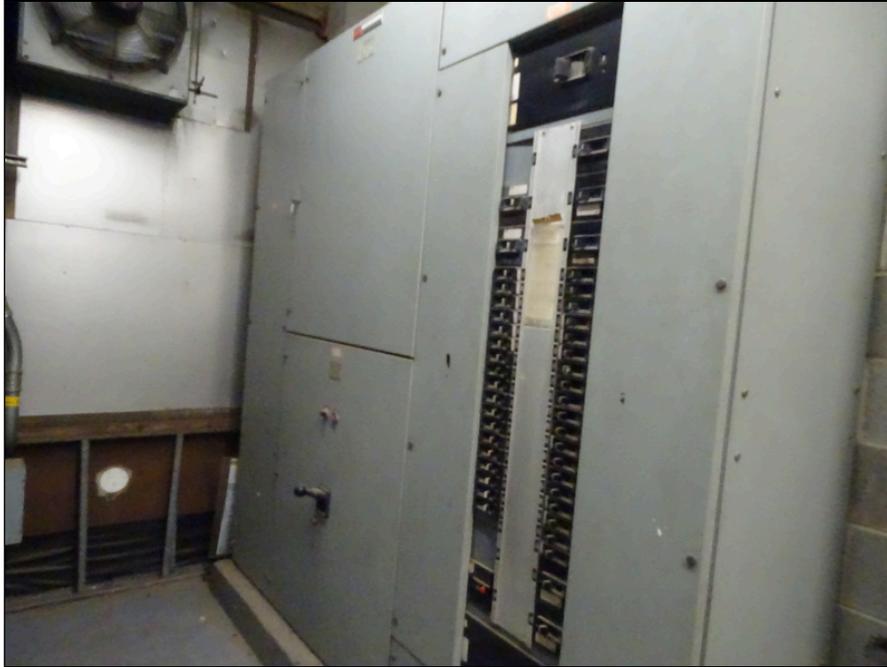
91 - Electrical entrance.

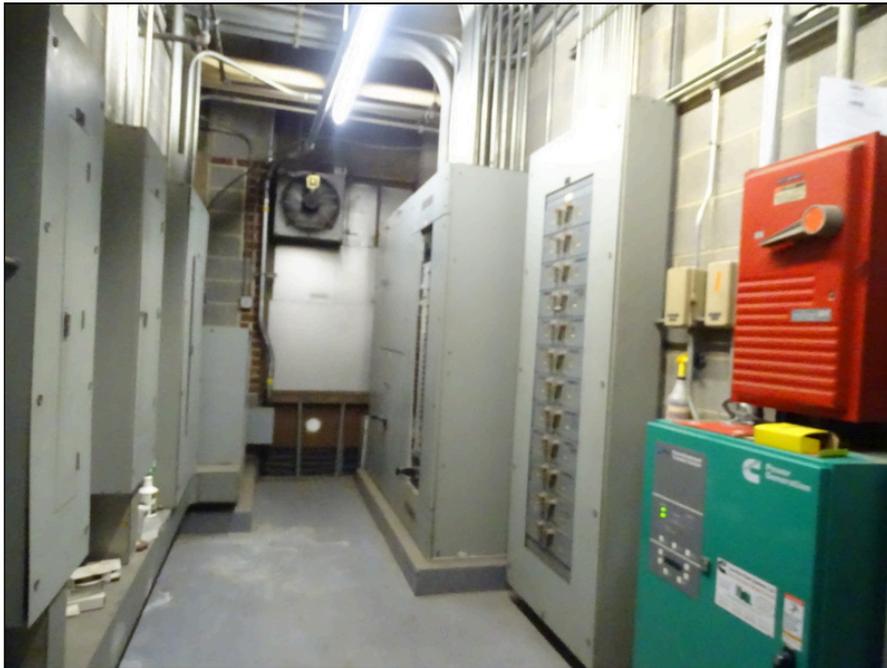
92 - Main service disconnect.

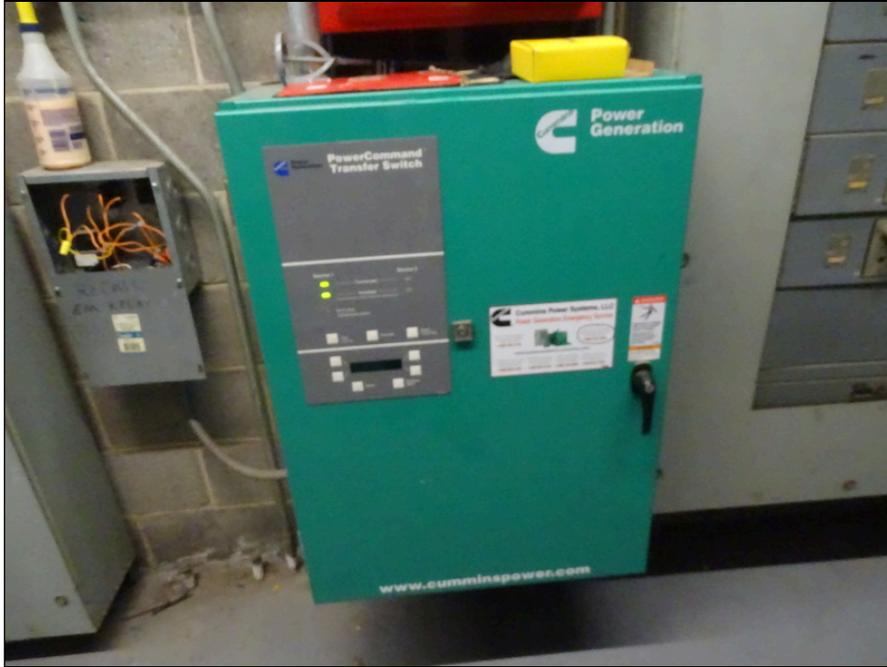
93 - Transformer switch.

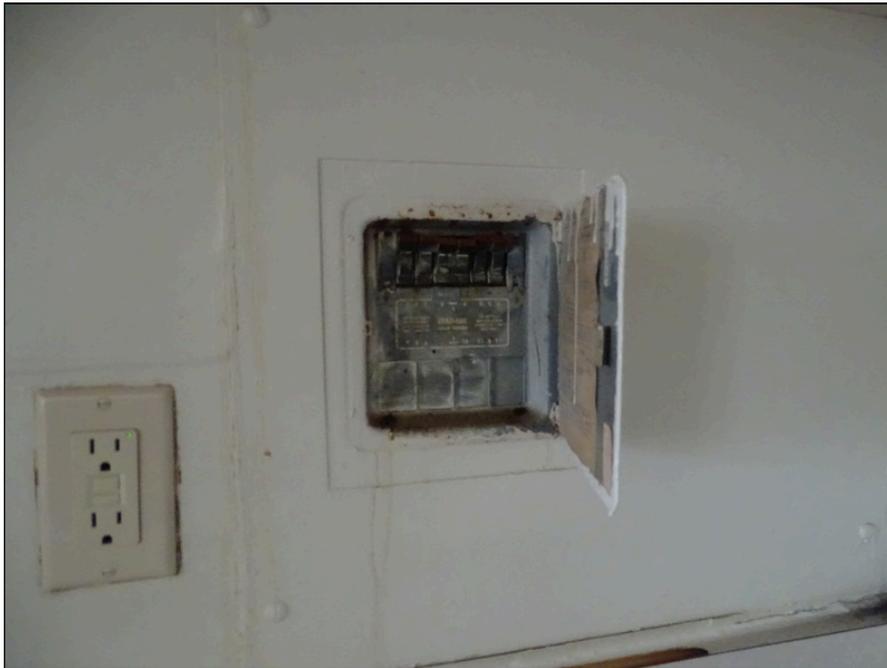
94 - Electrical panels.

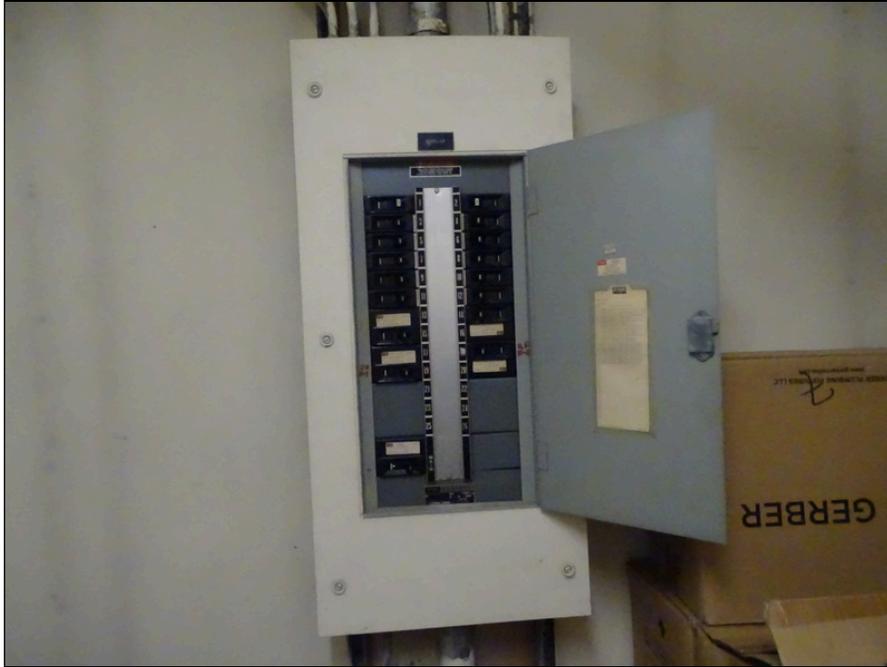
95 - Electrical panels.

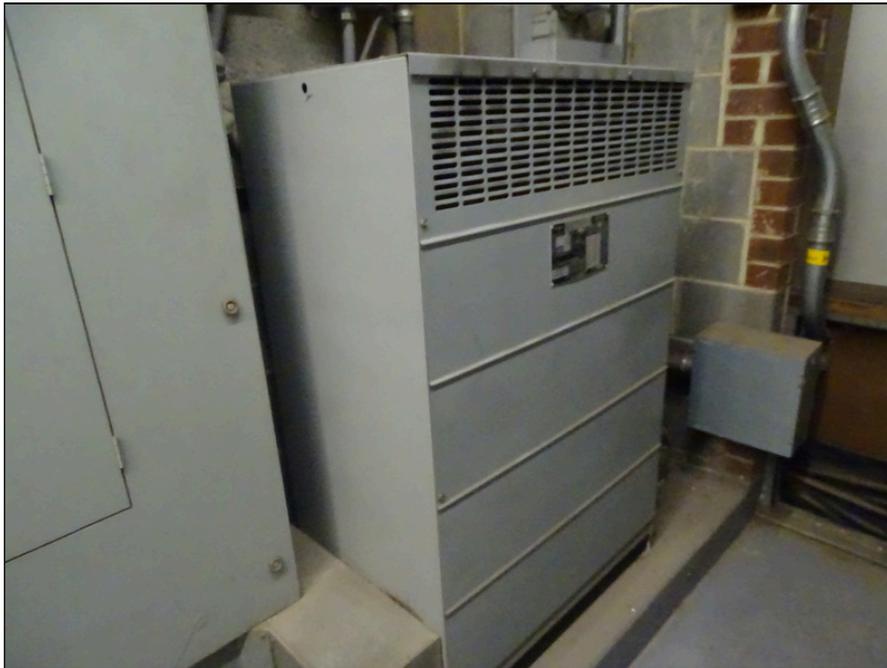
96 - Building transformer.

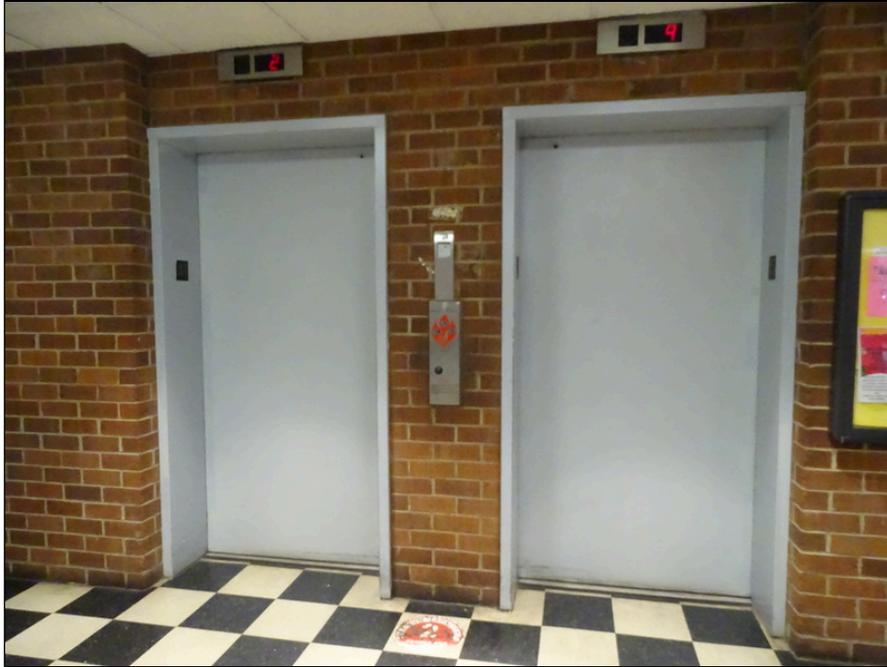
97 - Elevator lobby.

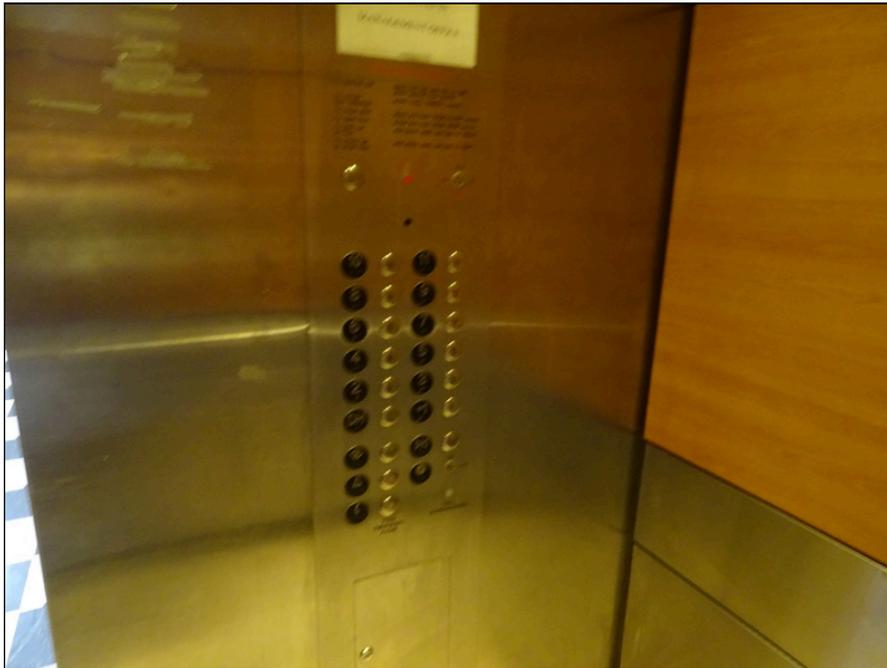
98 - Elevator cab finishes.

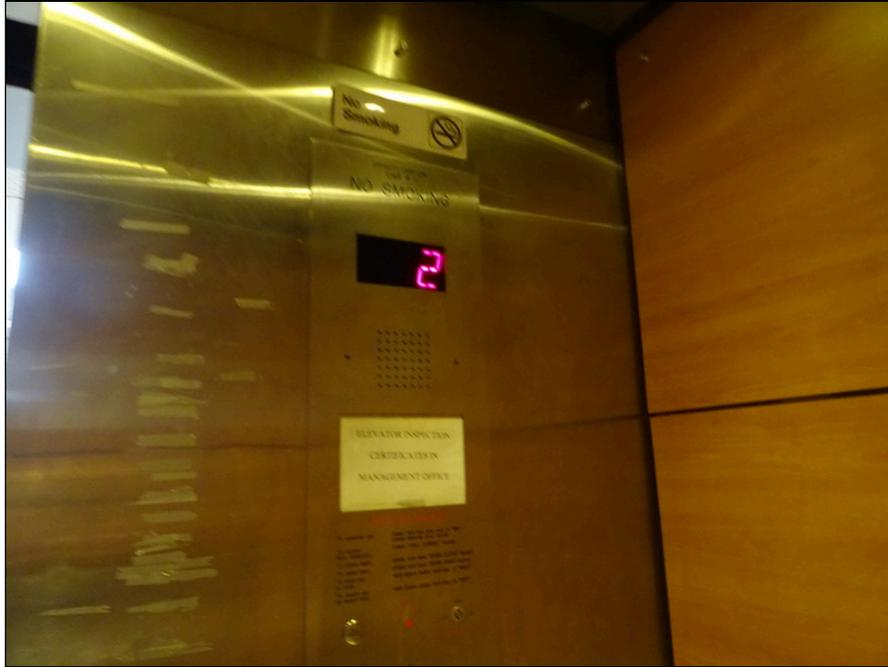
99 - Elevator cab finishes.

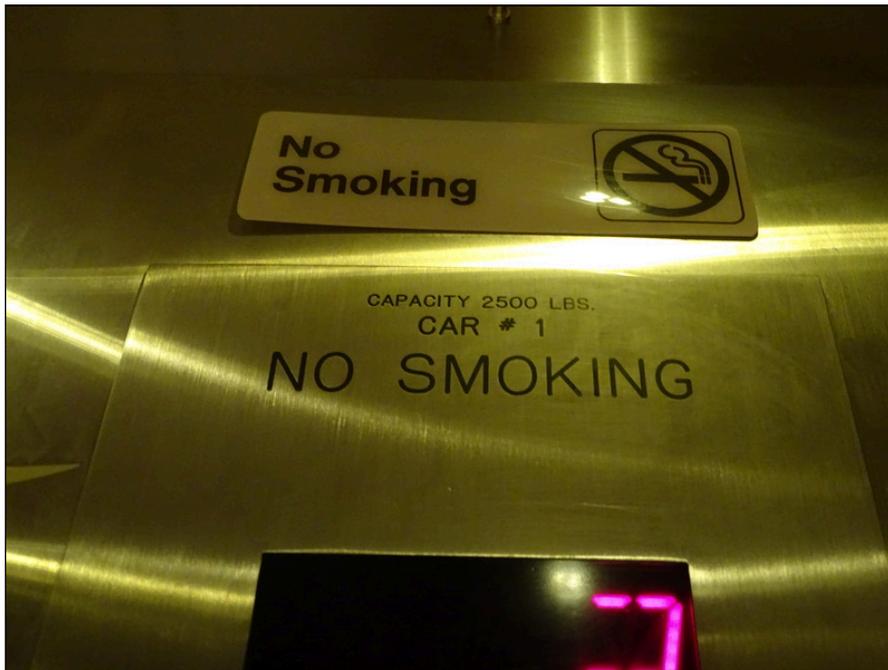
100 - Elevator cab finishes.

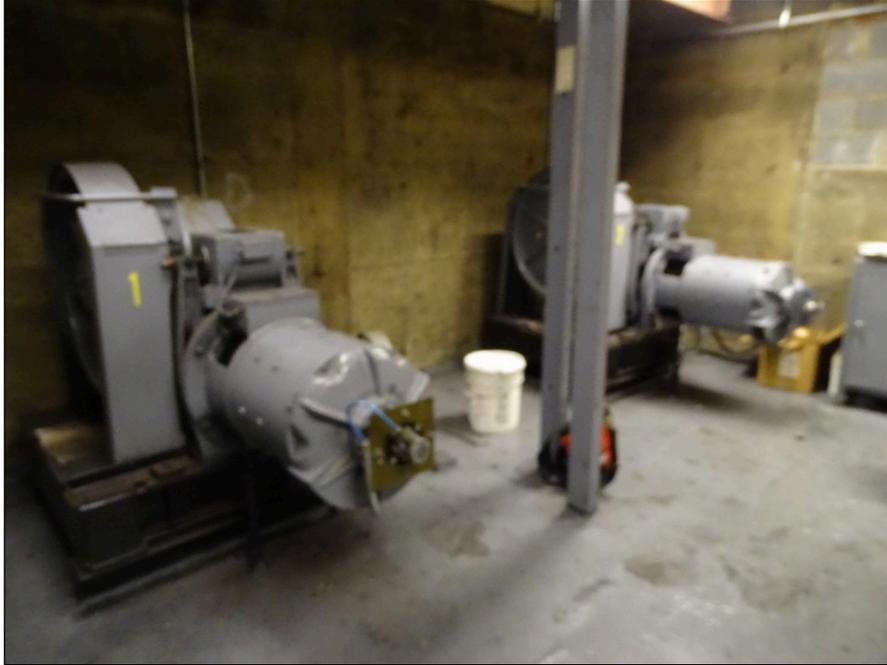
101 - Elevator machine room.

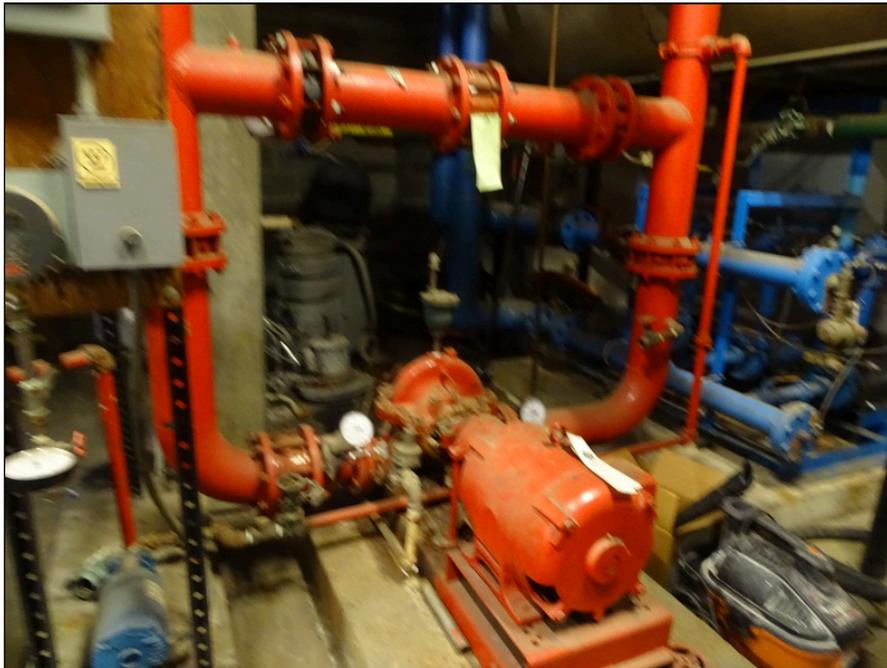
102 - Fire suppression system is located in the utility room.

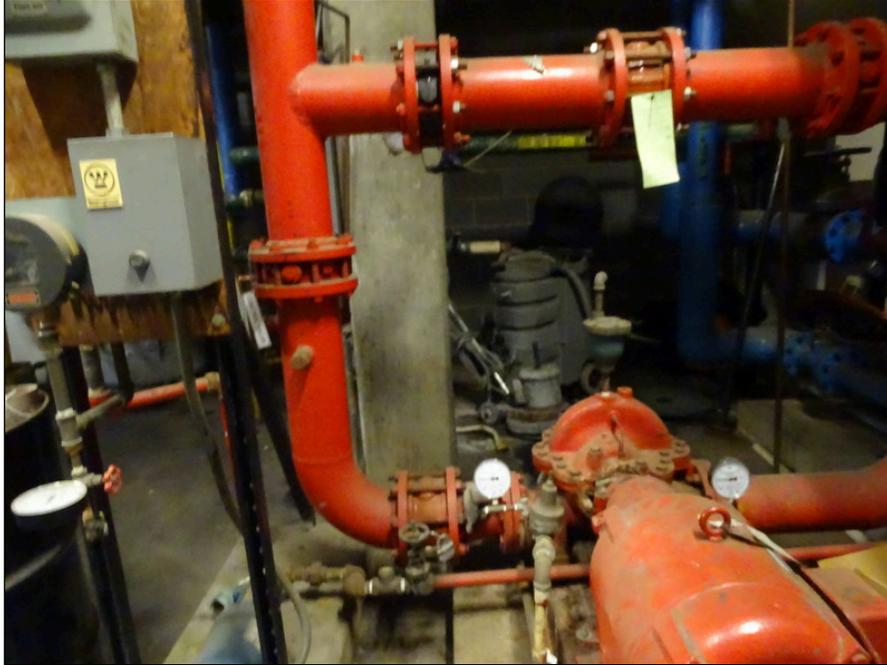
103 - Fire suppression system is located in the utility room.

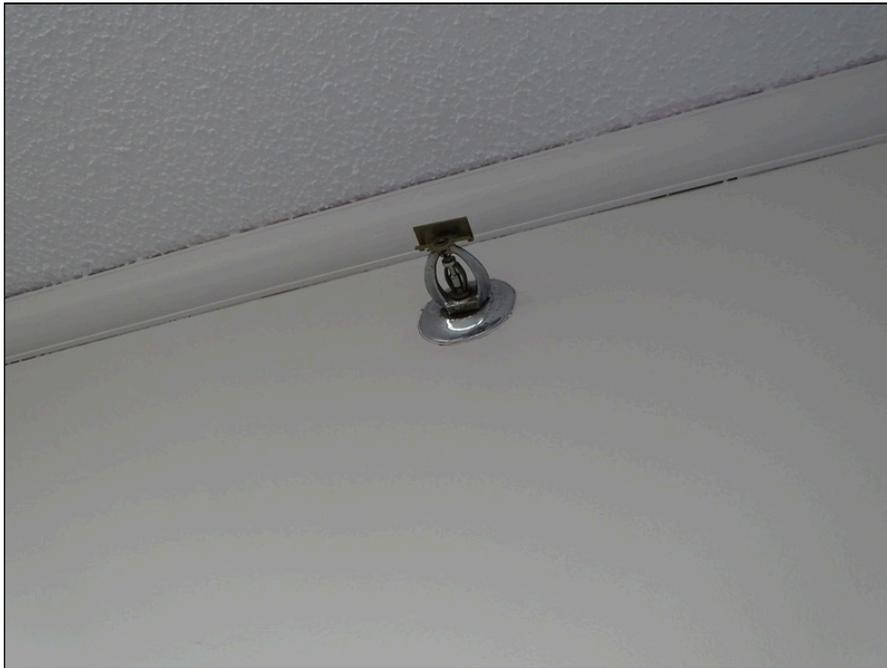
104 - Typical sprinkler head.

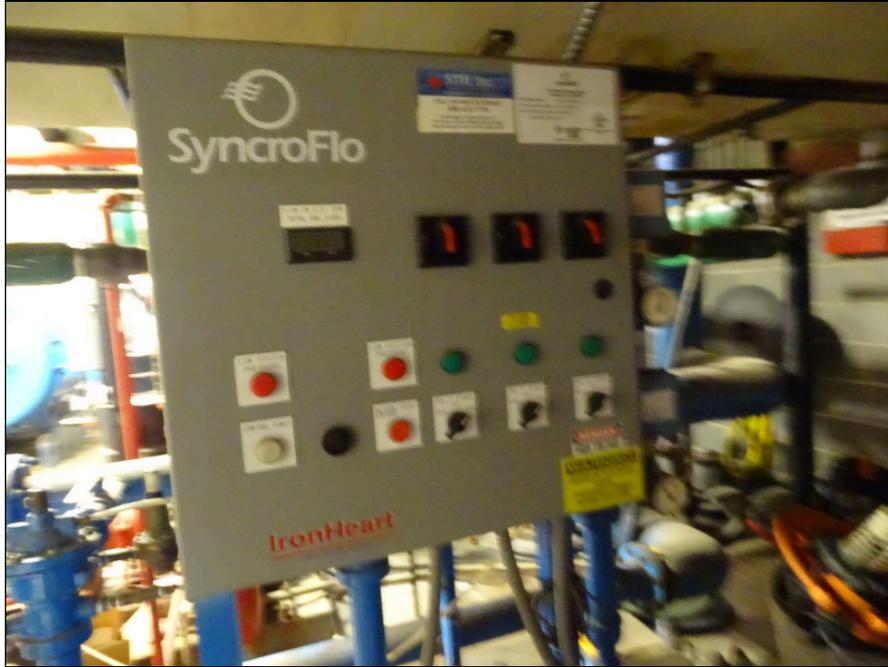
105 - Booster pump control.

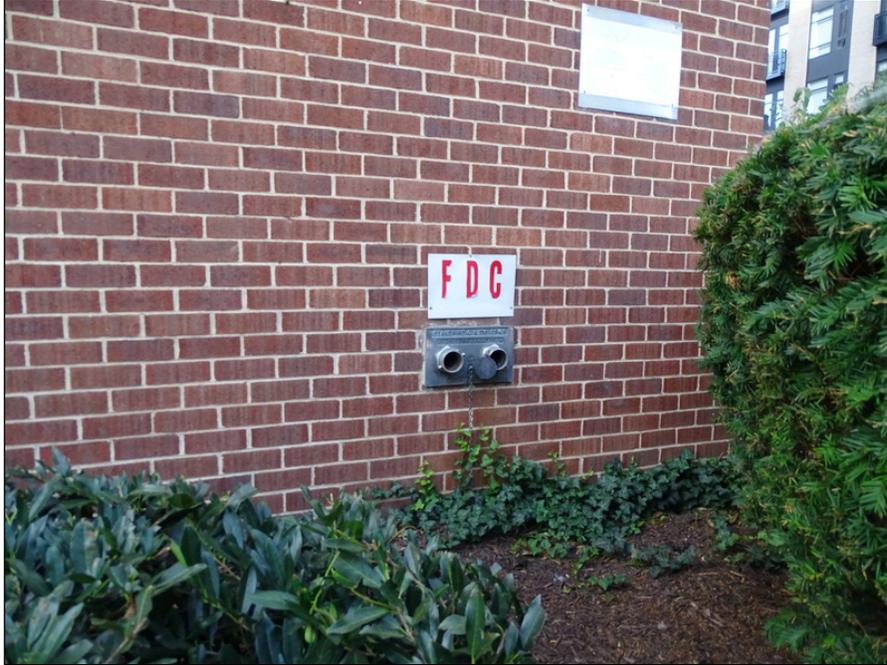
107 - Fire department connection.

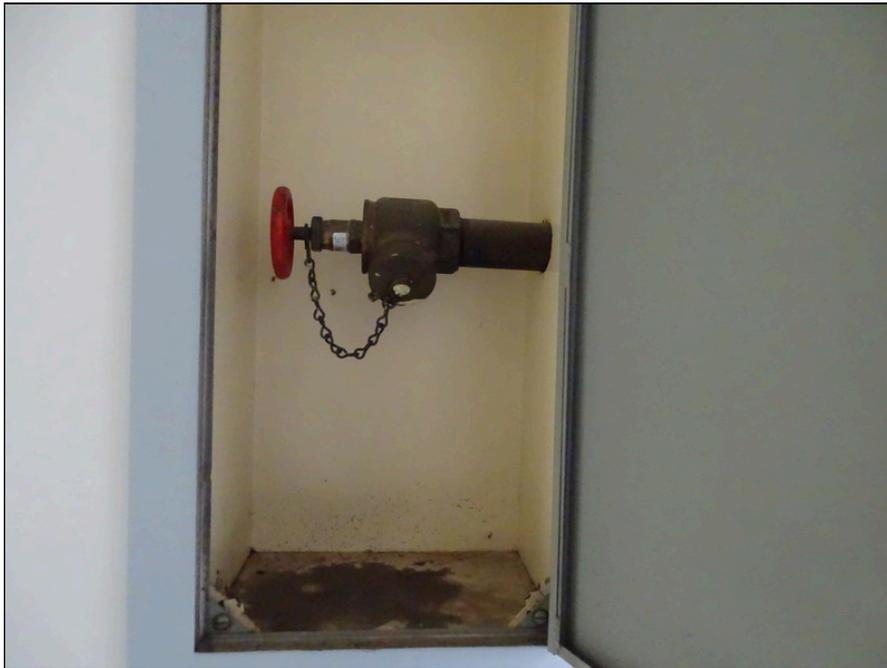
108 - Fire hose cabinet.

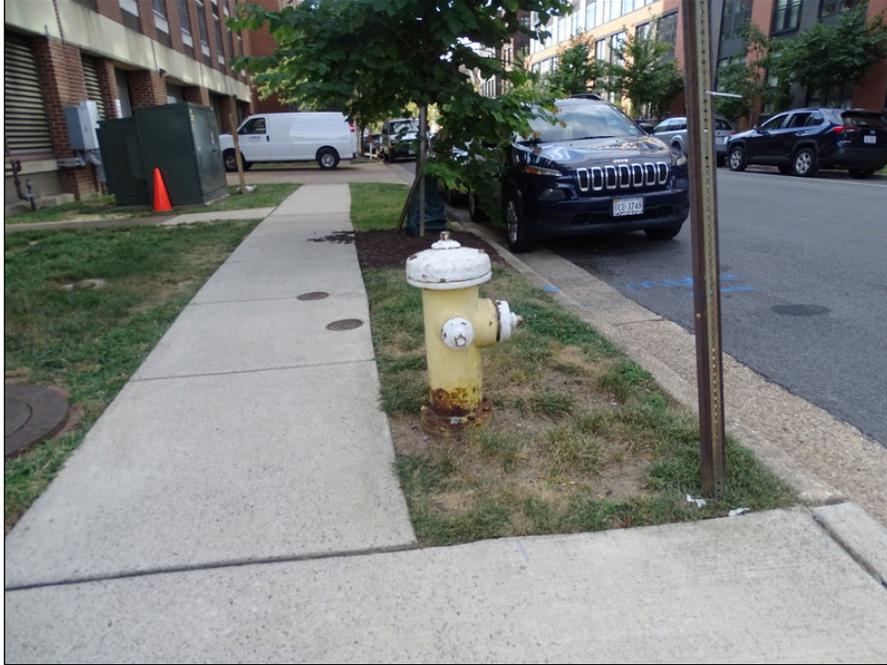
109 - Fire hydrant.

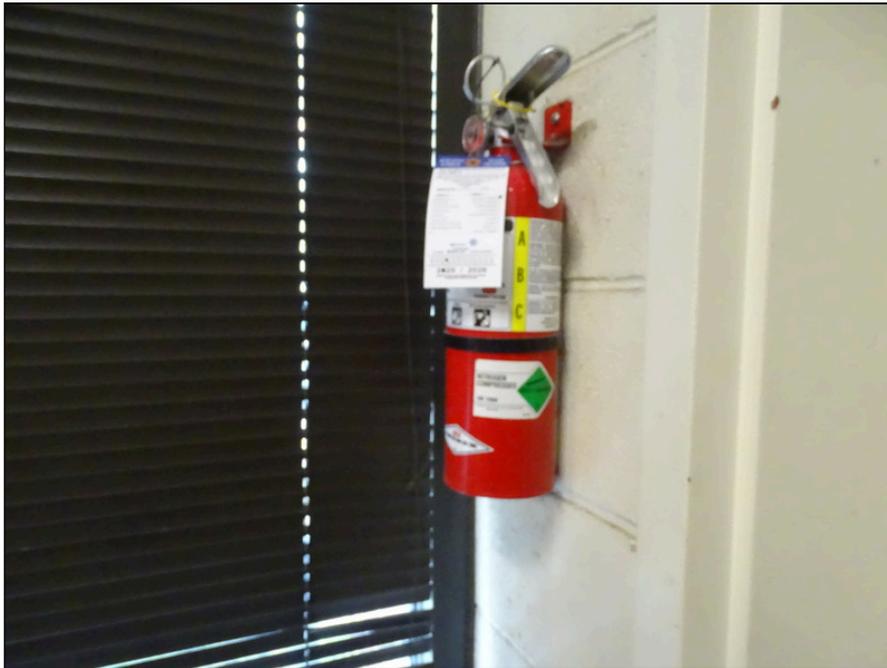
110 - Fire extinguishers.

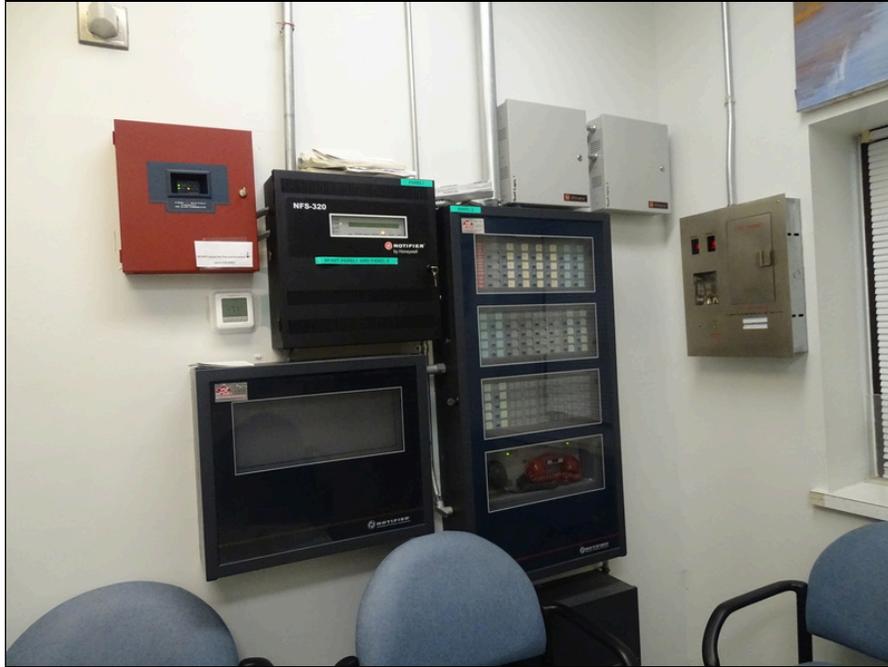
111 - Fire alarm control panel is located in the office.

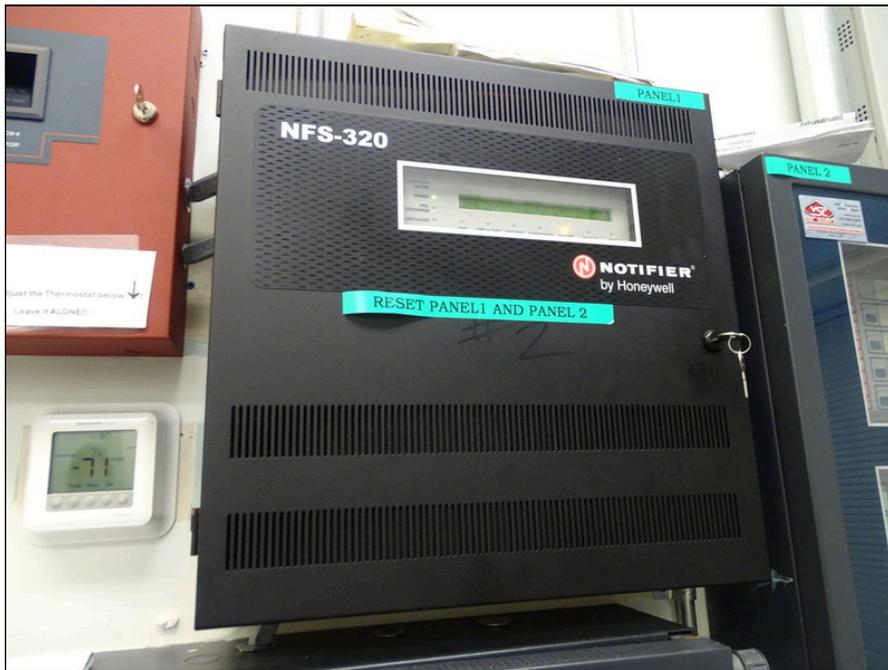
112 - Fire alarm control panel is located in the office.

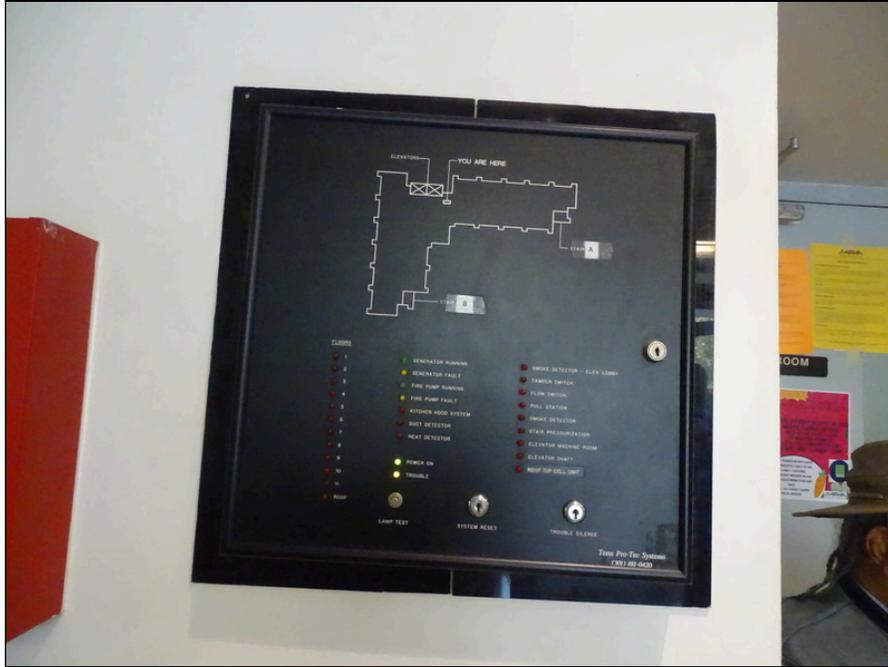
113 - Fire alarm annunciator.

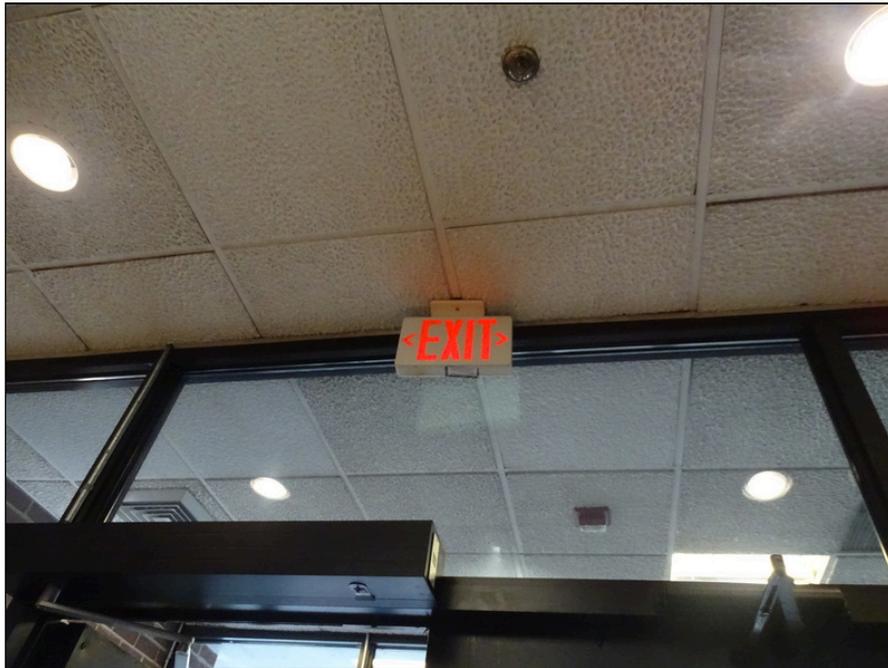
114 - Typical exit sign

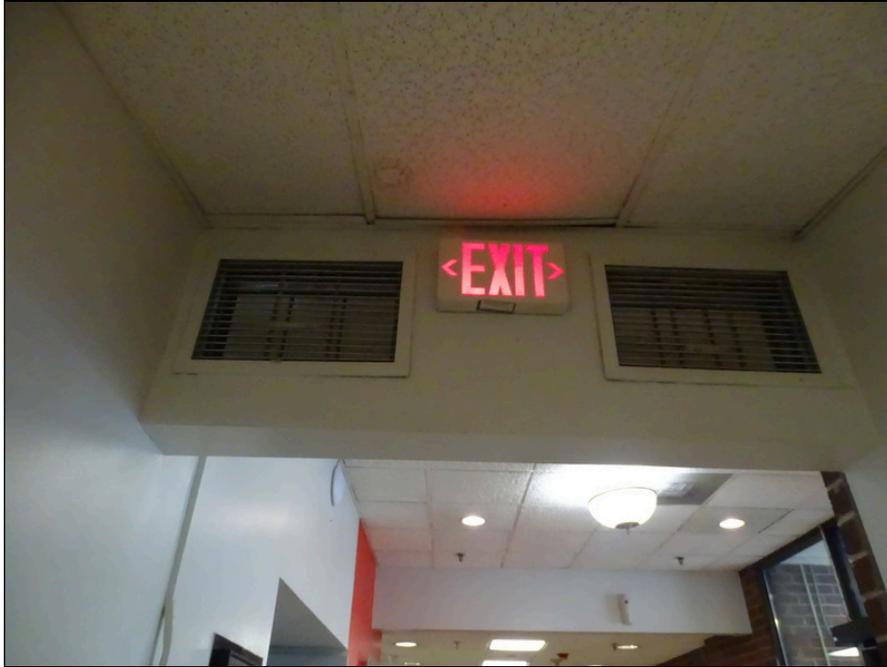
115 - Typical exit sign

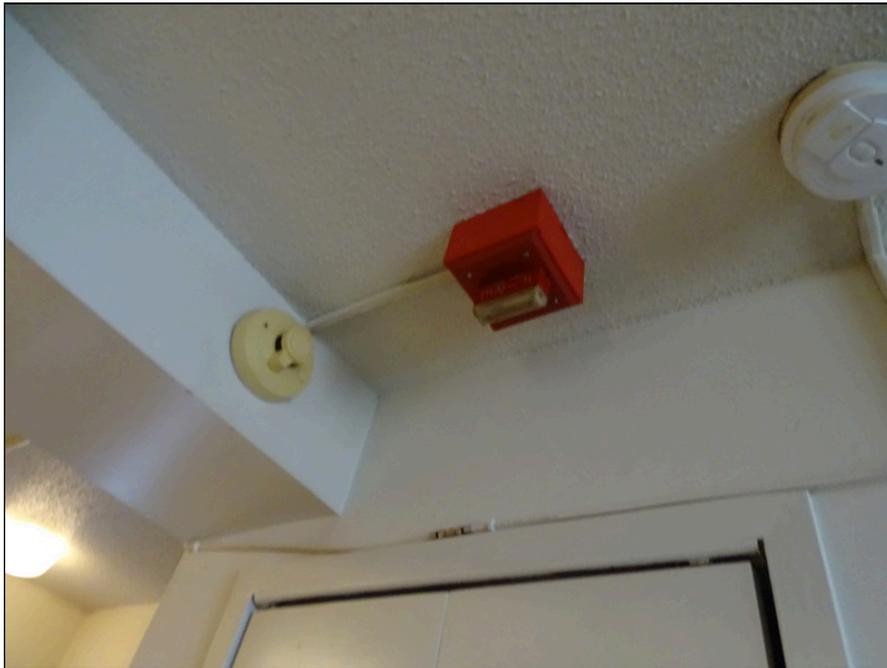
116 - Typical smoke detector and strobe.

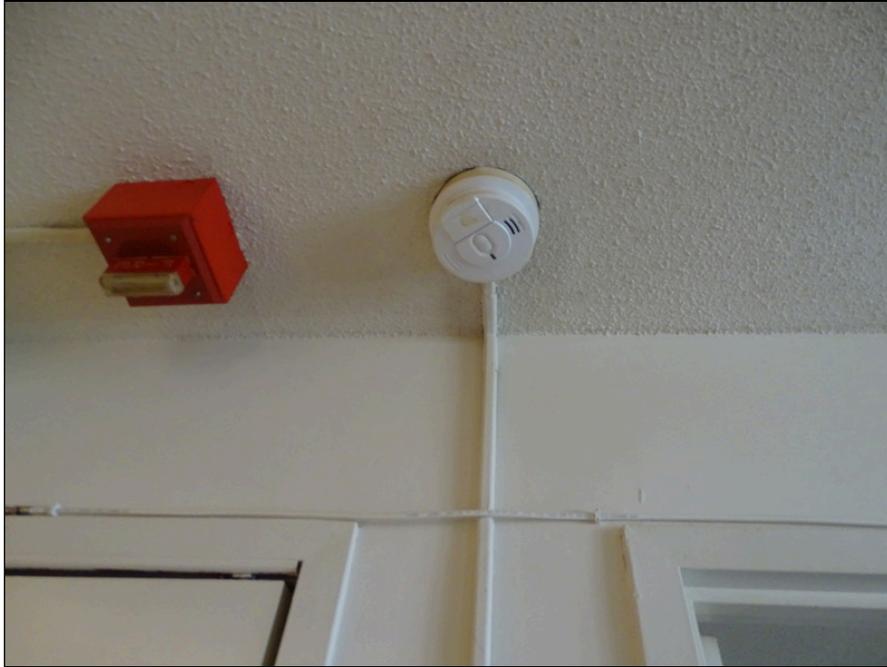
117 - Typical smoke detector and strobe.

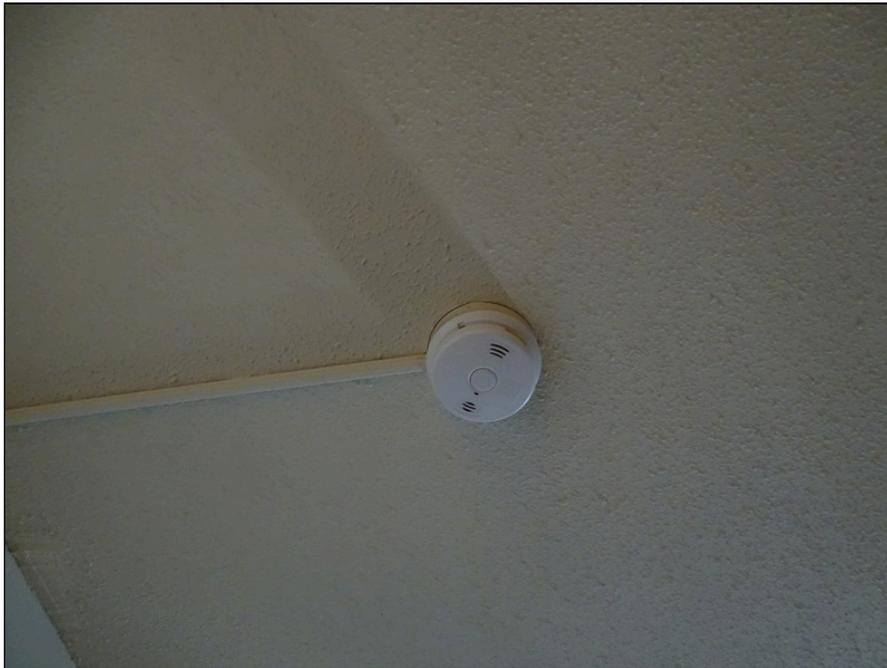
118 - Typical smoke detector.

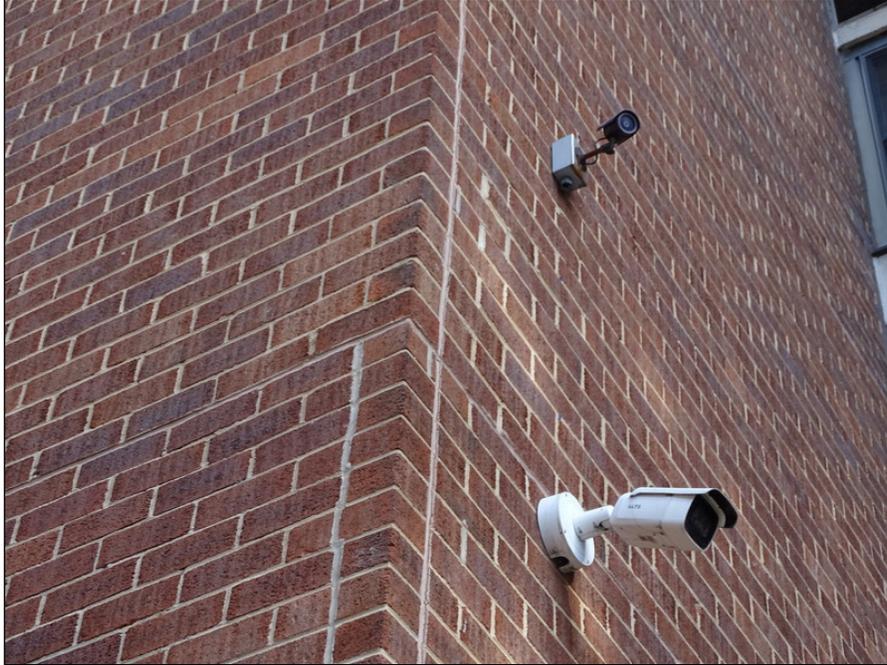
119 - Typical exterior camera.

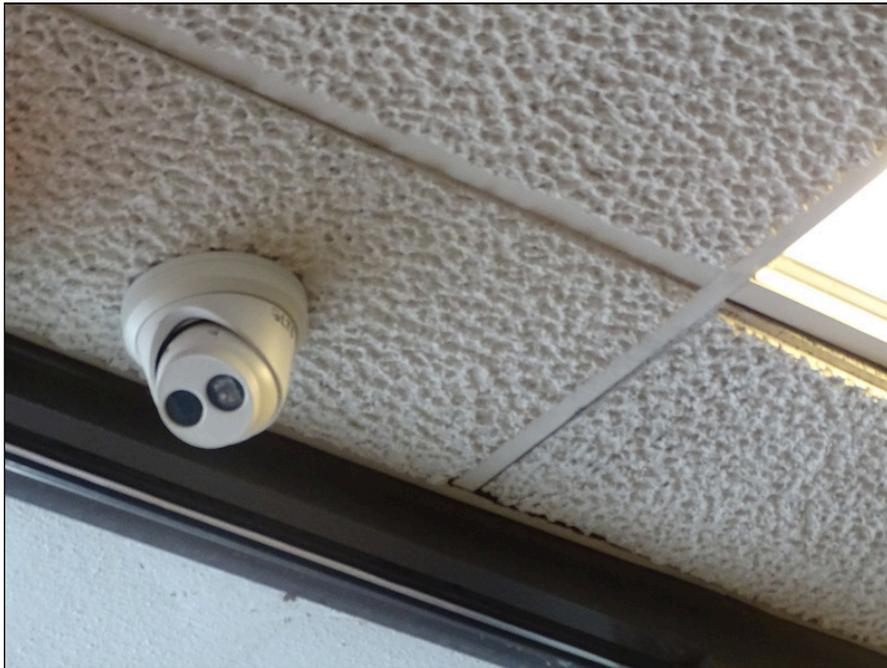
120 - Typical interior camera.
