PROPERTY CONDITION ASSESSMENT

LADREY HIGH-RISE APARTMENTS - PROPERTY CONDITION ASSESSMENT
300 WYTHE STREET
ALEXANDRIA, VIRGINIA

ECS PROJECT NO. 46:11503

SEPTEMBER 11, 2025

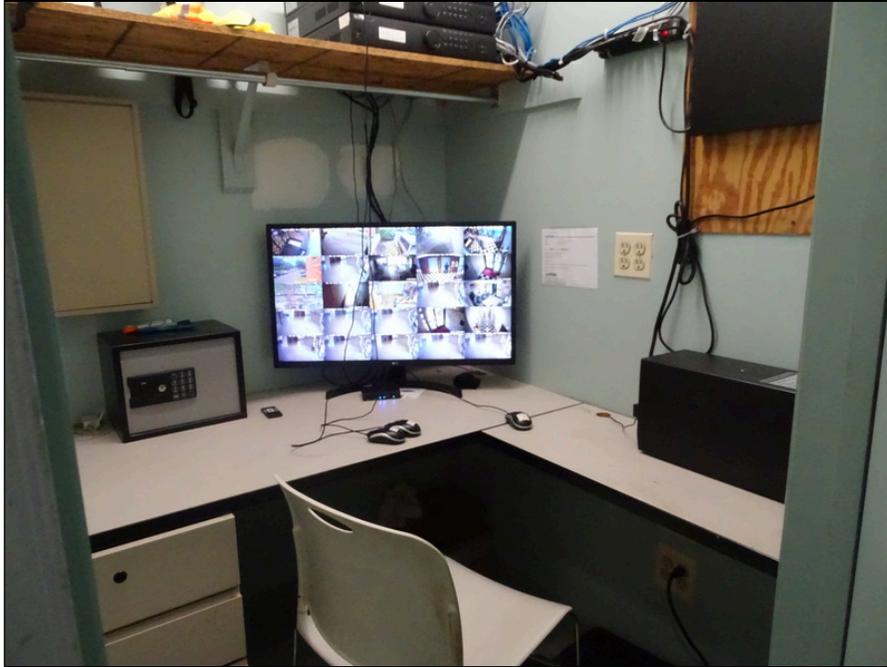
121 - Security monitoring system.

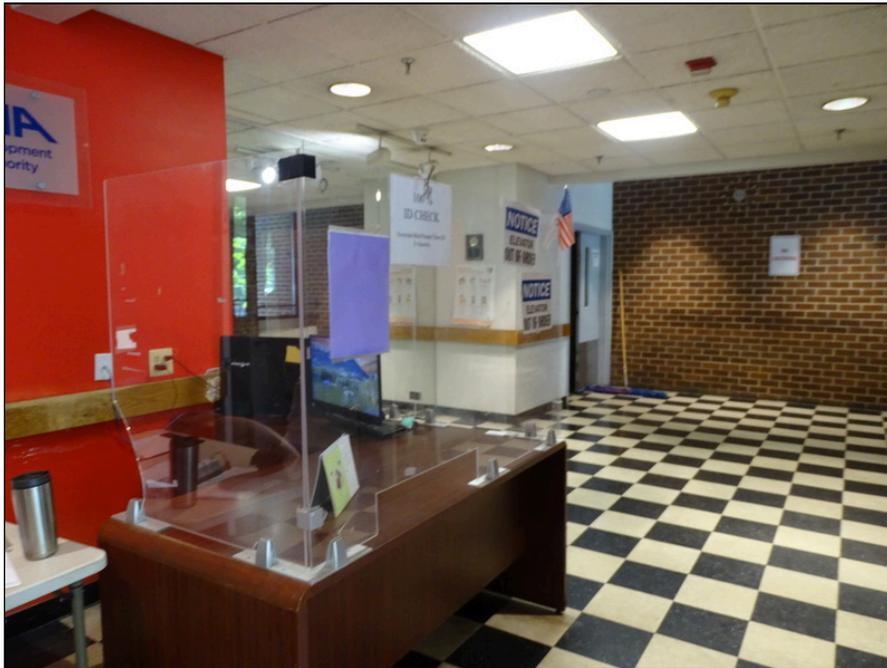
122 - Interior finishes - Reception.

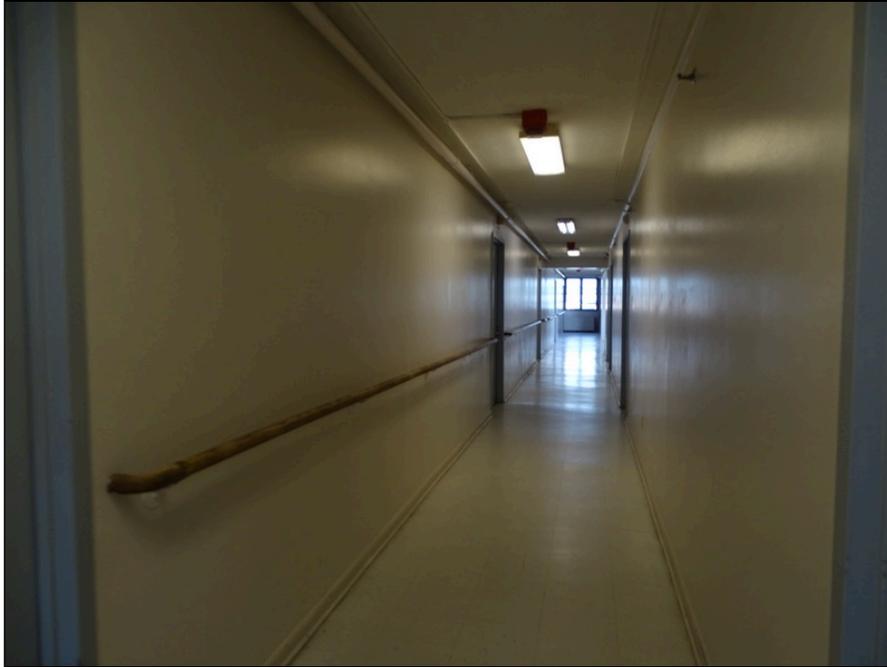
123 - Interior finishes - Corridor.

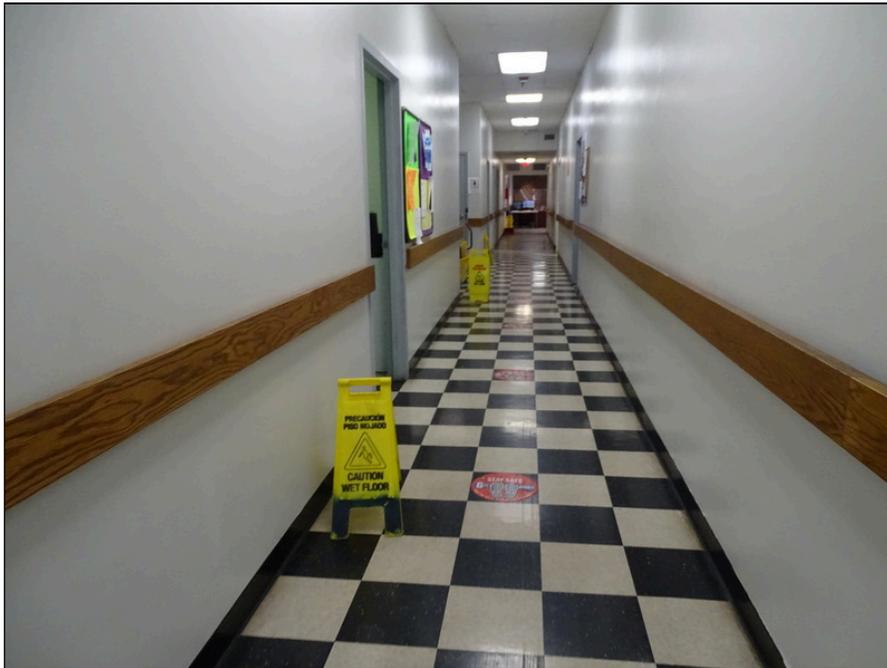
124 - Interior finishes - Corridor.

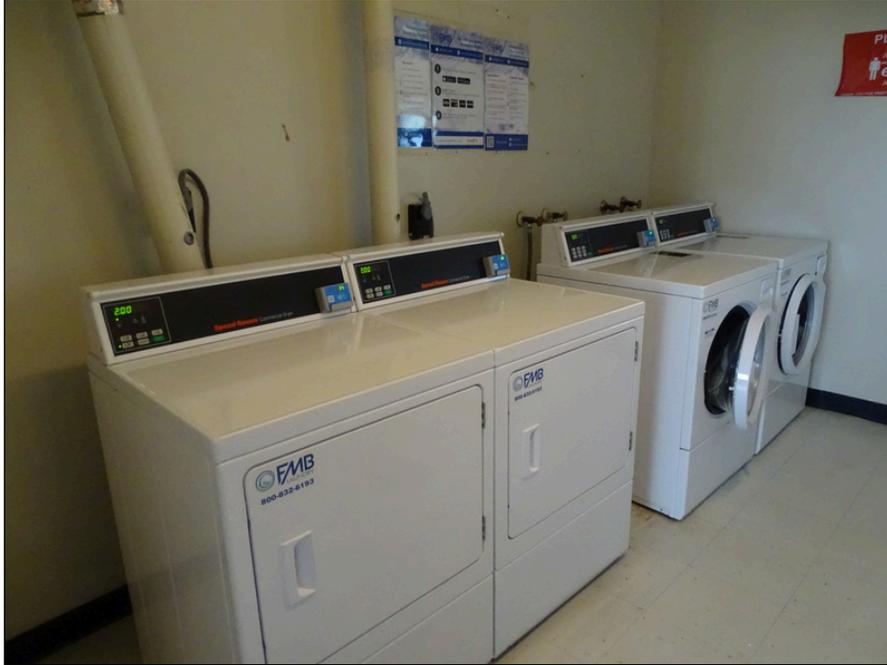
125 - Interior finishes - Laundry room.

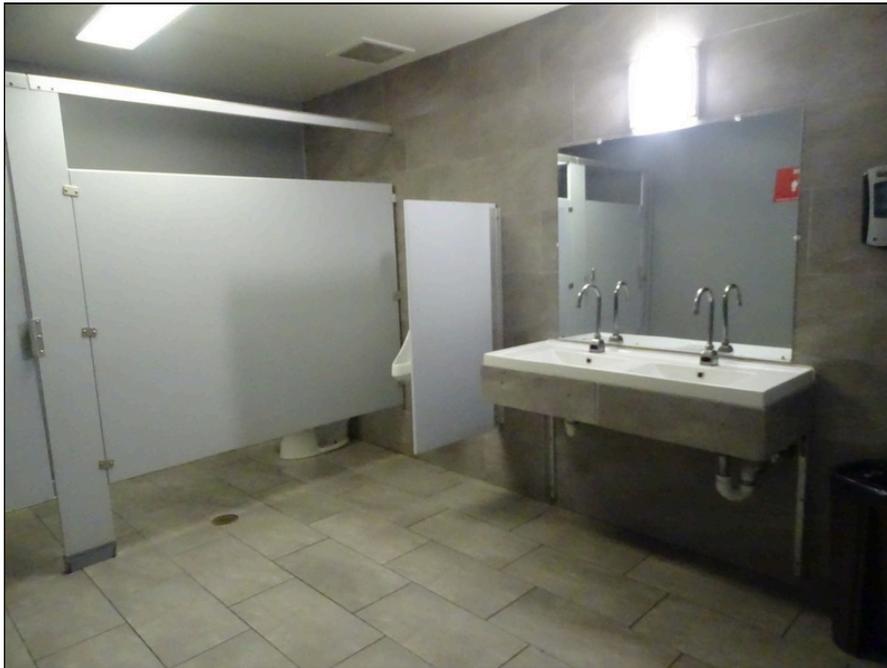
126 - Interior finishes - Restroom.

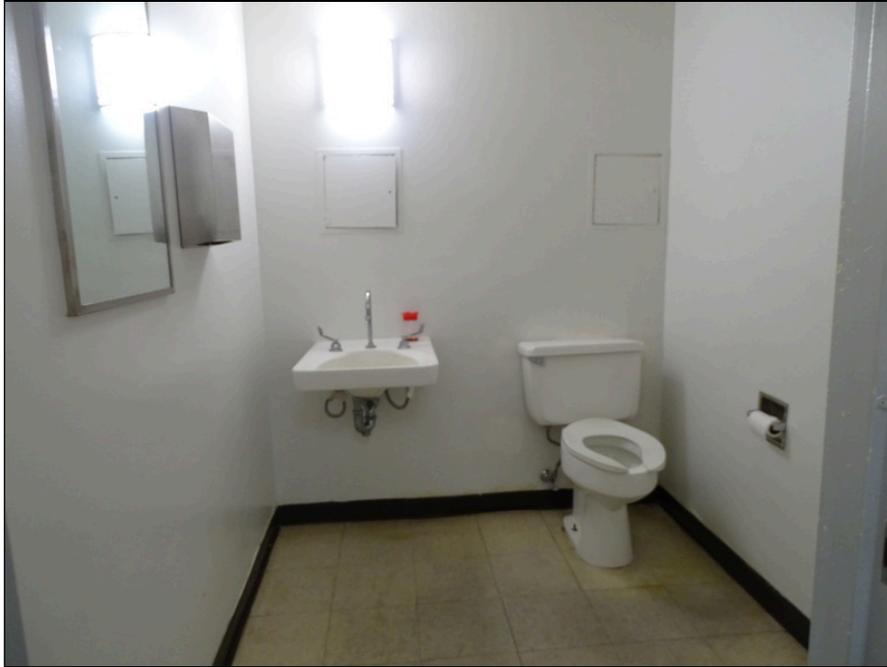
127 - Interior finishes - Restroom.

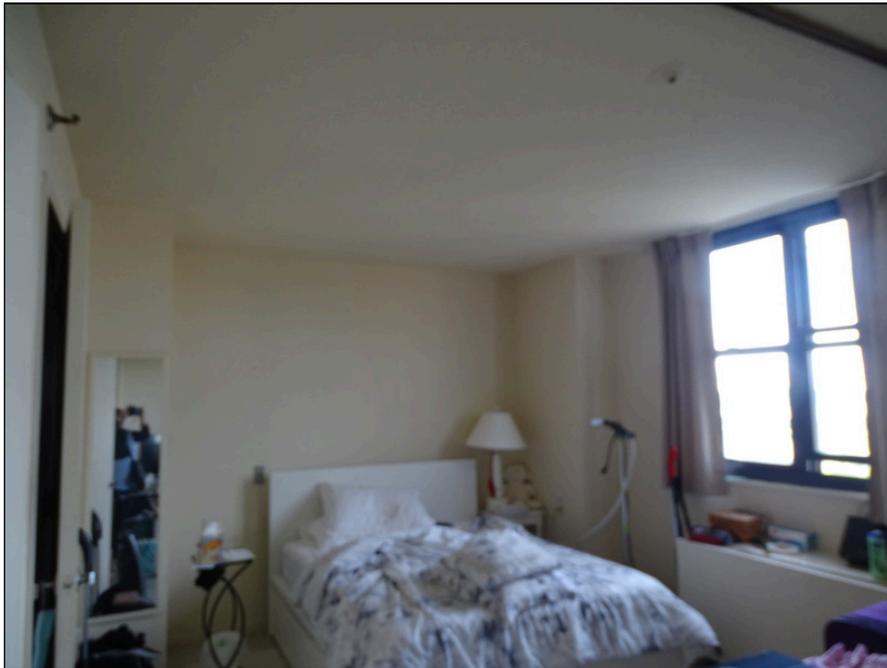
128 - Interior Finishes – Unit 1108, Bedroom

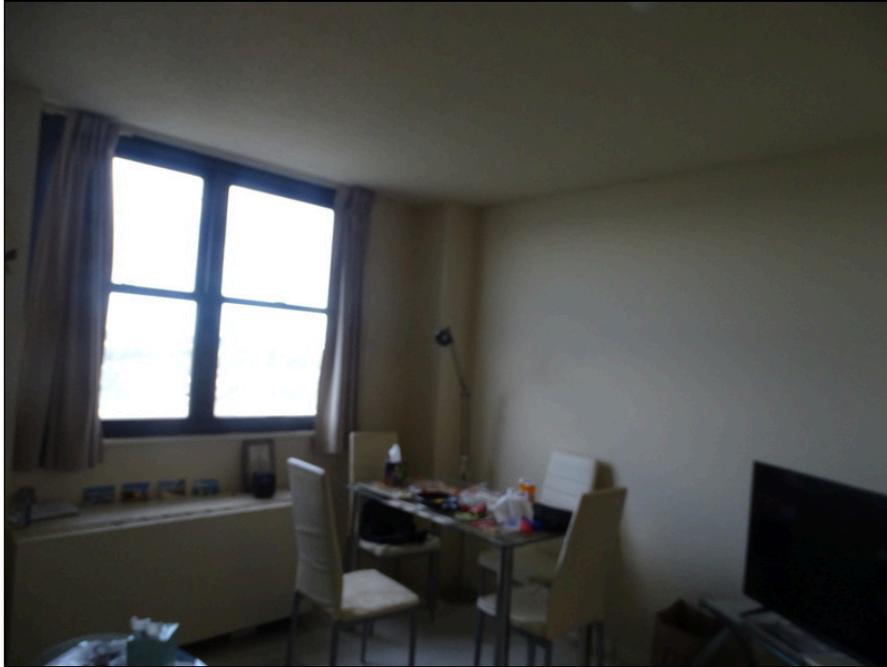
129 - Interior Finishes – Unit 1108, Living room.

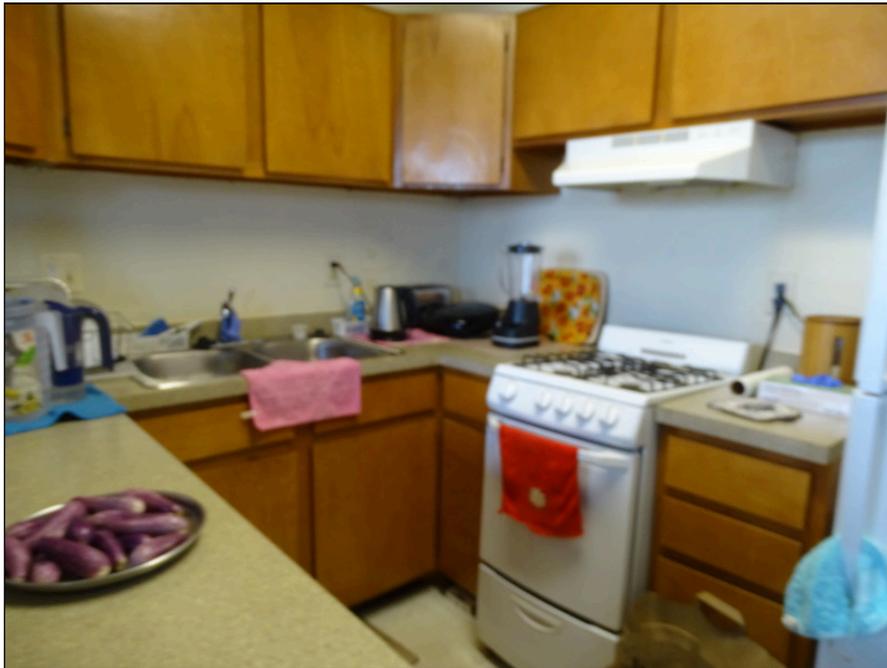
130 - Interior Finishes – Unit 1108, Kitchen.

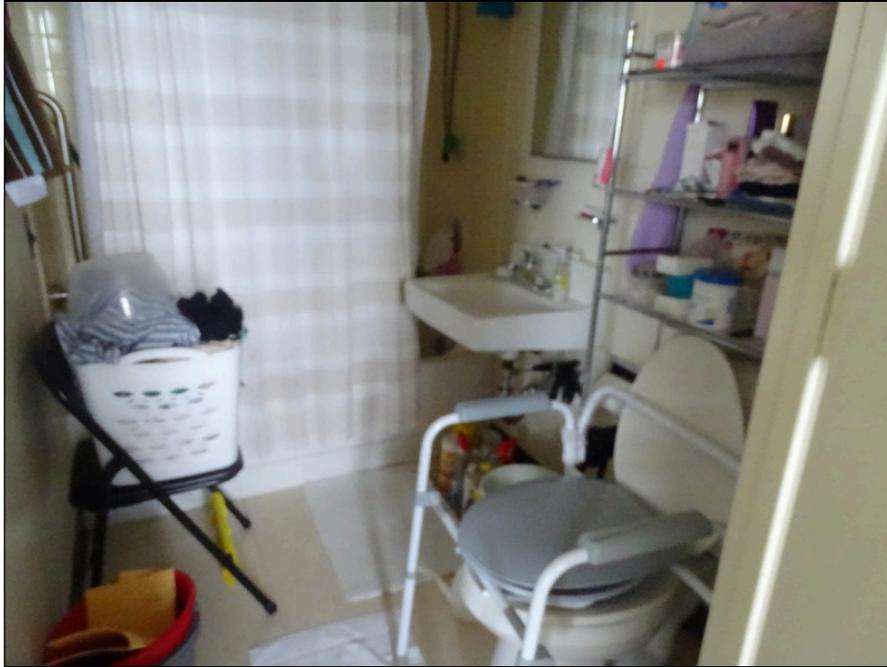
131 - Interior Finishes – Unit 1108, Bathroom.

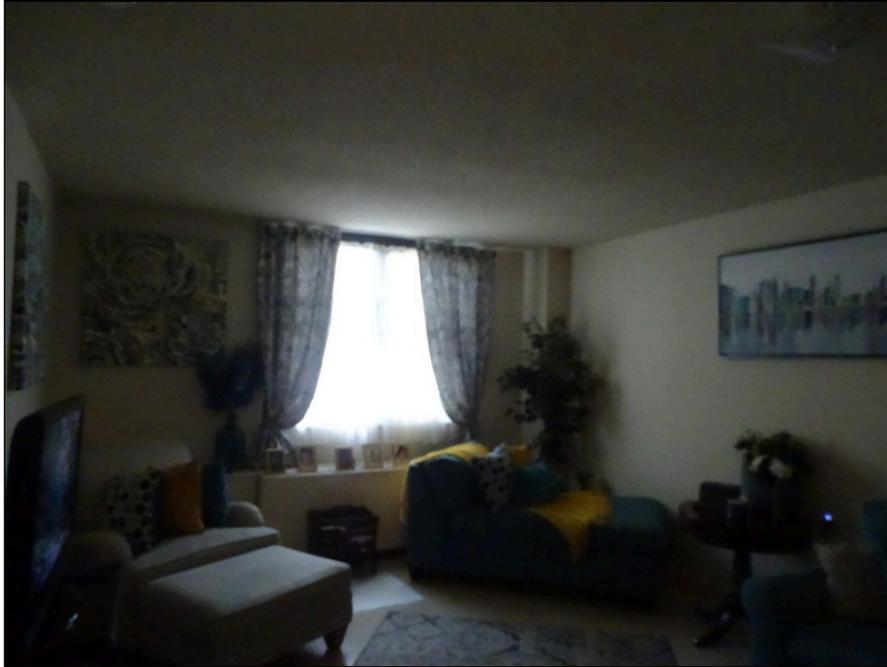
133 - Interior Finishes – Unit 201, Living room.

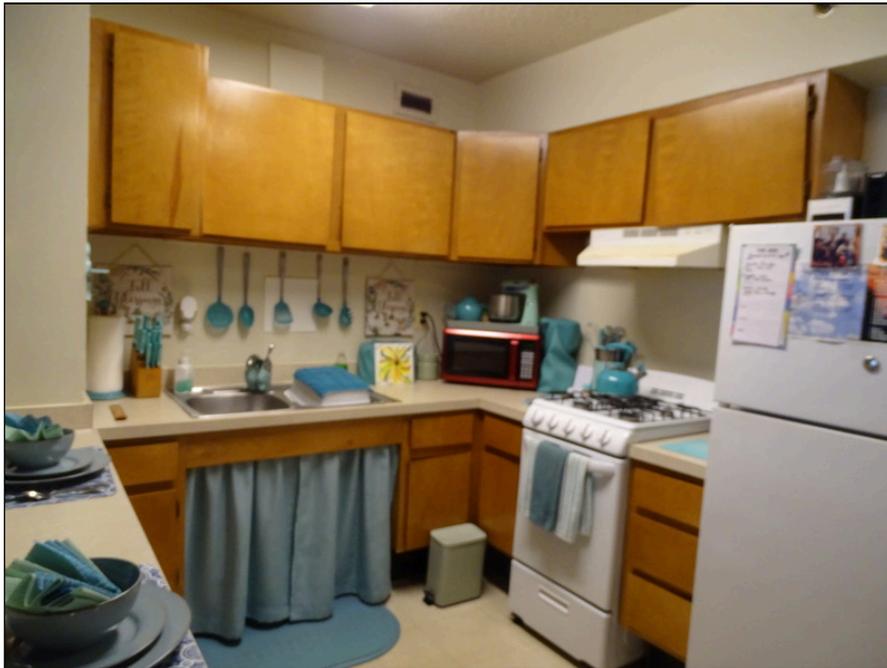
134 - Interior Finishes – Unit 201, Kitchen.

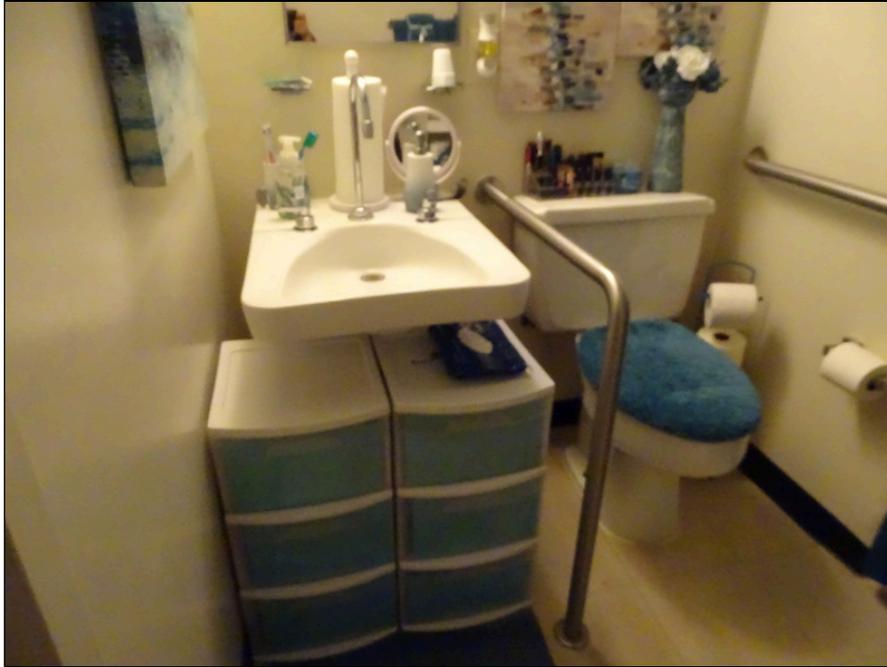
135 - Interior Finishes - Unit 201, bathroom.

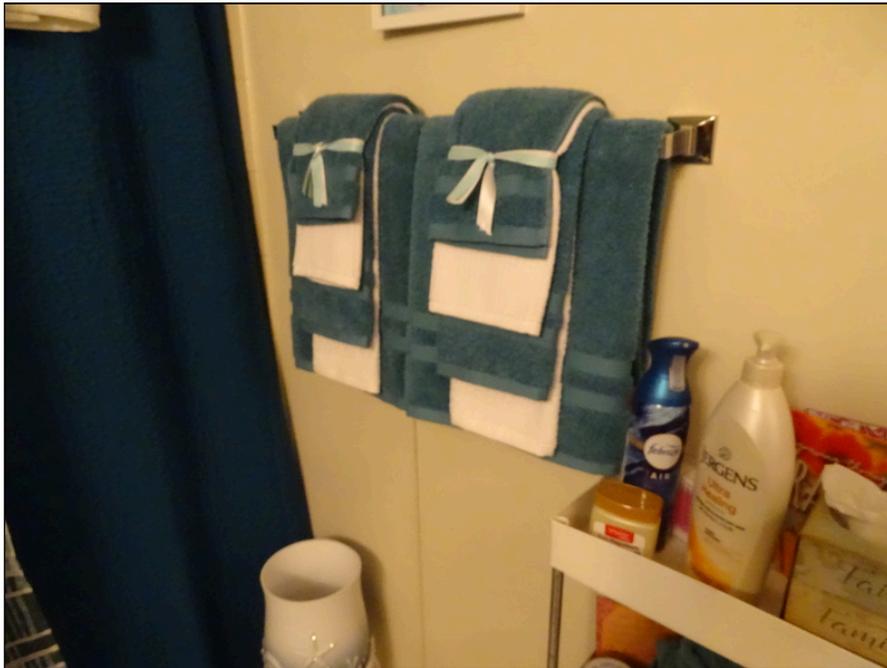
136 - Interior Finishes - Unit 201, bathroom.

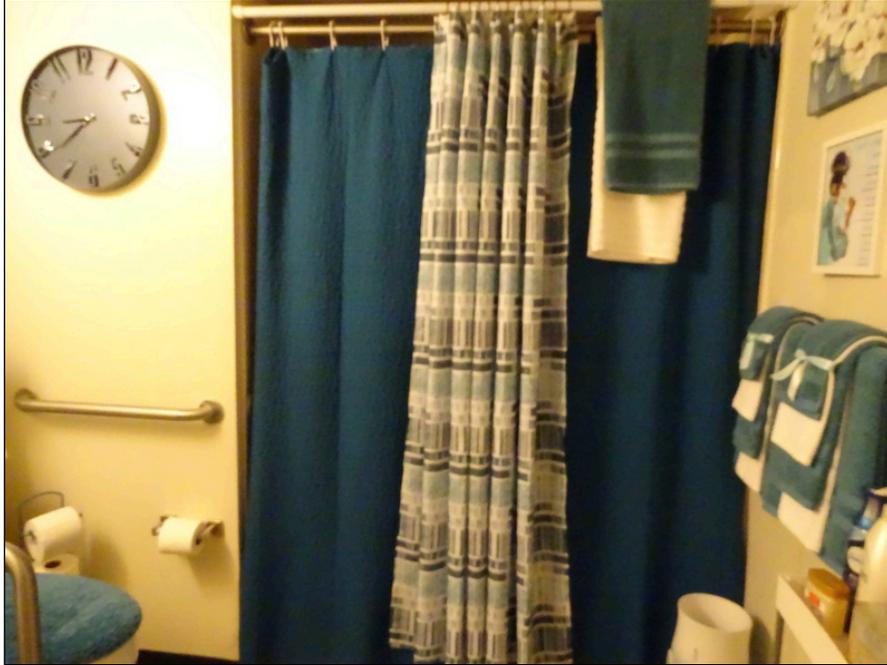
137 - Interior Finishes - Unit 201, bathroom.

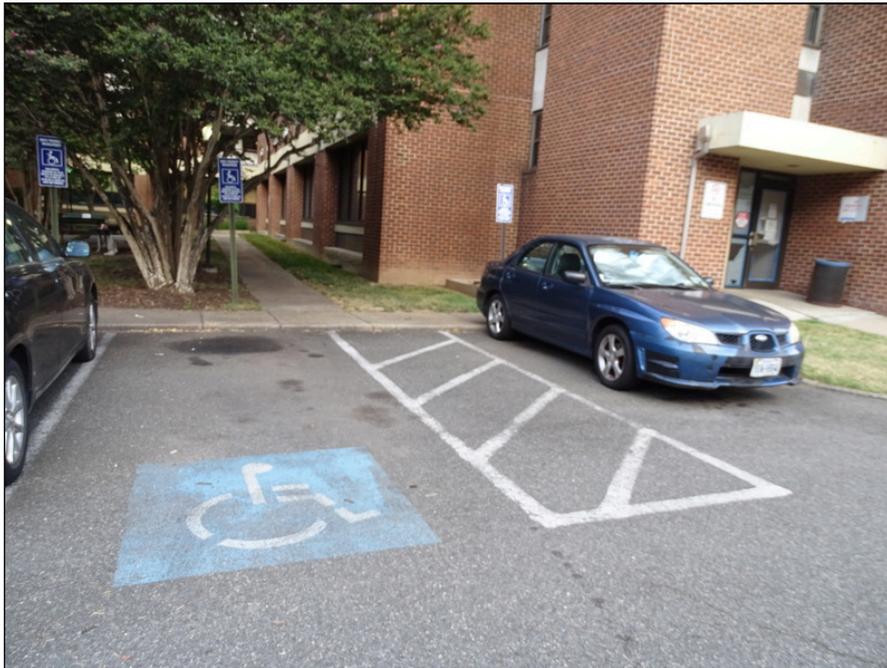
138 - Accessible parking.

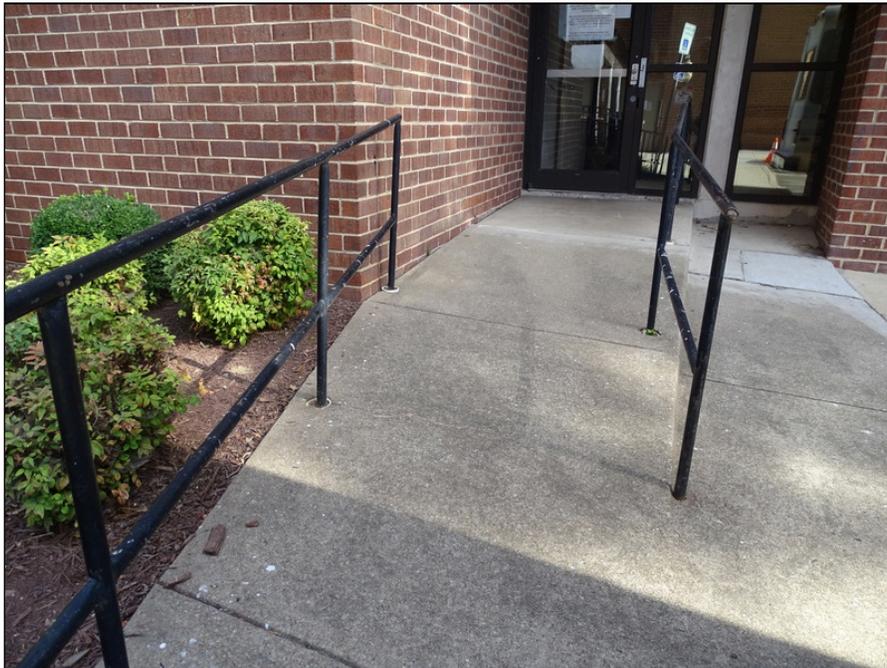
140 - Accessible ramp.

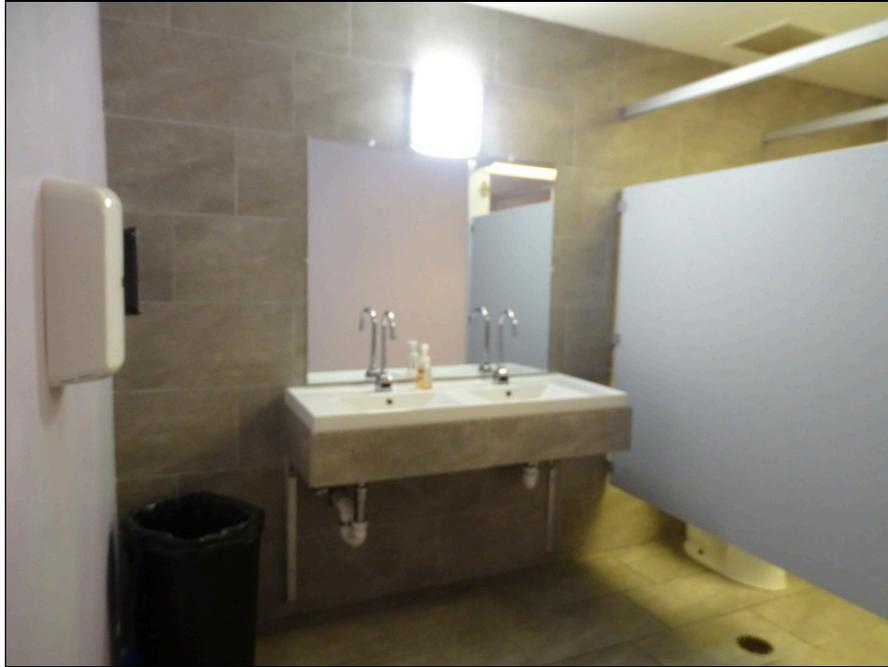
141 - Accessible stall - Note exposed pipe.

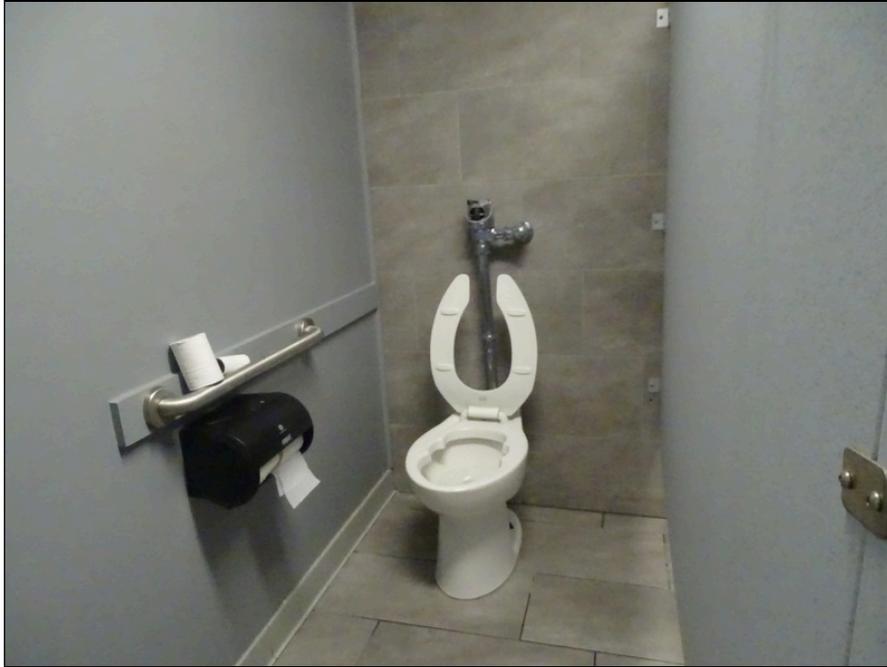
143 - Accessible stall.

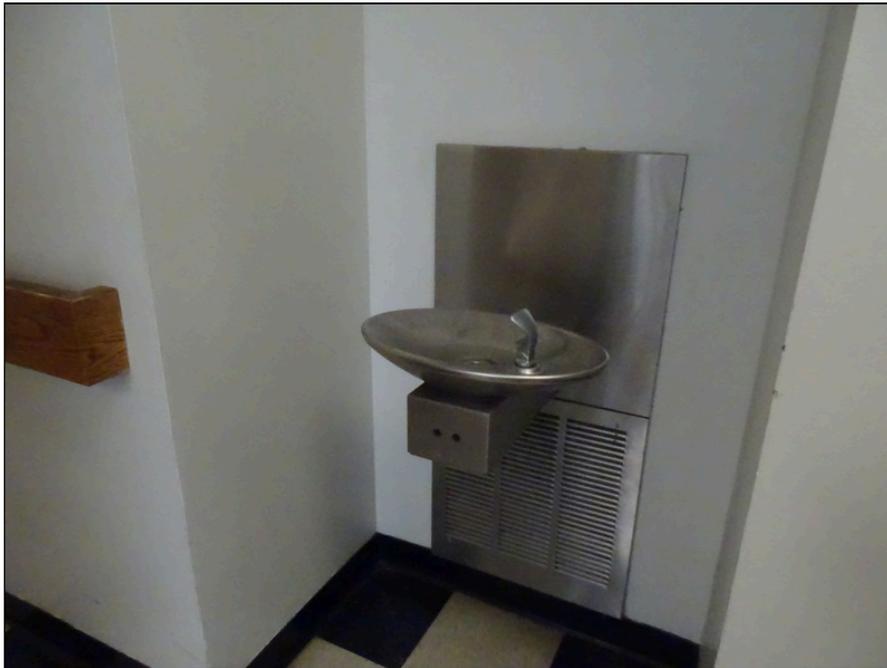
144 - Water fountain.
