CONSERVATION ASSESSMENT REPORT
for the
PUBLIC ART WORKS
ALEXANDRIA, VIRGINIA

Prepared for:
Matthew Harwood
Public Art Manager, Office of the Arts
City of Alexandria Recreation, Parks & Cultural Activities
1108 Jefferson Street
Alexandria, VA 22314

Prepared by:
Conservation Solutions, a Division of EverGreene Architectural Arts

REVISED: March 7, 2019

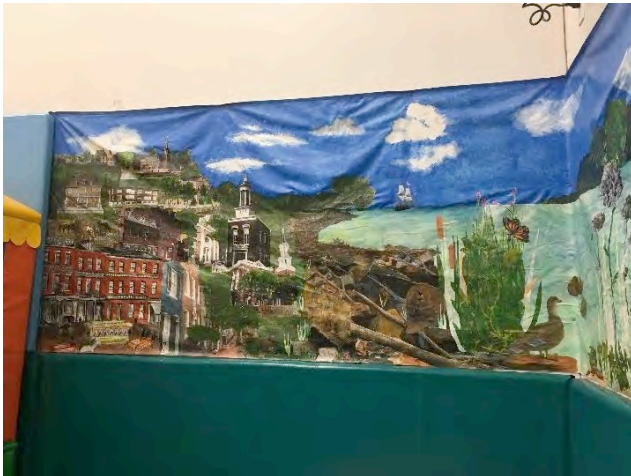
Figure 1. The banner measures approximately 30'x4'.

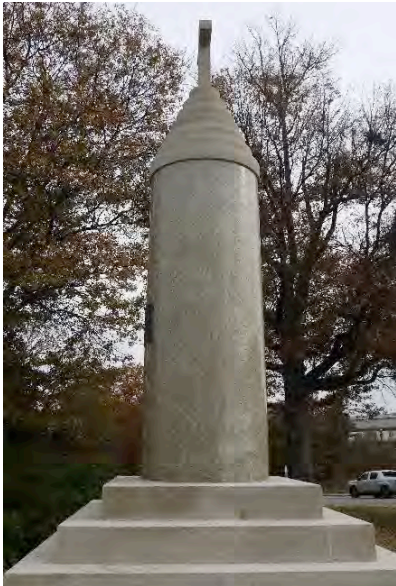
Figure 1. The War Dead Memorial measures approximately 22' in height.

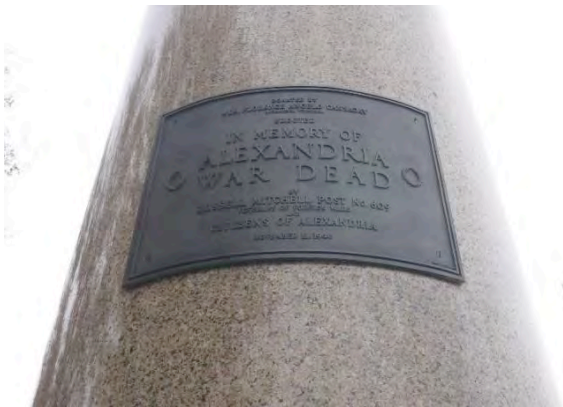
Figure 3. Detail of the bronze plaque.

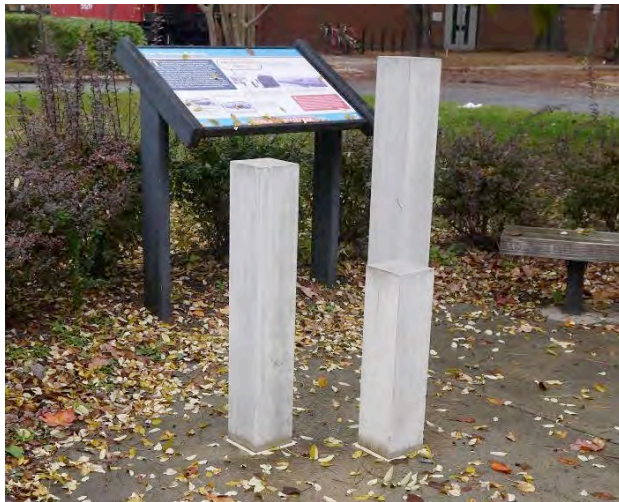
Figure 1. The sculptures measure approximately 4', 3', and 2' in height.

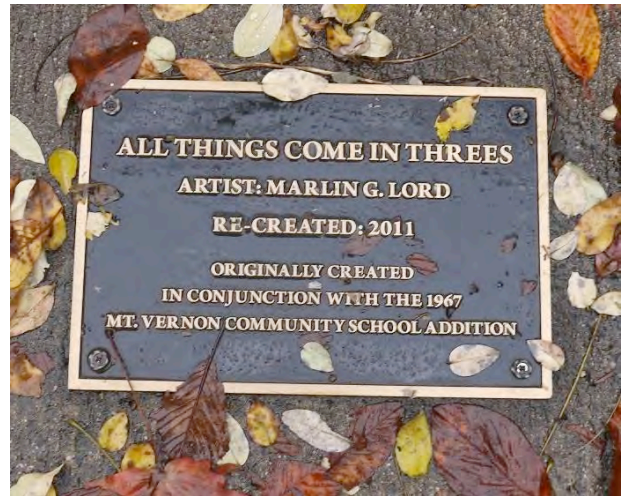
Figure 2. The dedicatory bronze plaque exhibits minor paint chip

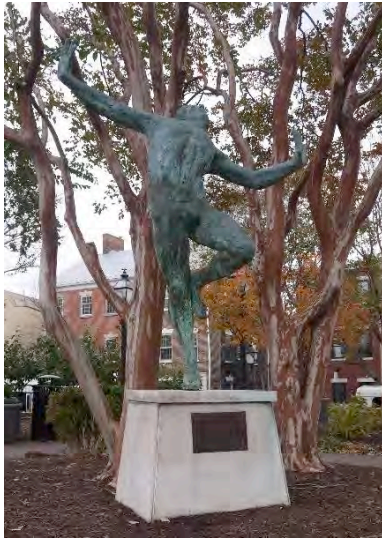
(Left to Right): Figure 1. *Brio* measures 8' in height including plinth. Figure 2. The cast stones of the pedestal have become displaced. Figure 3. Copper staining has discoloured the joints.

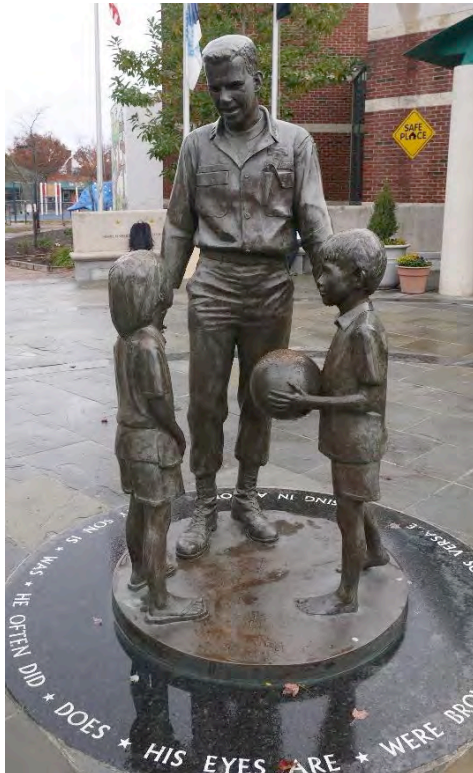
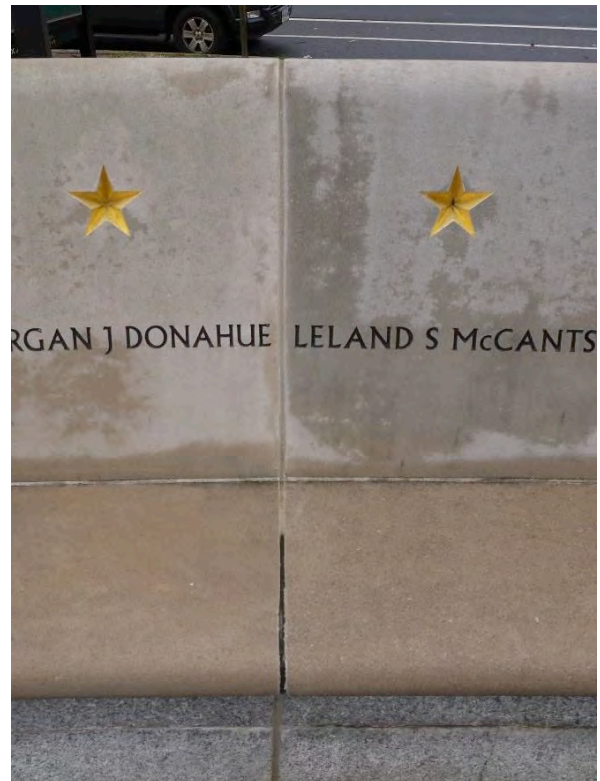
(Left) Figure 1. The statue of Captain Rocky Versace measures approximately 6' in height.
(Right) Figure 2. Each name is accompanied by a gilded star.

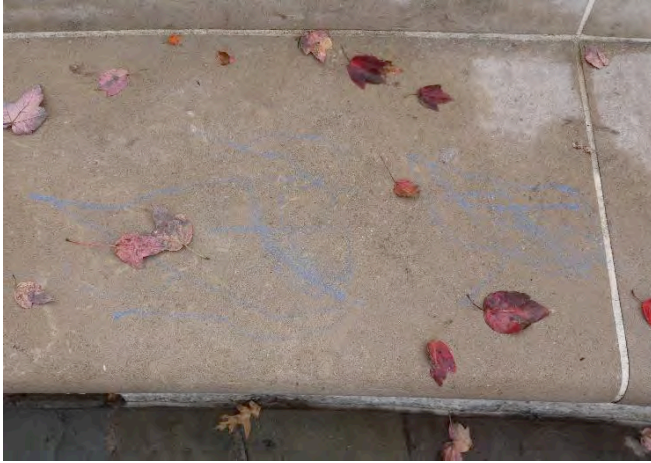
(Left) Figure 5. Localized graffiti on the limestone bench.

If any graffiti is observed, a conservator should be consulted for its removal. Graffiti should be addressed as soon as possible, as it will become more difficult to remove over time. Products and procedures should be tested to determine the safest and most efficient cleaning method. Less aggressive graffiti removal techniques should be attempted prior to the use of more interventive options.

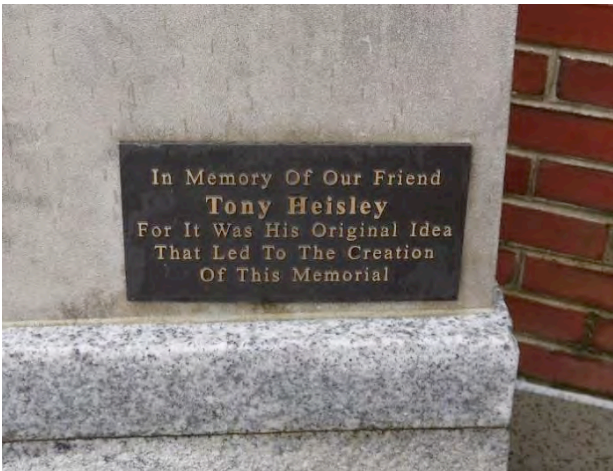
(Left) Figure 7. The dedicatory bronze plaque is in good condition.

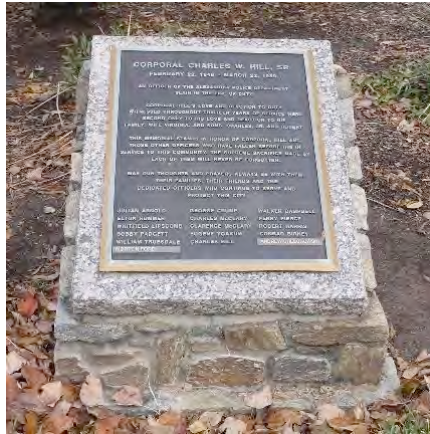
Figure 1. The plaque and base measure approximately 3'x3'.

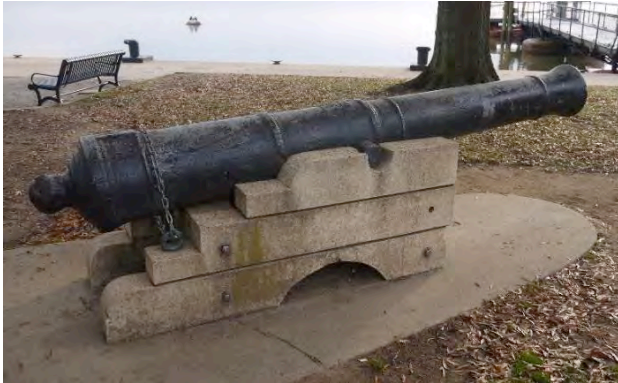
Figure 1. The Royal British Canon memorial.

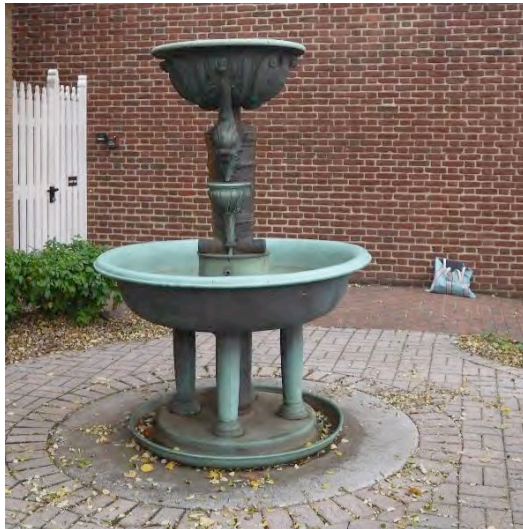
(Left) Figure 1. The fountain measures approximately 6' in height.

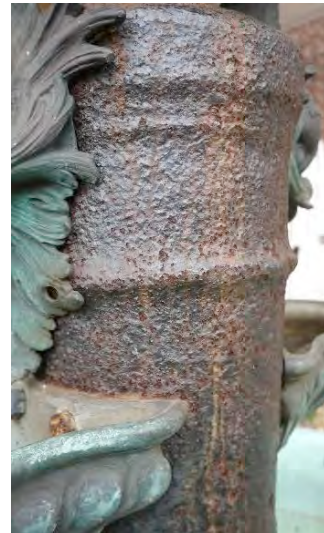
(Right) Figure 2. The cannon exhibits severe corrosion and pitting.

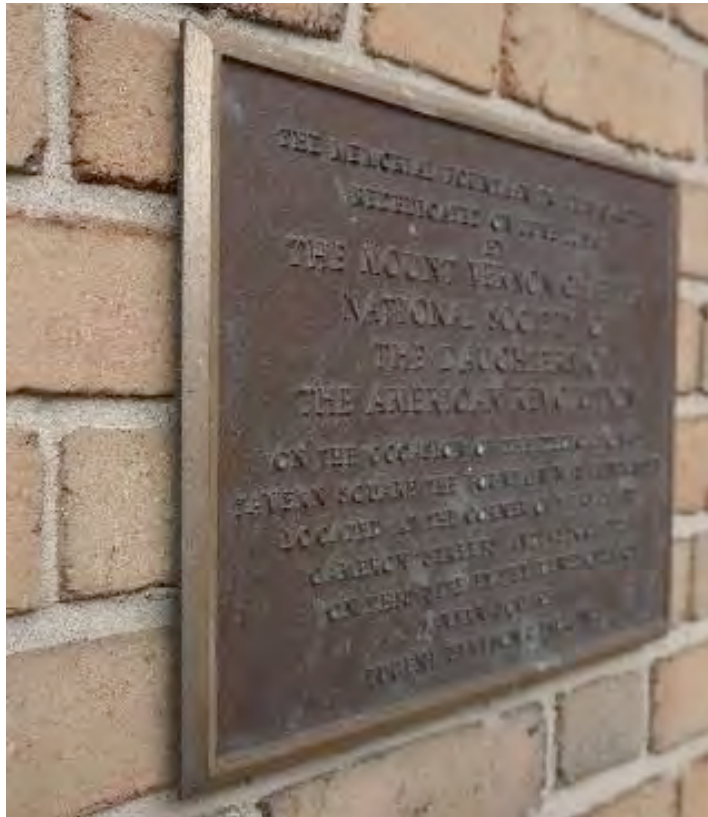
Figure 4. Dedicatory plaque on a wall adjacent to the garden.

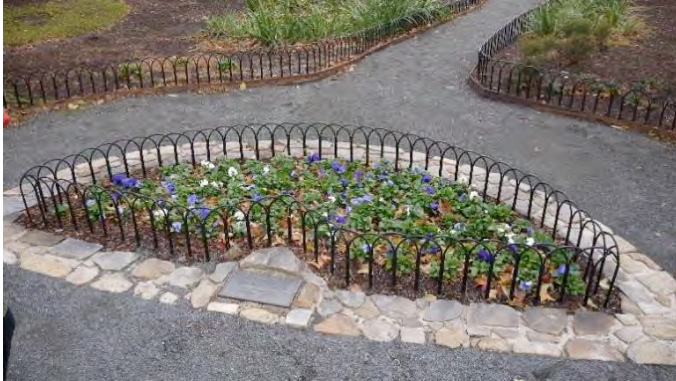
Figure 1. The memorial garden, overall image.

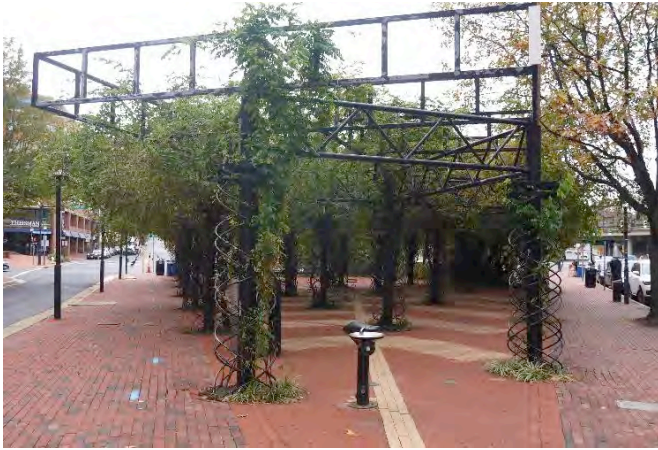
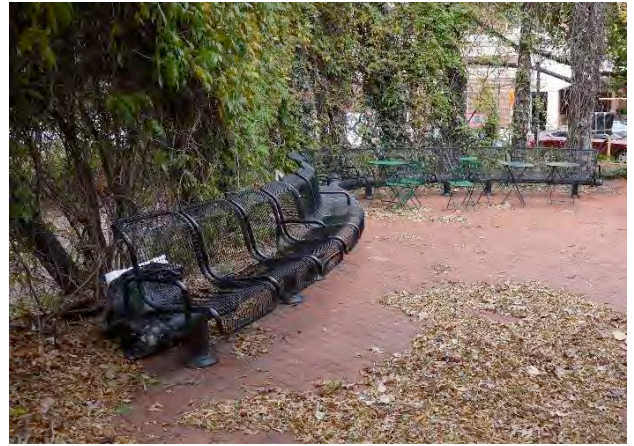
(Left) Figure 1. Typical view of the hanging garden, looking east. (Right) Figure 2. Typical view of the topiary wall, looking north.

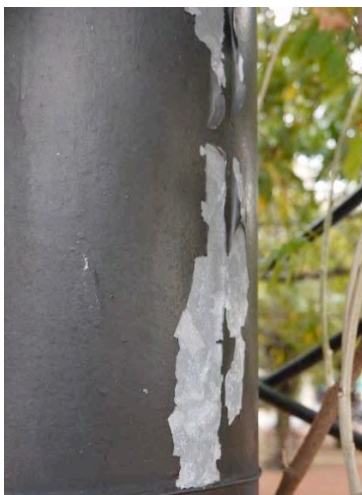
(Left) Figure 3. Detail of paint loss on a steel structural member revealing the galvanized surface below.

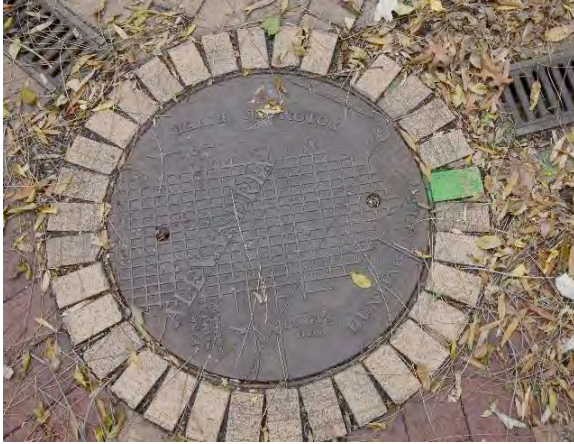
(Left) Figure 9. The decorative manhole covered cover with green paint.

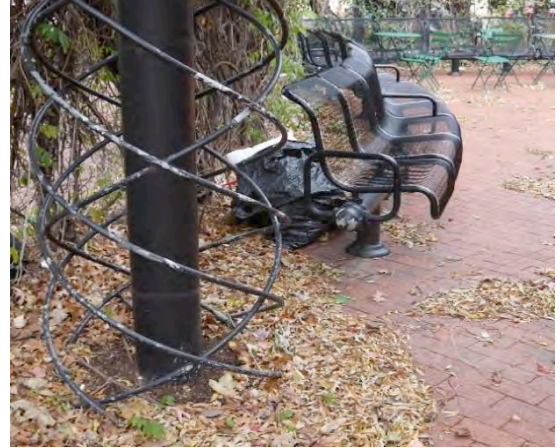
(Right) Figure 10. Typical trellis post encircled by plantings and decorative metal swags.

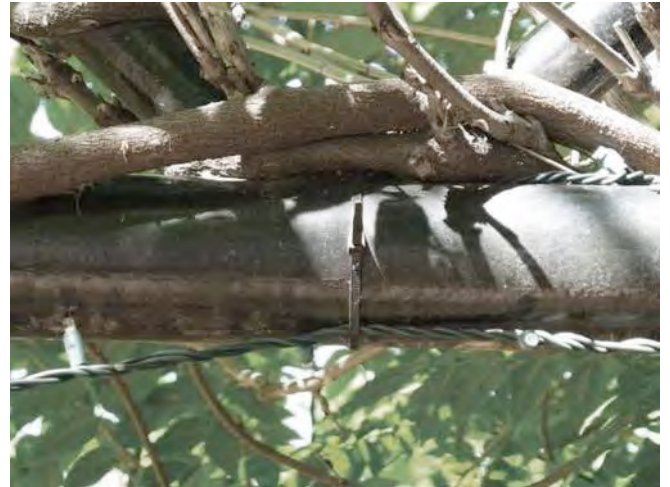
(Right) Figure 12. Detail of the zip ties that have been used to suspend strings of lights from the trellis, causing abrasion of the paint.

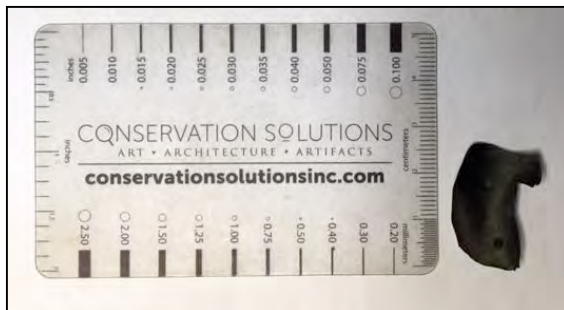
At the request of the client, additional reviews of the existing black paint were reviewed. The sample was obtained during the 2018 conditions assessment performed by Conservation Solutions, a division of EverGreene Architectural Arts in 11/ 2018. The sample represents flakes of paint that had fallen from the substrate to the ground and was not removed directly from the surface. The sample shows that there is no primer, which is confirmed by the exposed patches of the metal substrate from where the paint coat has deteriorated.

Figure 1. King Street Gardens Park, paint sample.

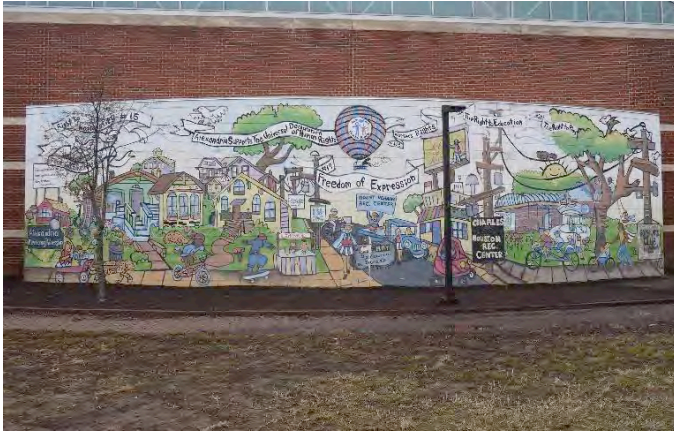
(Left) Figure 1. Overall view of the mural on the north side of the building. (Right) Figure 2. Detail of one of the instances of paint blistering and loss.

This is a large-scale mural that was painted by the community as part of a community project, therefore the materials and technique could affect the mural's condition. The mural is generally in fair overall condition with specific issues focused around joints and at the base. The mural is painted on a curved CMU wall on the north elevation of the recreation center. The ground at the base of the wall is mulched, which has caused some residual soiling at the base; there are also footprints on the wall from people leaning against it. There are lots of abrasions and scuff marks on the lower third of the wall. The abrasions are expected based on the mural's proximity to a playground and walkway.

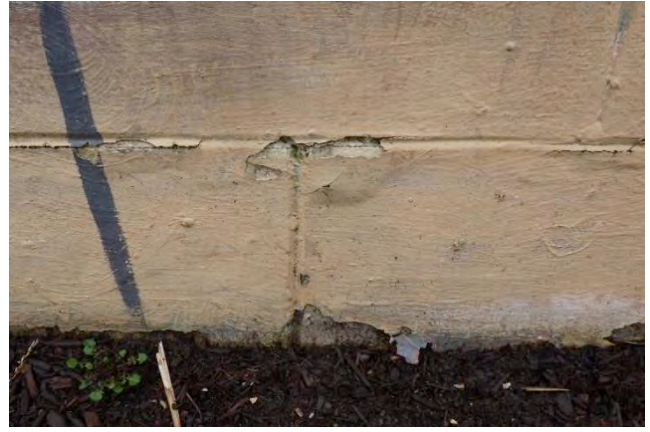
Along the central seam of the wall expansion joint is a crack; indicating movement, which has caused paint failure. Paint failure is worse at the bottom third section, where several large patches of paint are missing. Following the expansion joint at the bottom course of blocks there is paint failure from excess moisture retention. Throughout the wall there are tiny chips from impact damage. There is failing paint at the second expansion joint on the west corner, which is less severe than the failing paint at the center joint. At the second expansion joint the paint is cracked but not lost. At the east corner there is more severe damage and an open hole in the CMU block. Flashing at the top of the wall serves to shed off water, limiting staining or streaking from water run-off from the roof. There is no artist's signature or lighting.

The paint over the expansion joint should be carefully scored over the sealant to anticipate the movement that is likely to continue to occur at locations like the central seam, and to prevent further tearing, peeling, and loss. Existing losses adjacent to the joint should be carefully inpainted to match adjacent surfaces. Area of paint loss should be treated with mild abrasives to free loose paint for selective repainting. The dirt that has splashed back up on the lower edge of the mural should be carefully removed with lower pressure water and a soft, natural bristle brush or sponge. The hole should be patched with a compatible contract patch material, to prevent water infiltration.

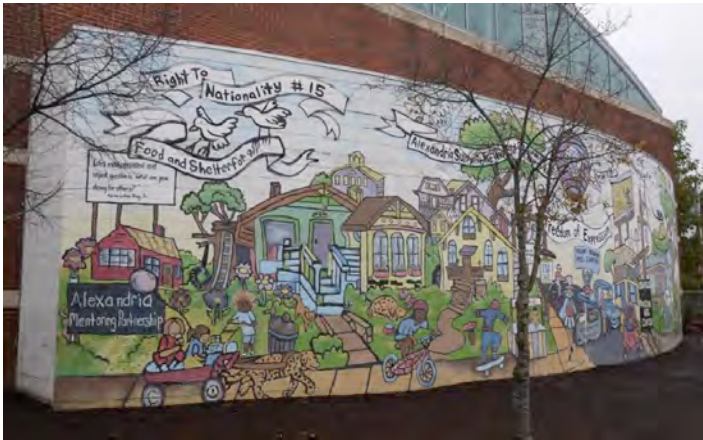
(Left) Figure 3. General view of the mural overall.

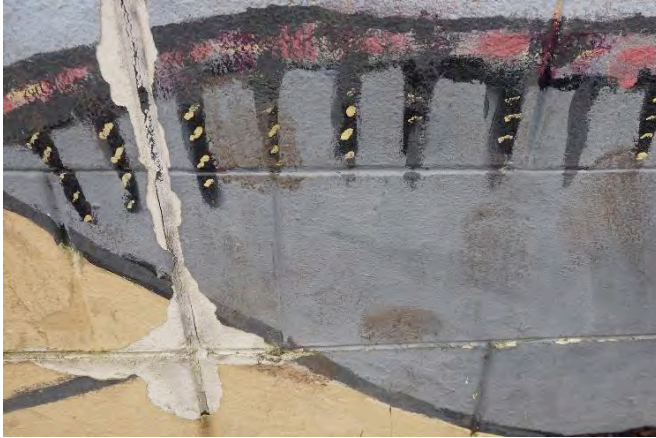
(Left) Figure 5. Flaking of the topcoat reveals the primer underneath.

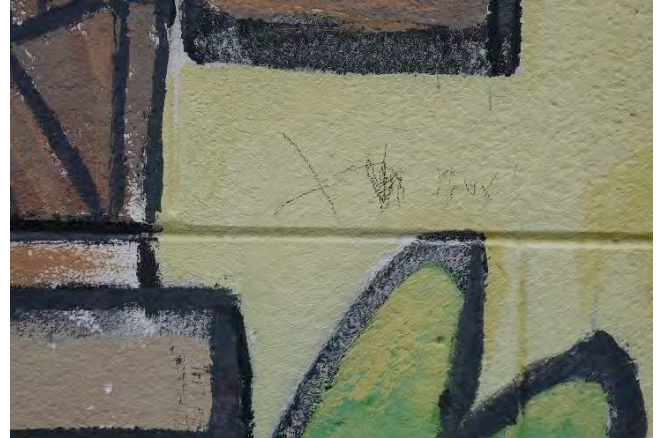
(Right) Figure 6. Incident of graffiti.

For general maintenance, the mural should be cleaned every 2-5 years with a mild detergent and low-pressure rinsing. Washing should only be done if the temperature is to remain above zero for the following 48 hours. If any graffiti is observed, a conservator should be consulted for its removal. Alternatively, the artist could be contacted to re-paint over any affected areas. The condition of the mural along with its support and any connection bolts or fasteners should be inspected annually. If failing paint is identified the artist and a conservator should be consulted.

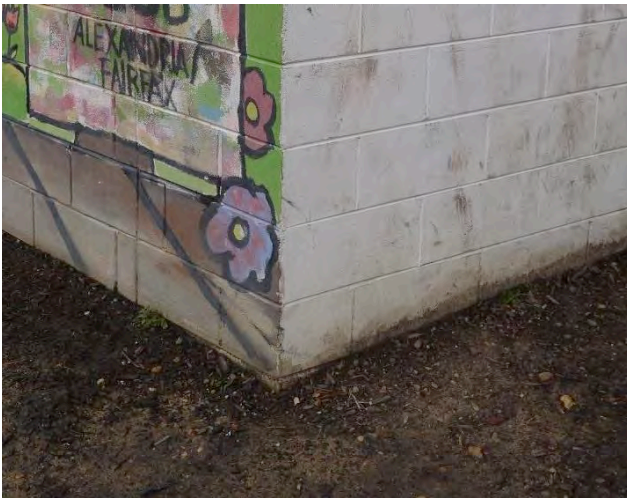
(Left) Figure 7. Splash- back from the ground below has soiled the lowermost 12" of the mural.

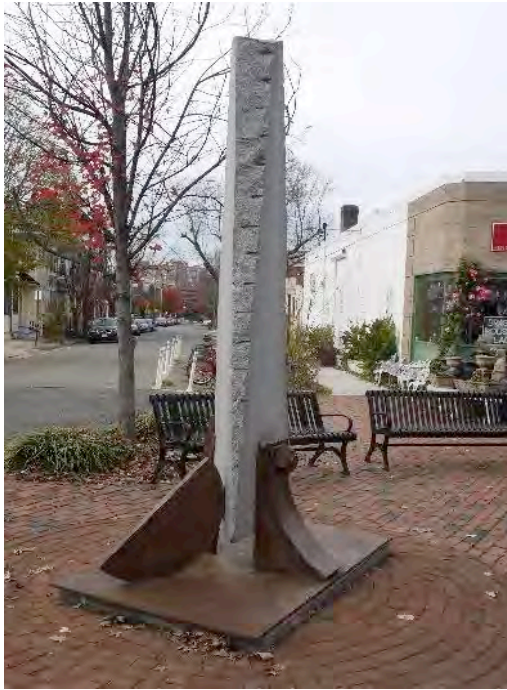
Figure 1. The totem measures 113' x 66' x 44'.

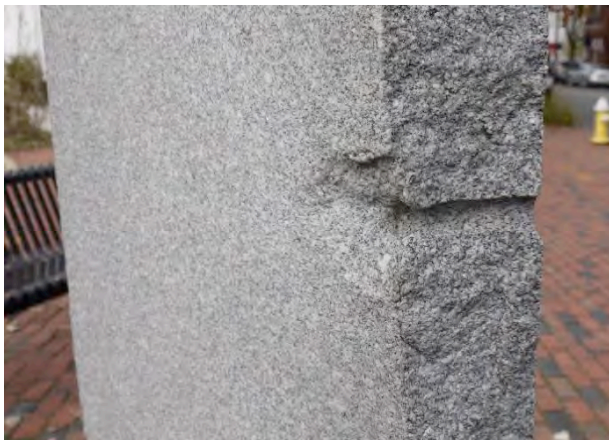
Figure 3. Detail of rough-cut edge.

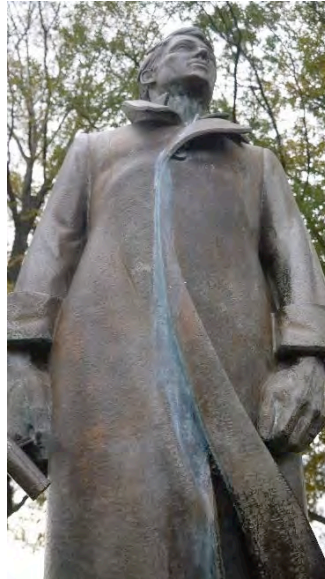
(Left to Right) Figure 1. General view of the Shipbuilder sculpture. Figure 2. Detail of surface corrosion and soiling. Figure 3. General view of decorative granite scroll.

The sculpture is in overall fair condition. A life-size bronze figure stands atop a granite pedestal with decorative corbels on three sides with three circular bronze plaques affixed to the sides of the pedestal. The corbels are soiled and invite people to climb on the sculpture. Wax on the figure is blanching in numerous locations. There is verdigris corrosion in numerous places on the feet of the sculpture and streaks down the face and jacket. In the folds of the sculpture is evidence of mud daubers. Caulking between the sculpture and the granite base is starting to fail. Copper corrosion staining is visible on the polished marble underneath the bronze figure. Two of the three circular plaques have little to no wax coating remaining and are corroded. The plaque at the front of the sculpture appears to have been treated more recently and was possibly lacquered; it displays little corrosion. The pedestal is surrounded by brick pavers, which are stable but soiled.

The bronze figure and plaques are in need of cleaning and recoating. After the general washing of the sculpture, detail cleaning of the figure should be performed using nylon abrasive pads or bronze bristle brushes on an as-needed basis to remove active corrosion. The conservator should determine the appropriate coloration for the figure in consultation with the client and artist. Based on this, the figure may require spot- or total patination. The bronze should be finished with a protective wax or lacquer coating containing a corrosion inhibitor. The two bronze medallions in poorer condition than the plaque located at the front of the sculpture require recoating at this time.

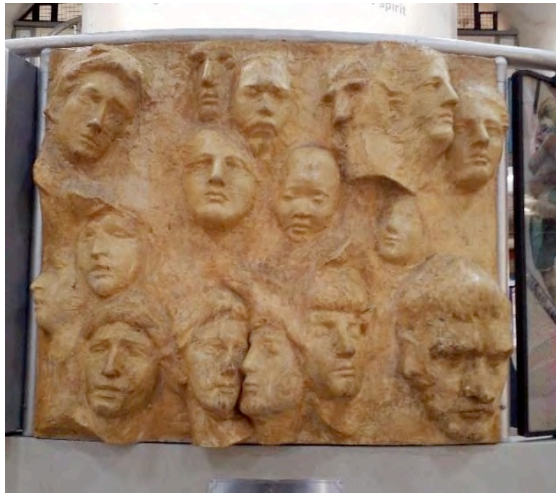
4. Fiberglass, face sculpture with epoxy paint by Mirella Belshe
Located fourth from right, the decorative relief of faces is cast from paper and resin, which have yellowed over time. The resin has failed on some of the raised surfaces of the faces. These areas are creamy compared to the yellow resin. There is a moderate level of soiling on the skyward surface underneath the railing

(Left) Figure 3. Fiberglass, face sculpture with epoxy paint by Mirella Belshe.

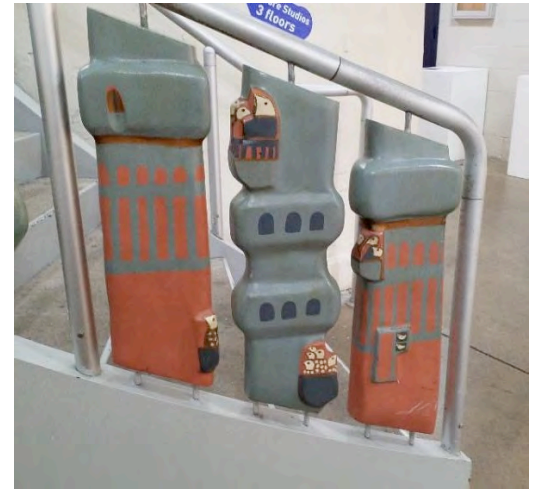
1. 3 painted wood sculptural balusters by Murney Keleher
Located bottom right, the three balusters are painted wood. There are abrasion marks on the first baluster nearest to the start of the stairs. Its location makes it easily scuffed. It has a moderate level of soiling overall. The balusters are coated with a clear stain finish that has started to yellow.

(Right) Figure 4. 3 painted wood, sculptural balusters by Murney Keleher.

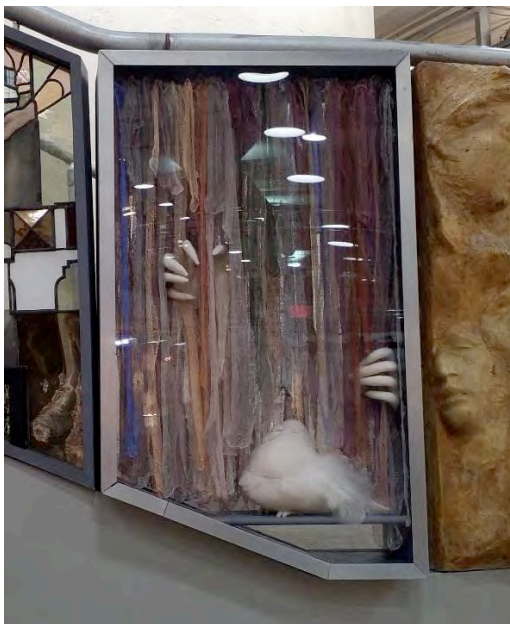
5. Textile artwork by Joyce Zipperer
Located fifth from right is a framed textile piece. The piece consists of strips of differently dyed/ colored loose weave fabric that are nailed to an internal wood strip allowing them to hang. A figurative bird and spider made of fabric hang on interior stair side. Plaster fingers reach through the strips of fabric. The textiles are contained by a wood case with a metal trim and Plexiglas panels. Dust has collected at the bottom of the frame. There are numerous accretions and smears on the Plexiglas. At the top left-hand corner of the outer side the Plexiglas is scratched.

(Left) Figure 7. Textile artwork by Joyce Zipperer.

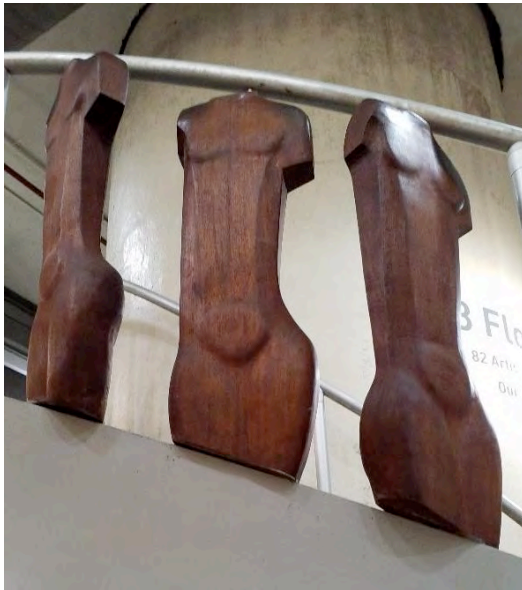
(Left) Figure 11. Wood carved torso by Julie Schieder.

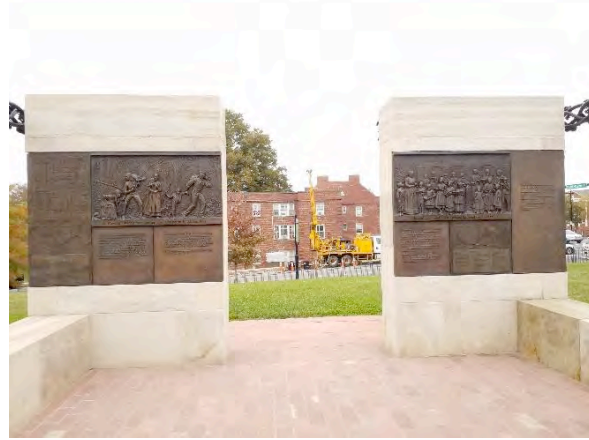
(Left) Figure 5. Cemetery entrance; the sandstone pier shows severe iron-staining from the ferrous bolts. (Right) Figure 6. View of the north wall (interior facing) with bronze plaques.

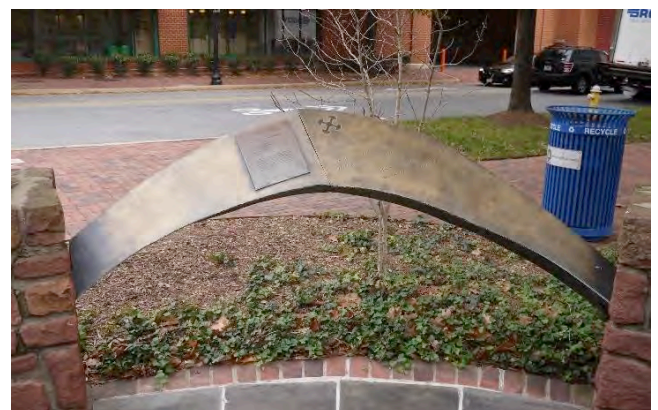
(Right) Figure 2. Part A, bronze signage.

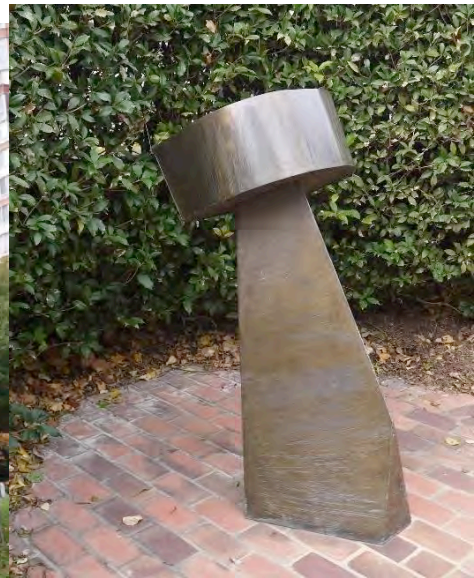
(Right) Figure 6. Bronze podium, Part C. Once integrated, it is no longer accessible because of the surrounding vegetation.

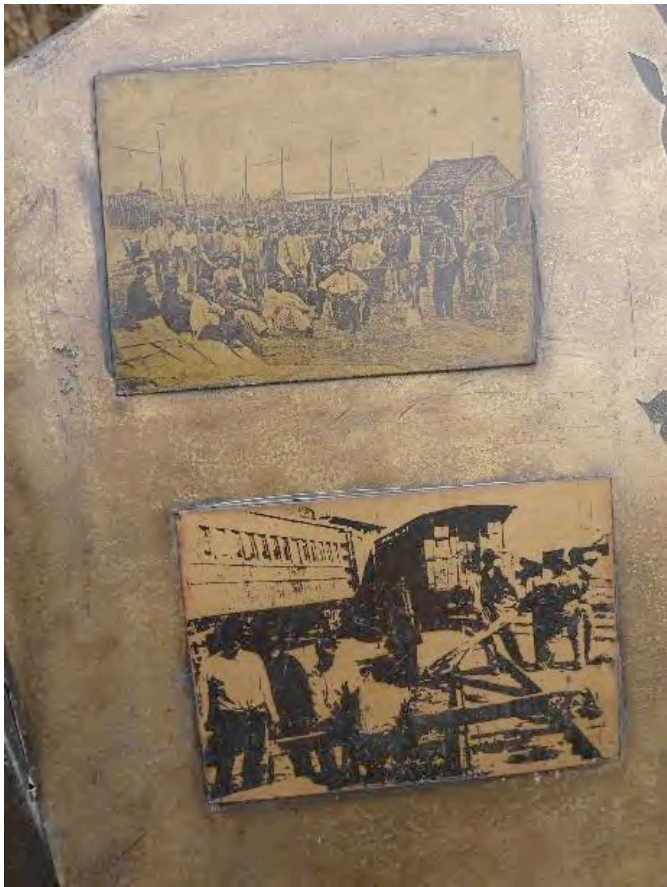
Figure 8. Detail of etched imaging in bronze signage, Part B.
