Fort Ward Park and Museum Area Management Plan

Appendix I FORT WARD PARK DRAINAGE MASTER PLAN

URS Corporation, 2014

FORT WARD PARK DRAINAGE MASTER PLAN

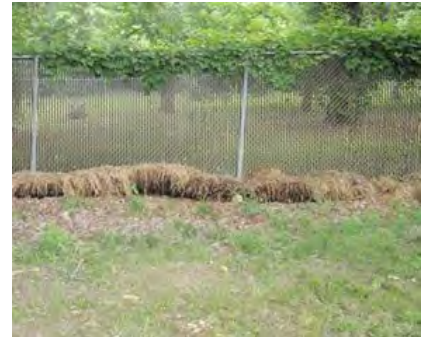
Existing Site 6 Hay Bales

Runoff from the utility yard (Site 6) to the Oakland Baptist Cemetery (Site 8) is eroding the cemetery site. Temporary practices including hay bales, trenches, culverts, and a catch basin are in place to control runoff (Figure 3). The drainage area includes 0.2 acre of developed area (driveways and buildings) and 1.5 acres of grass or bare earth. The utility yard and the cemetery are composed of hydrologic soil group D soils, which are poorly drained with low infiltration rates and high clay content.

The proposed site improvements are two permanent earthen diversion berms to direct runoff from the utility yard to a catch basin. Figure 8 displays the proposed location of the two diversion berms. The northern berm keeps runoff from entering the cemetery while the southern berm keeps runoff from the road off the site and provides additional protection on the grave sites outside of and south of the cemetery from upstream runoff. The berm would follow the natural slope (4 percent) south of the Oakland Baptist Cemetery. The proposed berm would be approximately 1.5 feet tall, with a minimum 2:1 side slopes (depending on obstructions), and would be 1 foot wide at the top (Figure 9). Erosion protection matting would extend from the base of the berm to the existing grade, and the upstream face would be protected using erosion protection matting or other erosion prevention measures (see Figure 9). The remainder of the berm would be made up of fill. The entire berm can be seeded with grass unless an impervious material is required to protect the berm slope instead of erosion protection matting. There are several potential options for the protected slope including erosion control matting, porous pavers, or riprap.

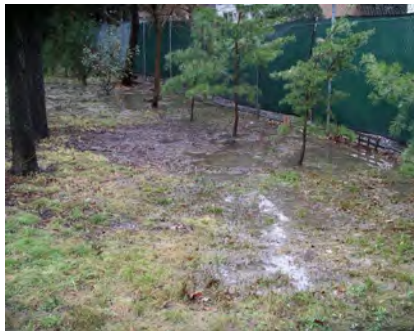
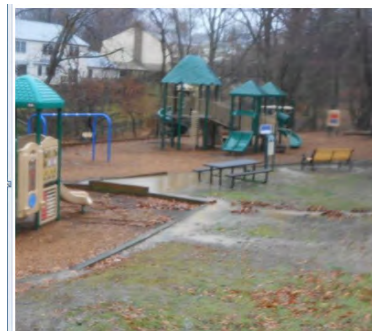
Issue: Flooding and Erosion

- Nuisance flooding and erosion in the park and at adjacent properties

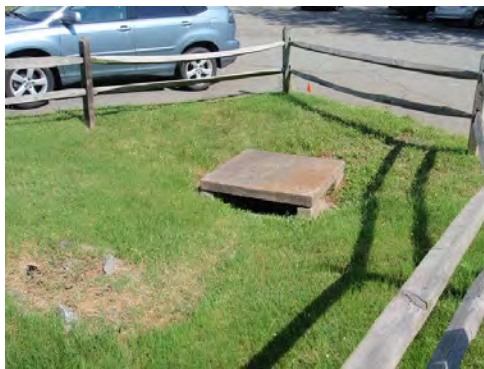
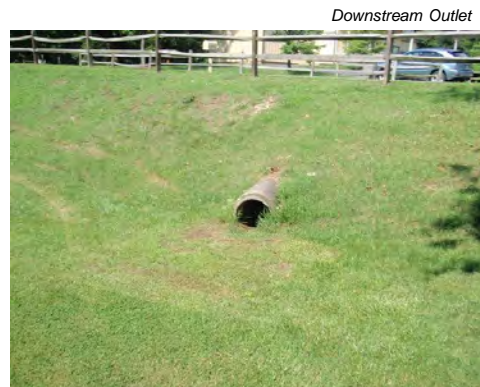
Site 1

- Shallow drop inlet near the museum and the parking lot. No major problems noted during the field trip.

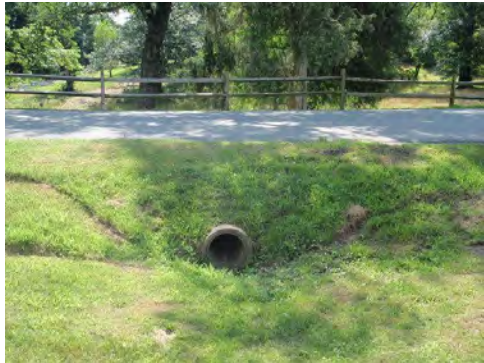
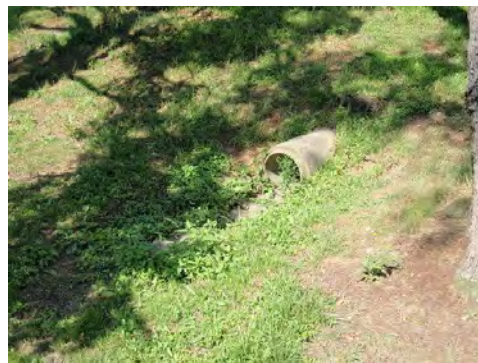
Site 2

- 15" culvert crossing under the entrance road near bathrooms. A small ponding area was observed at the culvert inlet.

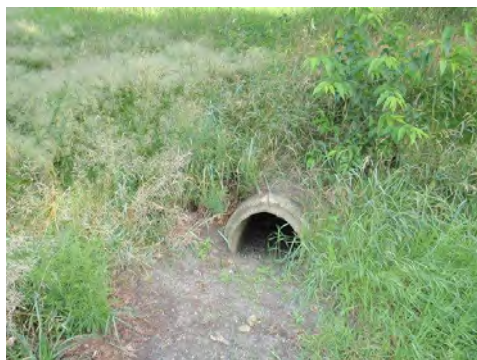
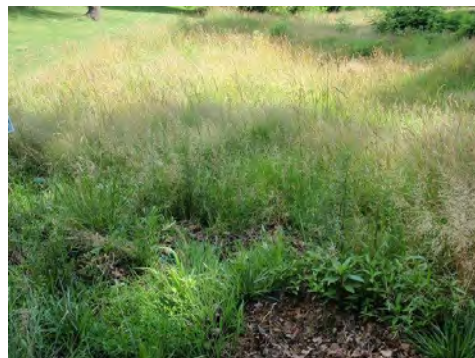
- Outlet of 18" pipe that collects runoff from upstream forested area and Braddock Road. Sediment and debris deposition was noted at the outfall.

The proposed retrofit to the Site 3 outfall is to install an underground stormwater filter beneath the parking lot southeast of the museum (Figure 6). Excavation of a portion of the parking lot is necessary and excess soil needs to be hauled offsite. The existing 18-inch reinforced concrete pipe would be cut in place and reconfigured and connected to the underground stormwater filter unit.

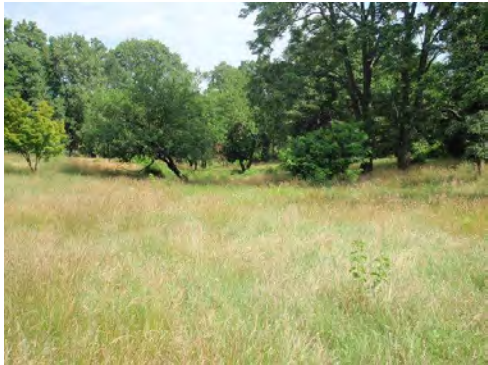
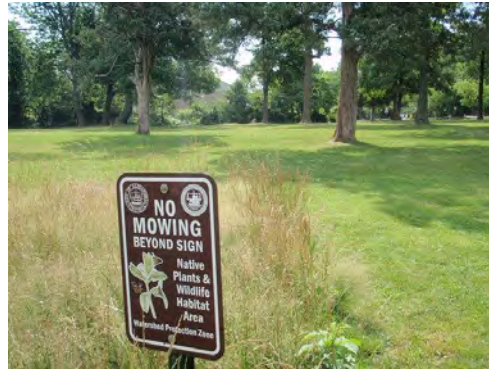
Site 4

- Swale in the natural area with "No Mowing" sign nearby. No major problems noted during the field trip.

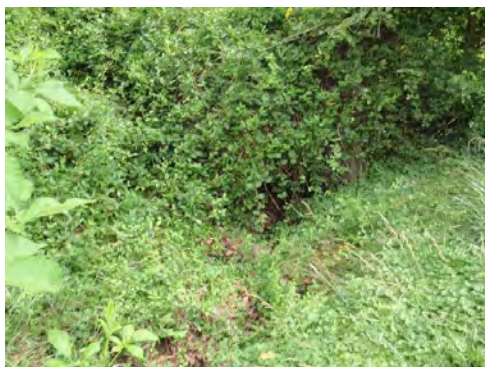
Upstream Face of the Culvert

- The 36" culvert under the road that leads to the utility yard is partially blocked and vegetation was overgrown around the culvert. Observed sediment and debris build up at the 6" PVC underdrain pipe that located just upstream of the 36" culvert.

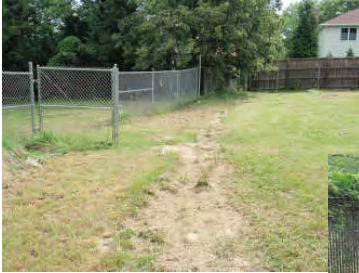
Infiltration Trenches

- Old Utility Yard. Several infiltration trenches have been installed to prevent runoff from reaching the cemetery. A temporary catch basin collects runoff from the small trench along the fence line which divides the park property from the neighborhood. The runoff from the catch basin drains to an area uphill of the road over the 36" culvert and downhill of the cemetery. Temporary hay bales have been setup up to prevent runoff from entering the cemetery.

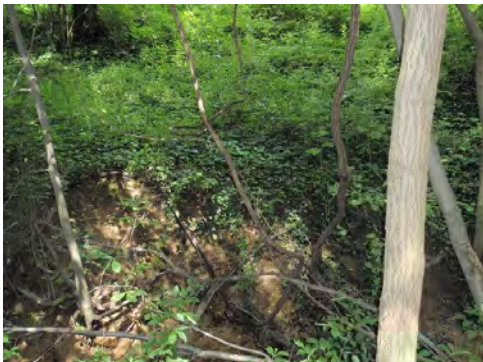
Stream Bed

- Main stream channel that runs through the park is eroded and there is concrete debris in the channel. A swale has formed from backyard drainage conveyance from residential property. In addition, there is a clogged inlet at downstream end of the natural stream channel.

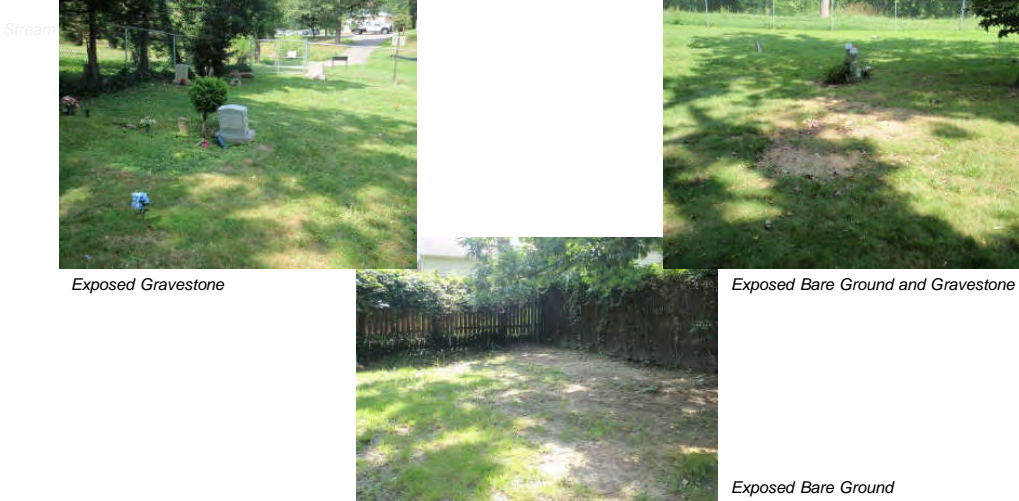
Site 8

- The base areas are exposed on several gravestones in the cemetery. Depressions have formed in front of several graves from ponding during rain events. There are several areas of exposed, bare ground in the cemetery. A channel is forming through the cemetery where runoff flows during rain

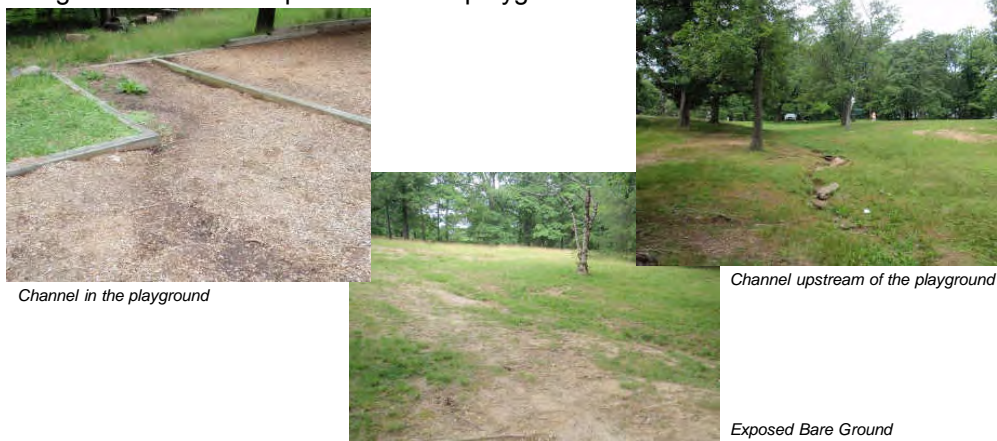
Site 9

- A channel has formed on the hill adjacent to the playground. There are two yard inlets that collect drainage from the hill before it gets to the playground. One of these inlets is completely covered by sediment and leaves. A channel has formed through the playground. There is a rock outfall and filter fabric at the outfall of the channel through the playground. There are areas of bare ground on the hill upstream of the playground.

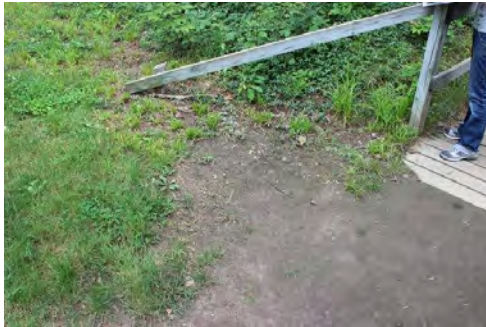
- There is a clogged yard inlet near the footbridge over the swale surrounding the Fort. The cross culvert inlet upstream from the rifle trench appeared to be clogged at the time of the field visit.

Clogged Inlet near Footbridge

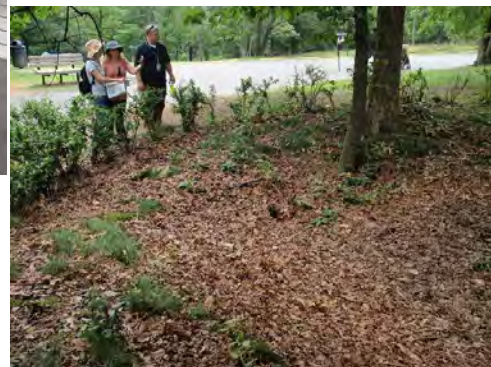
Clogged Inlet

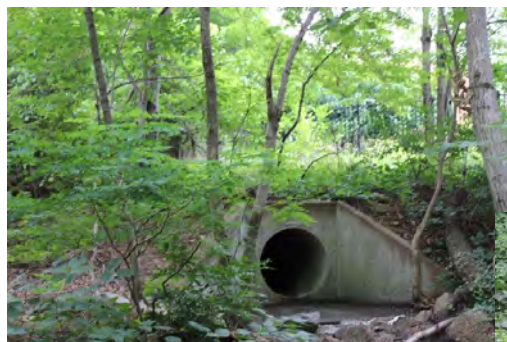
Inlet feeding into SWM pond from Marlboro Properties

- Pond at the NE corner of Park boundary. Potential water quality issues.

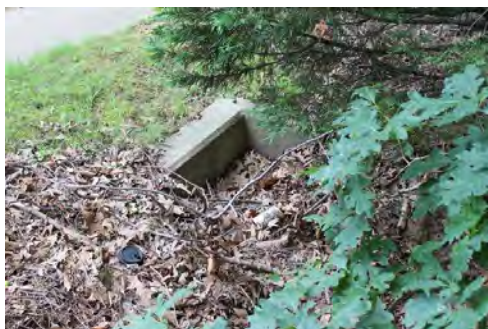
- Park outfalls along Van Dorn Street. Inlets collecting drainage from parks are clogged with debris. Channels have formed downstream of cross culverts discharging runoff

Clogged Inlet Outfall at the Park Property Line

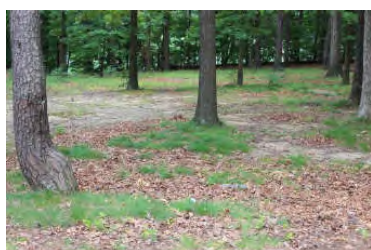
- There are bare spots on hill near the soccer field. An inlet at the base of the hill is clogged and a channel has formed upstream of the inlet.

Bare Ground

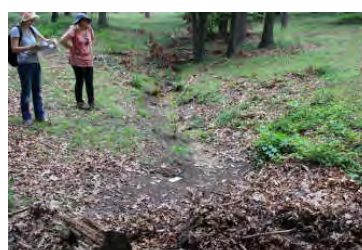
Channel Upstream

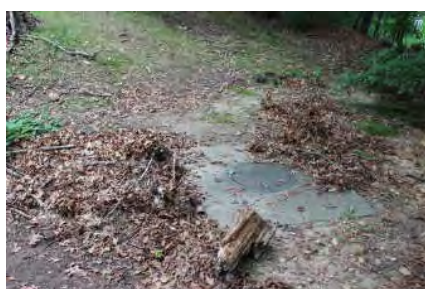
Clogged Inlet

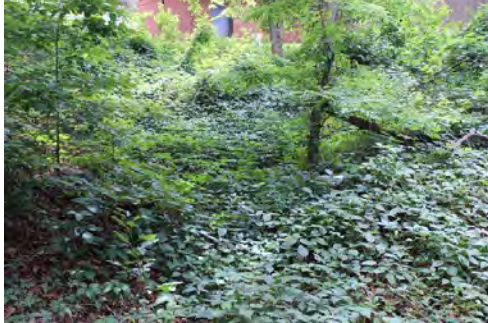
Upstream

- No problems were observed near the manhole and inlets near soccer field and amphitheater.

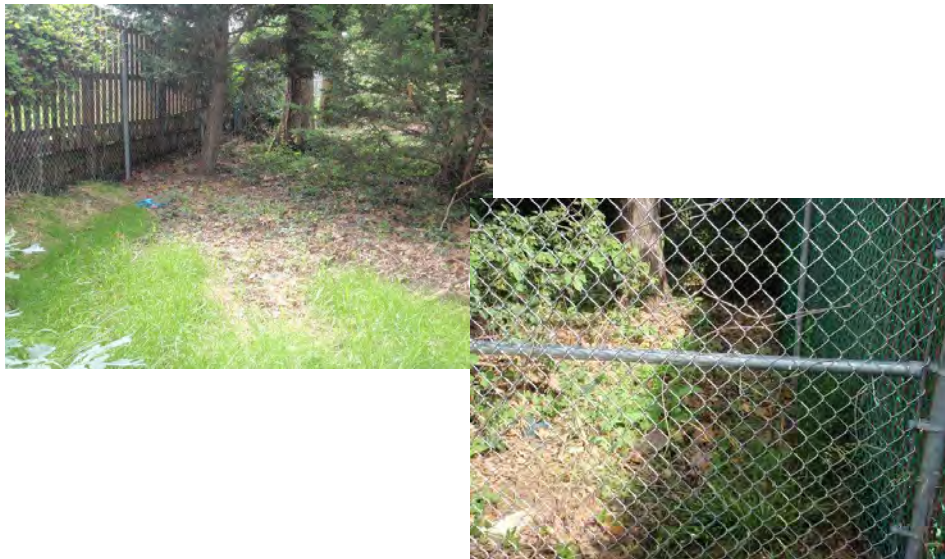
Site 16

- Runoff from the properties in Marlboro Estates is draining onto Park property and contributing to drainage issues

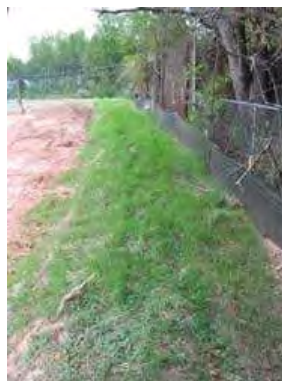
Site 6: Diversion Berms

- Existing Conditions: Temporary solutions to address existing drainage issues in the area: infiltration trenches, a temporary catch basin, and temporary straw wattles. A permanent solution is needed.

- Redirect Surface Flow around Oakland Baptist Cemetery (Site 6)
 - Diversion berm to redirect flow to avoid sensitive areas
 - Reduce inundation and erosion on the sensitive areas
 - Berm design avoids need for excavation adjacent to cemetery area
 - Protect cultural resources

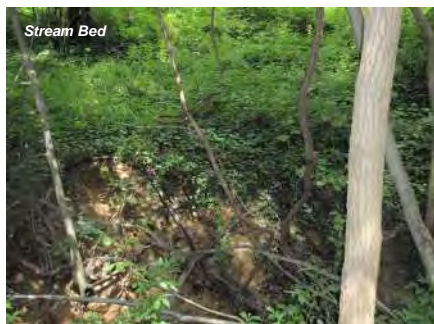
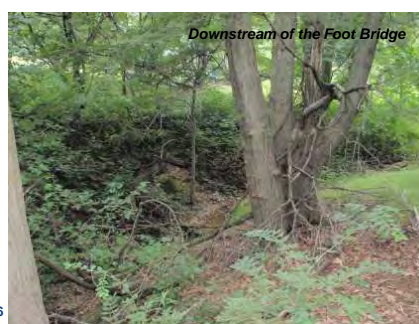
- Existing Conditions: Main stream channel that runs through the park is eroded and there is concrete debris in the channel. In addition, there is a clogged inlet at the end of the natural stream channel.

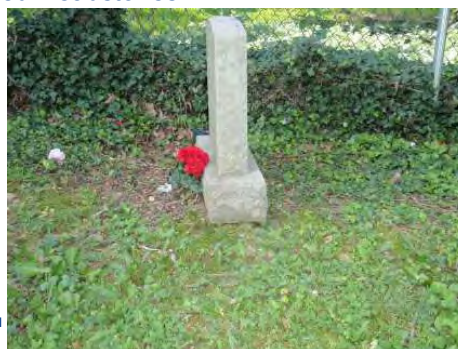
- Existing Conditions: The base areas are exposed on several gravestones in the cemetery. Depressions have formed in front of several graves from ponding during rain events. There are several areas of exposed, bare ground in the cemetery and channel is forming through the area.

- Turf Maintenance
- Water Diversion
- Conservation of Grave Depressions
- Conservation and Repair of Damaged Headstones

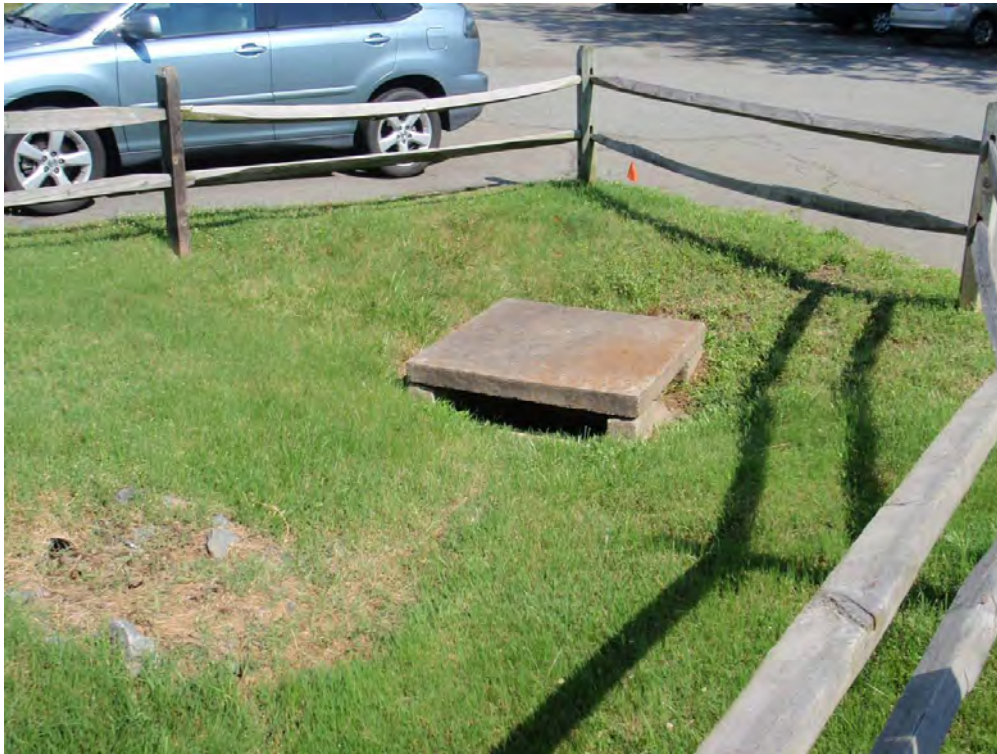
Figure B-2: Shallow drop inlet next to the parking lot (Location ID #23)

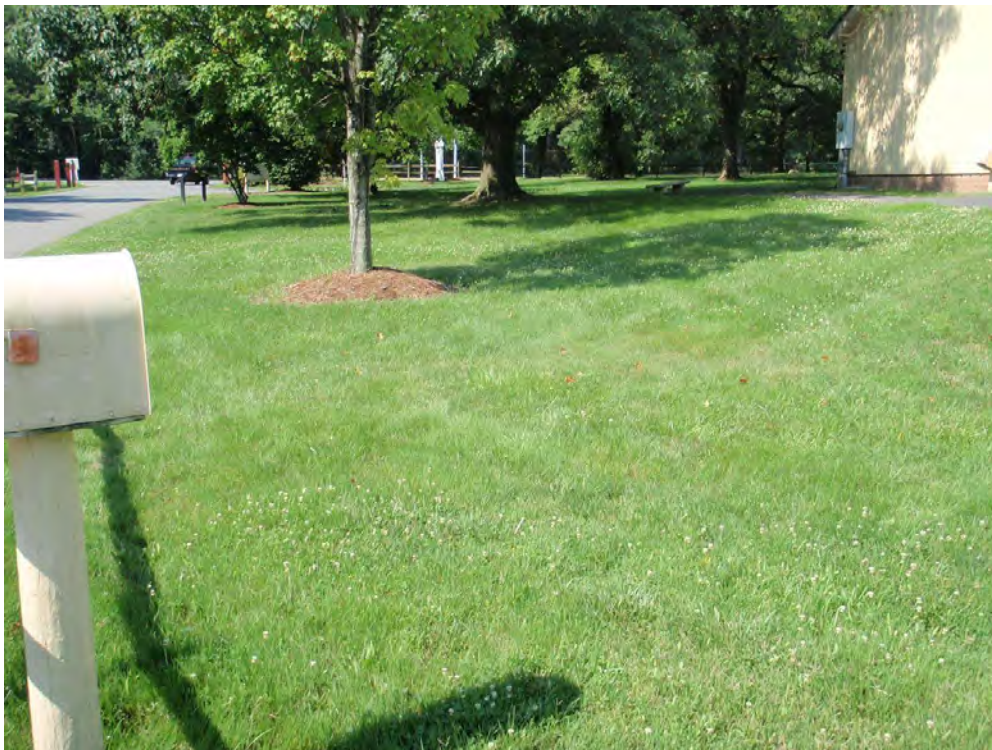
Figure B-3: Upstream of the shallow drop inlet (Location ID #24)

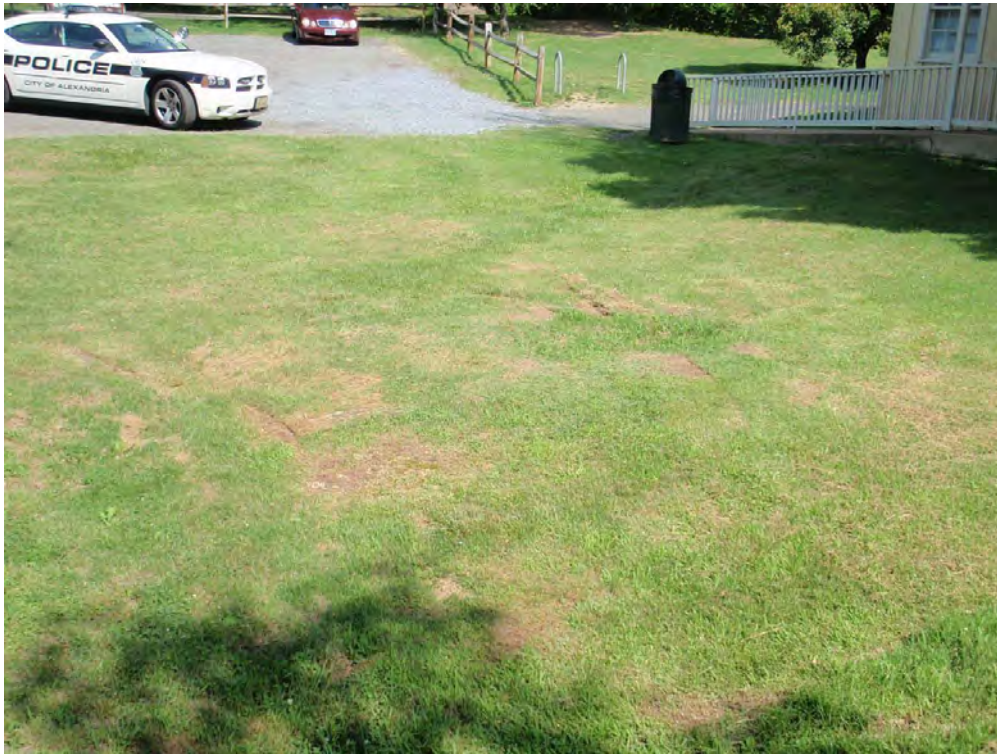
Figure B- 6: Upstream of the 15-inch concrete pipe (Location ID #26)

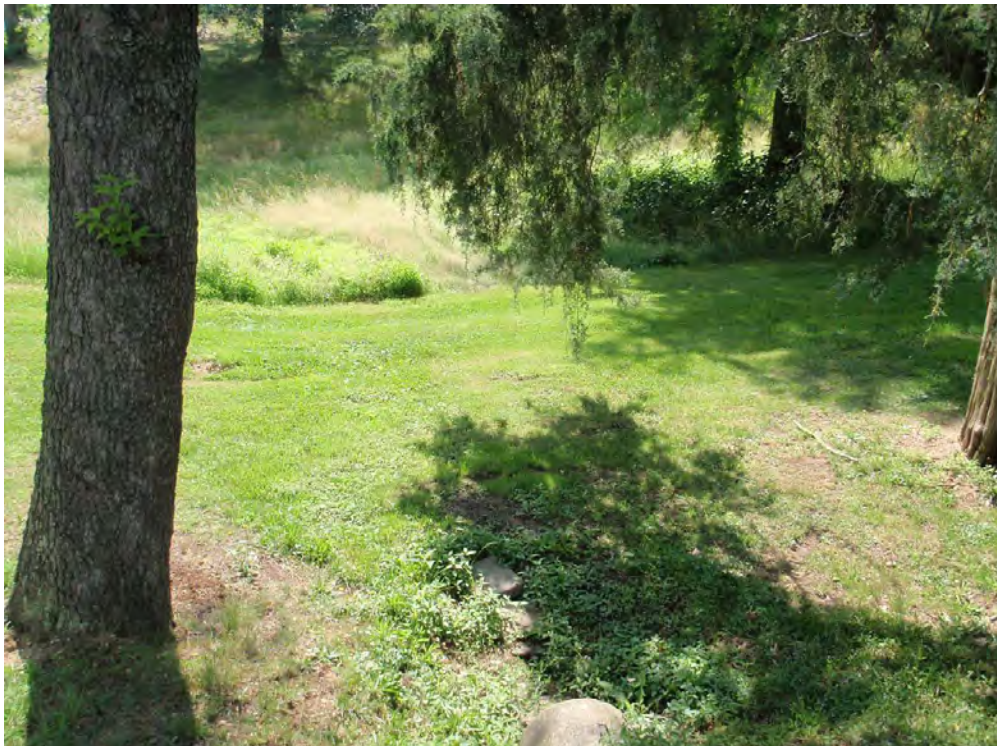
Figure B- 7: Downstream of the 15-inch concrete pipe (Location ID #27)

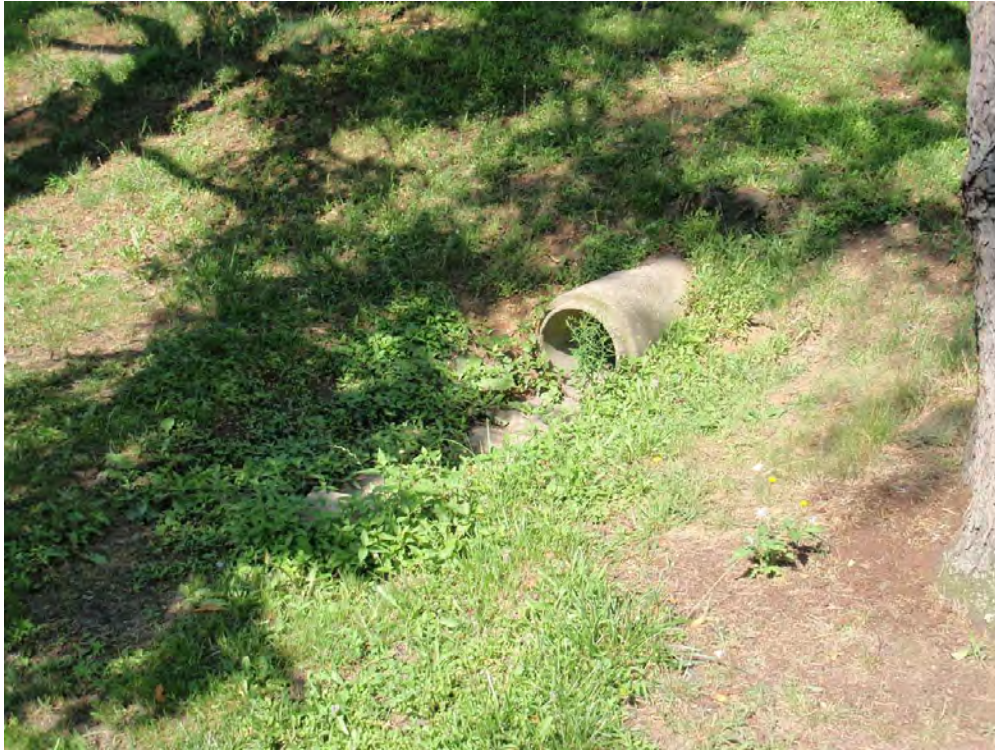
Figure B- 8: Outlet of the 15-inch concrete pipe (Location ID #28)

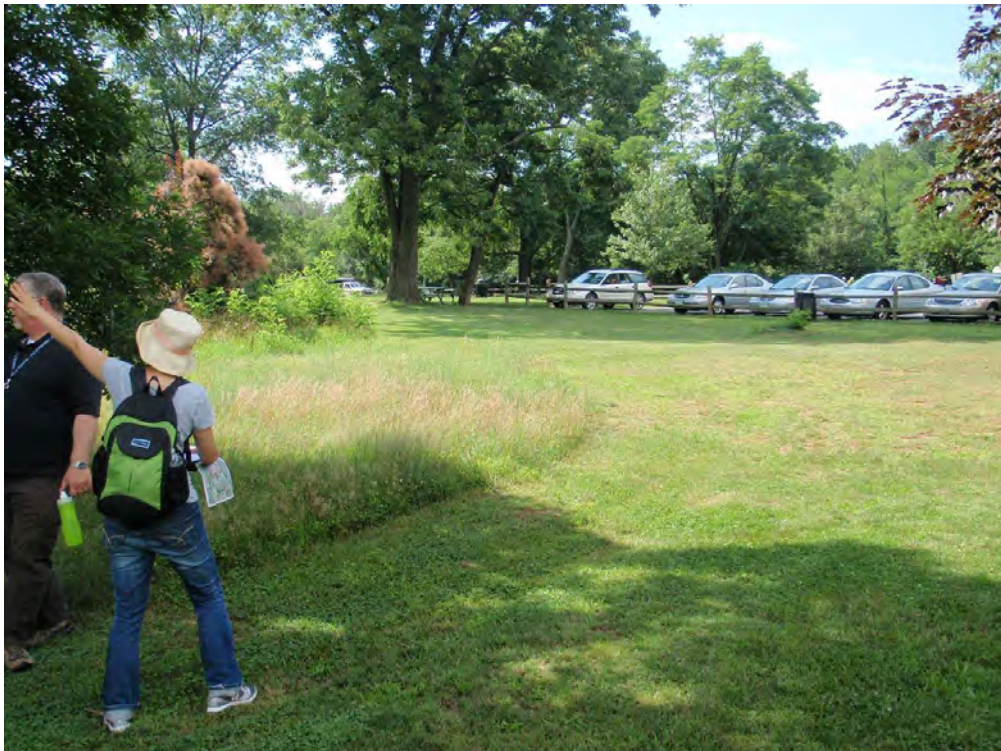
Figure B- 11: Open space upstream between the parking lot and the swale (Location ID #32)

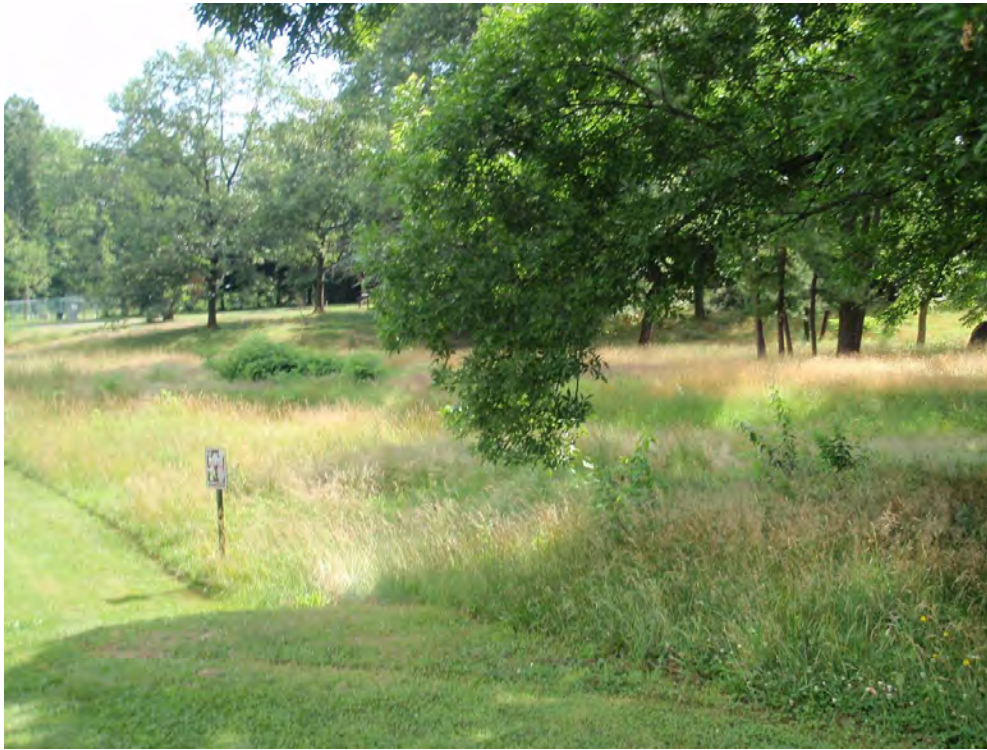
Figure B- 12: Open space upstream between the parking lot and the swale (Location ID #33)

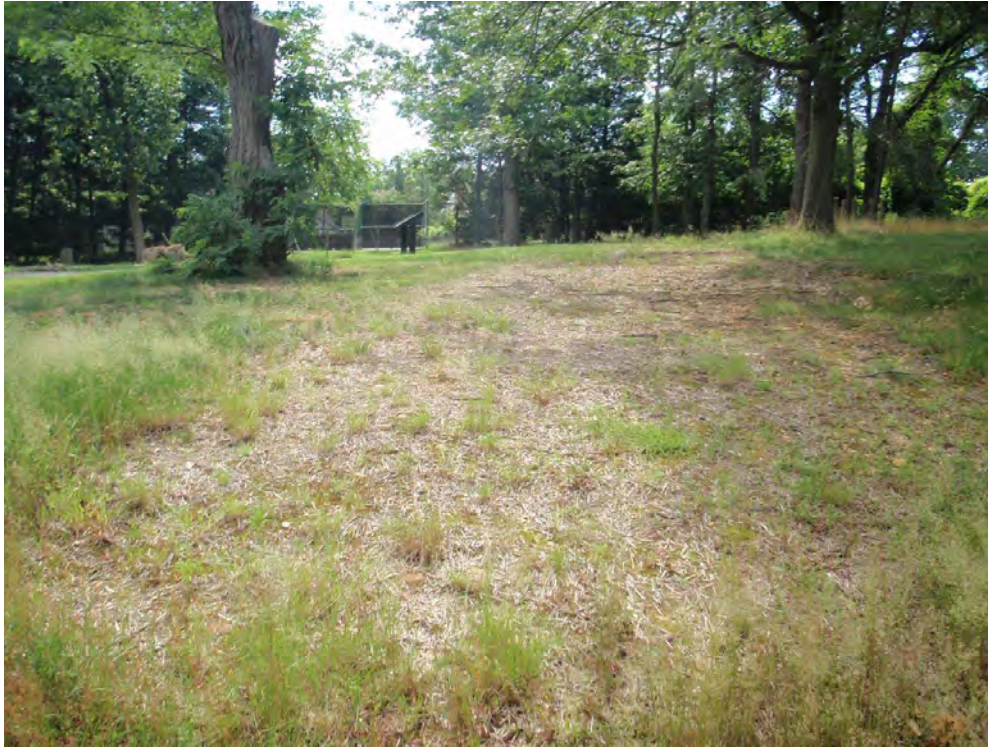
Figure B- 16: Upstream of the 6-inch PVC underdrain pipe (Location ID #39)

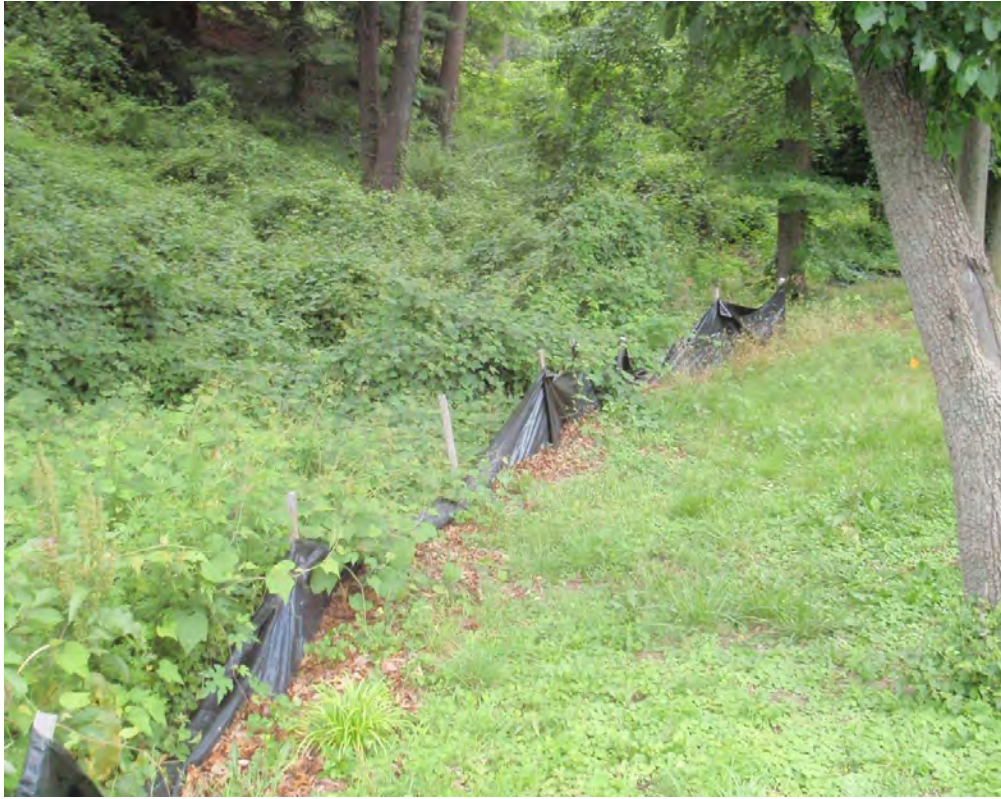
Figure B- 20: Silt fence downstream of the culvert (Location ID #43)

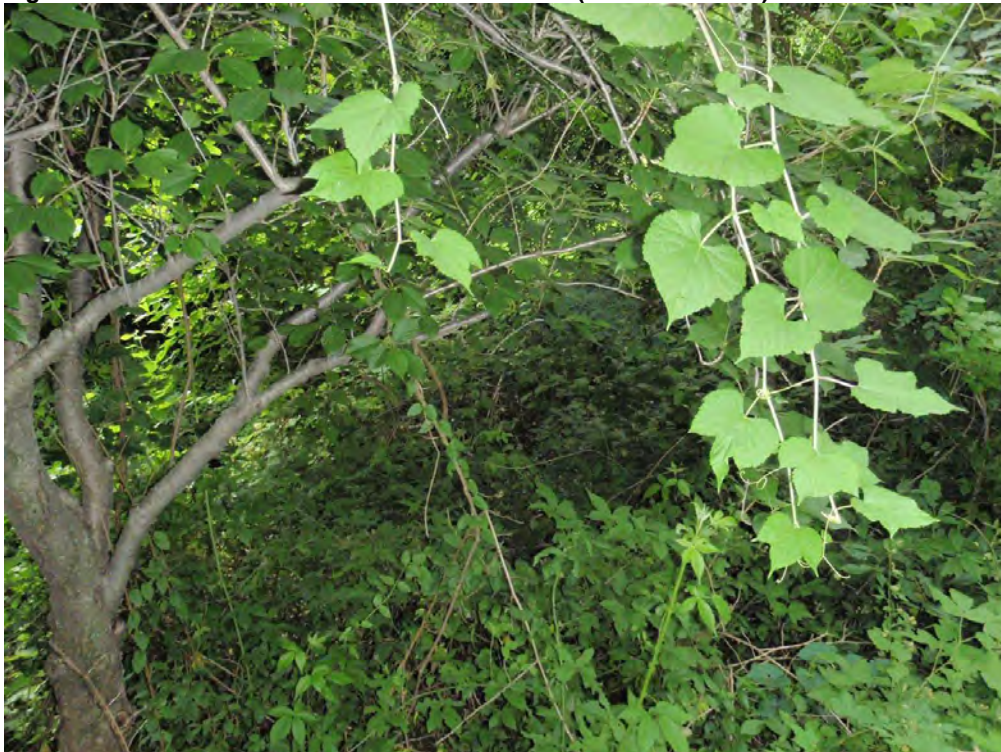
Figure B- 21: Downstream channel of the culvert (Location ID #44)

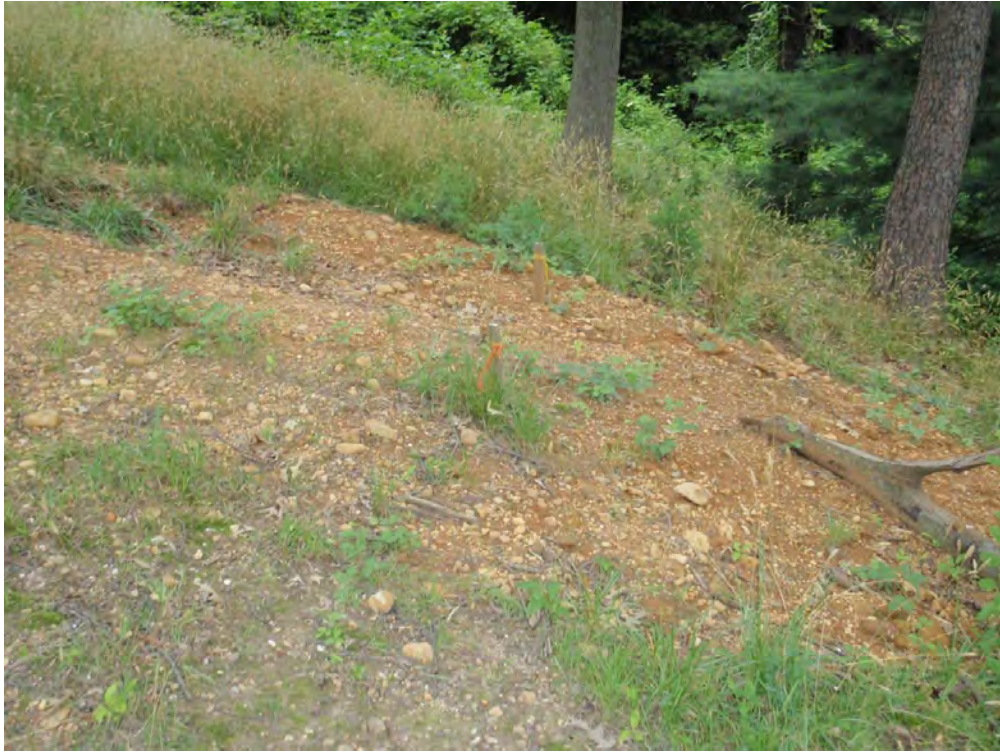
Figure B- 22: Downstream overbanks of the culvert (Location ID #45)

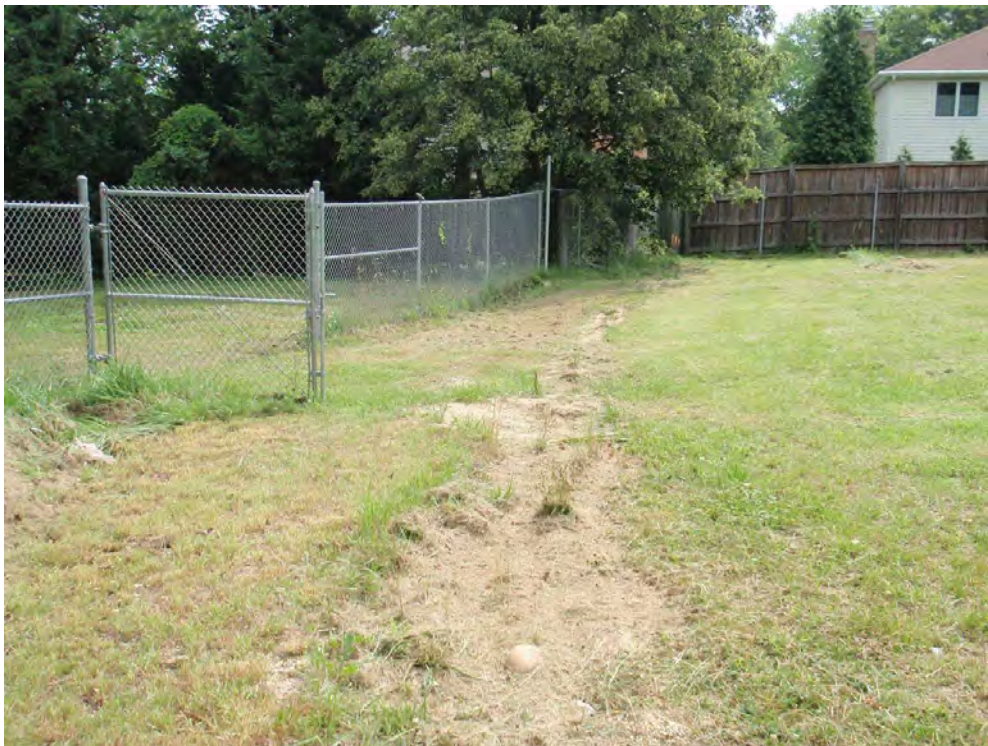
Figure B- 23: Trench drain along the chain-linked fence on the City property (Location ID #46)

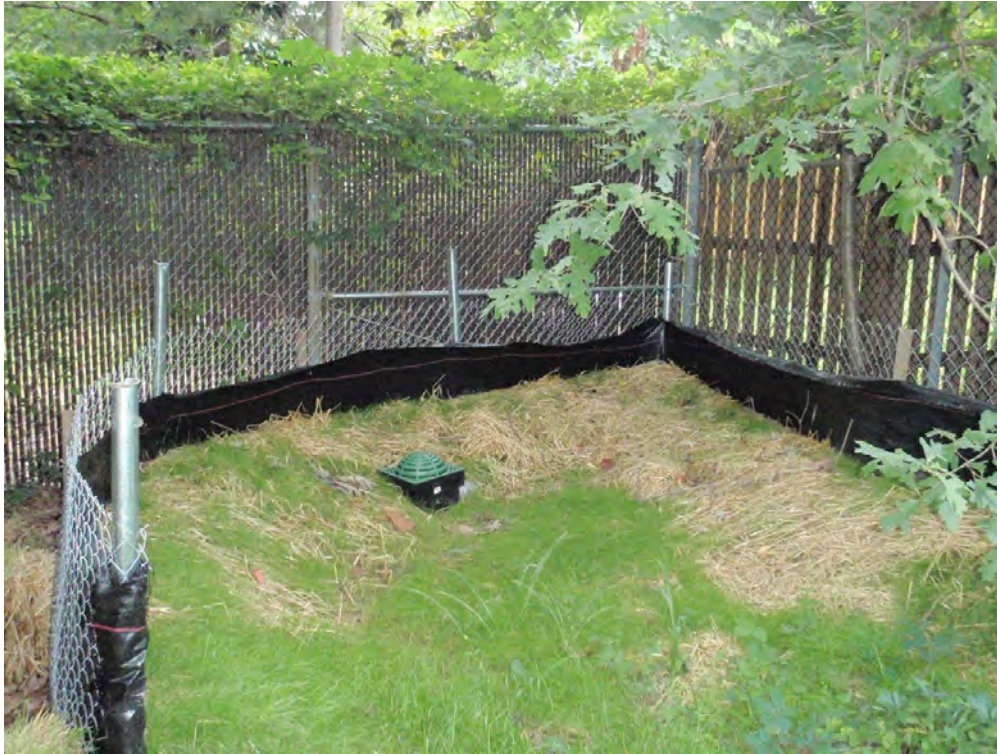
Figure B- 28: Catch basin as interim drainage solution (Location ID #51)

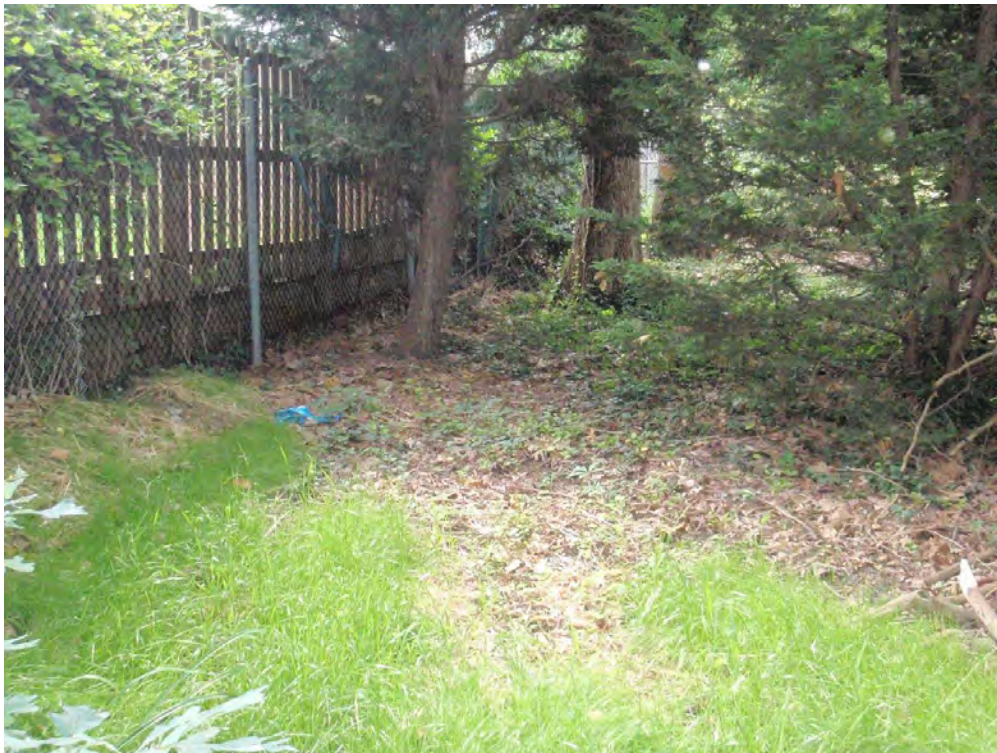
Figure B- 29: Upstream of the catch basin (Location ID #52)

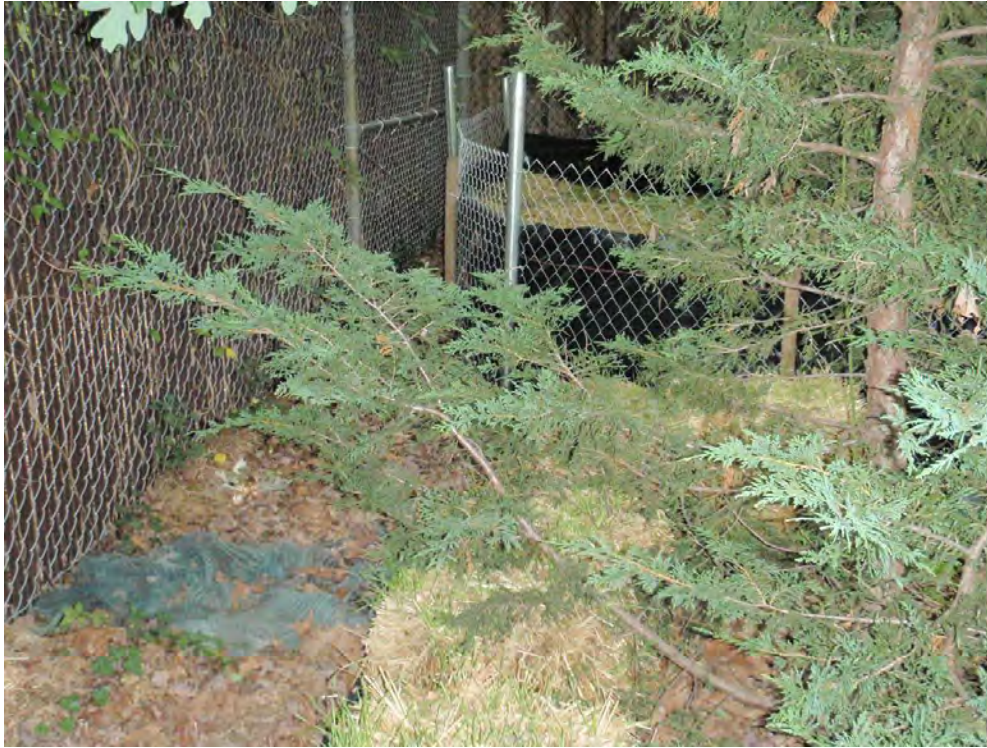
Figure B- 30: Hay barrel along the fence to the outfall pipe (Location ID #53)

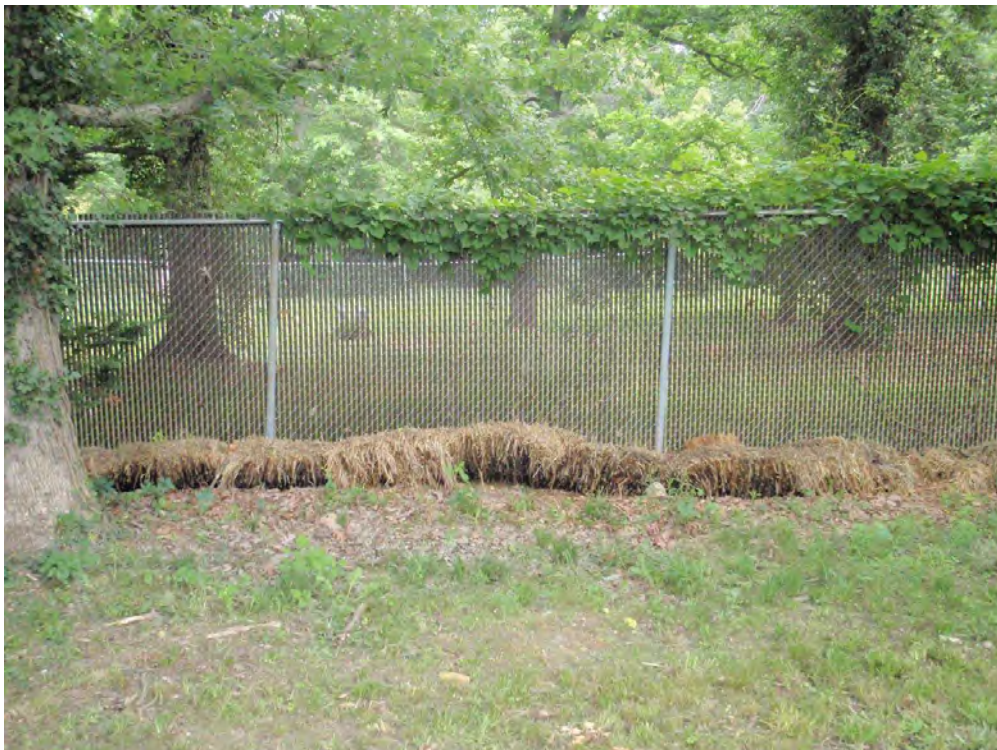
Figure B- 31: Hay barrel along the fence to the outfall pipe (Location ID #54)

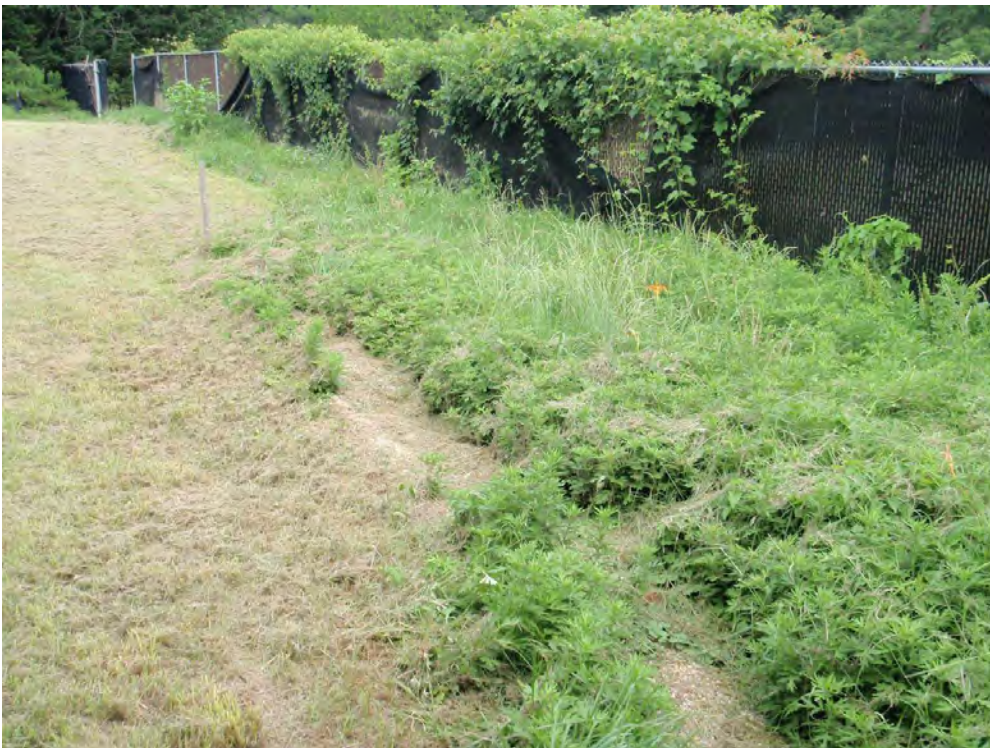
Figure B- 33: Trench drain along the fence (Location ID #56)

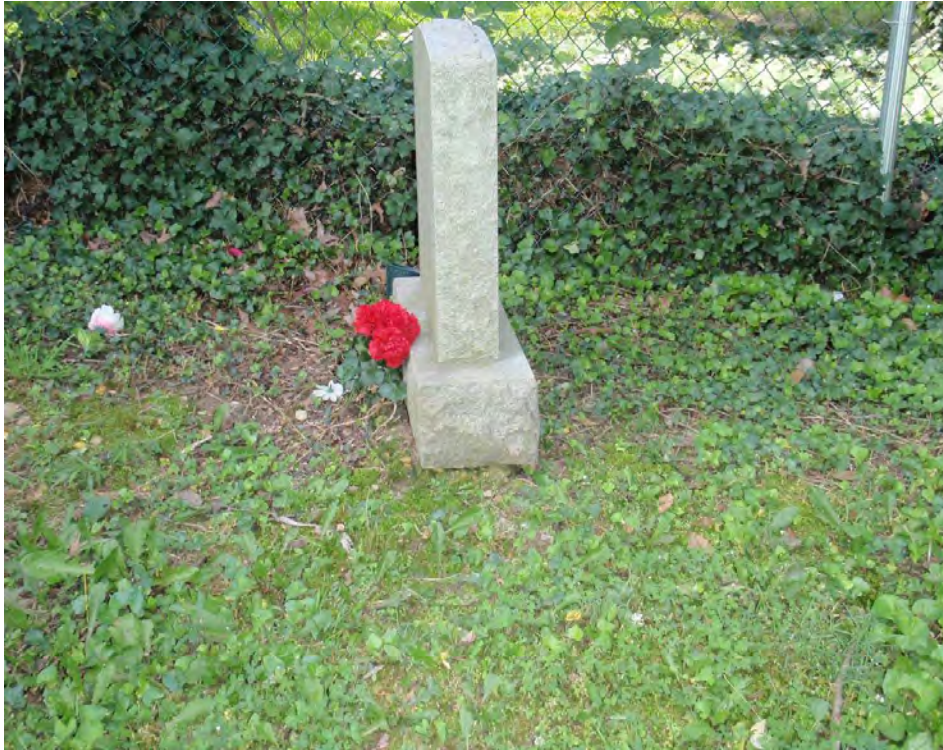
Figure B- 40: Exposed head stone in the cemetery (Location ID #63)

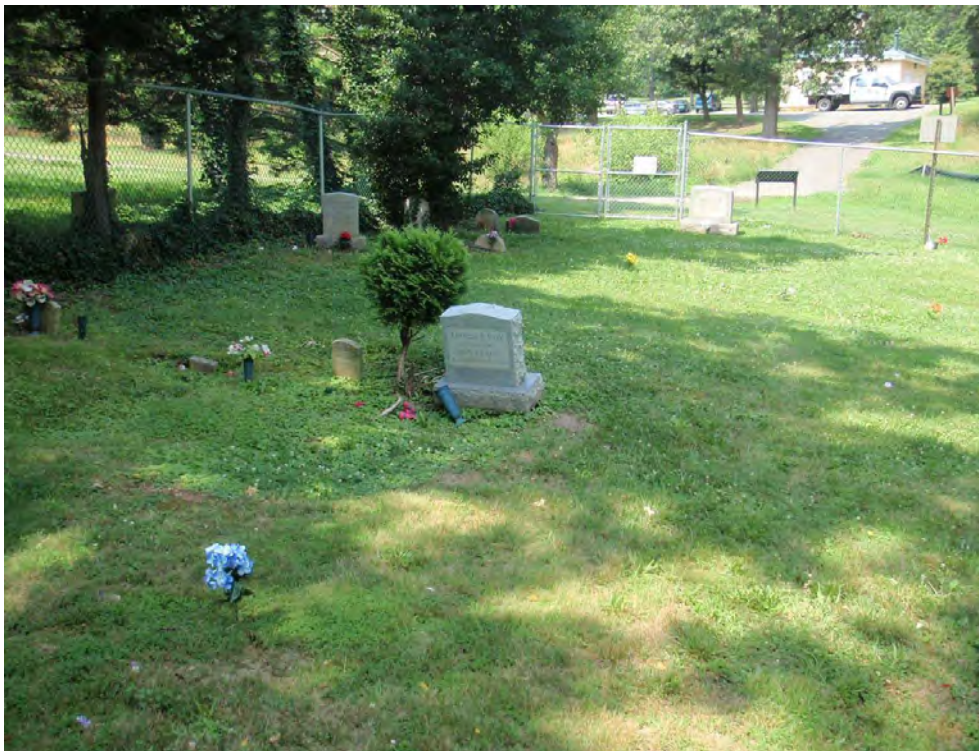
Figure B- 41: Exposed head stone in the cemetery (Location ID #64)

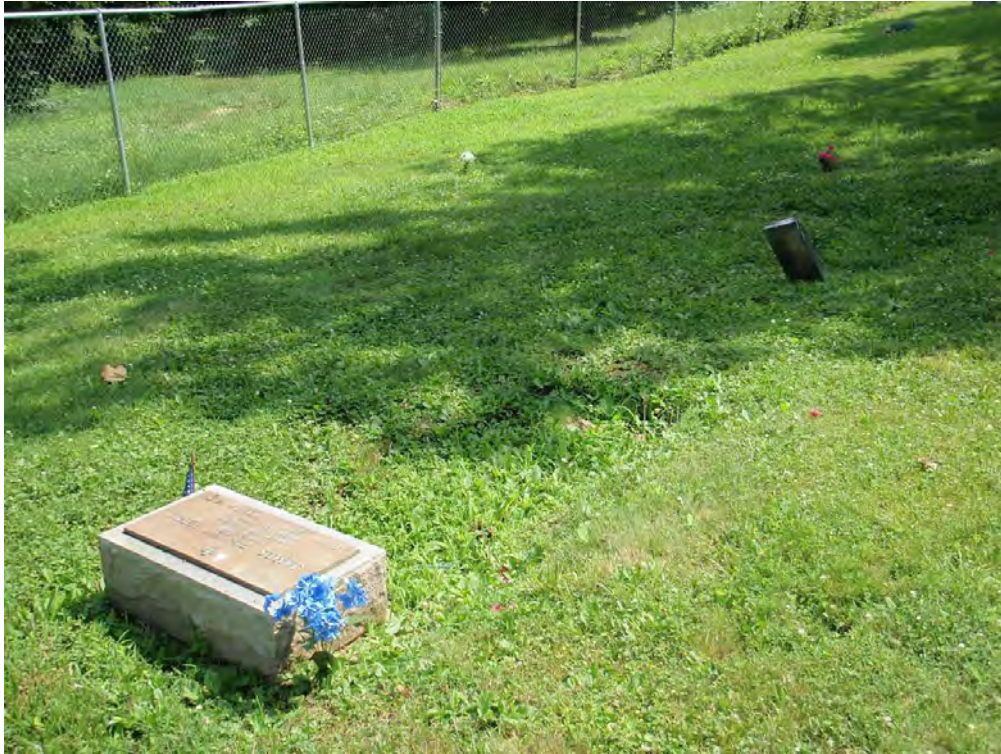
Figure B- 42: Depression in front of the grave (Location ID #65)
