Fort Ward Park and Museum Area Management Plan

Appendix I FORT WARD PARK DRAINAGE MASTER PLAN

URS Corporation, 2014

FORT WARD PARK DRAINAGE MASTER PLAN

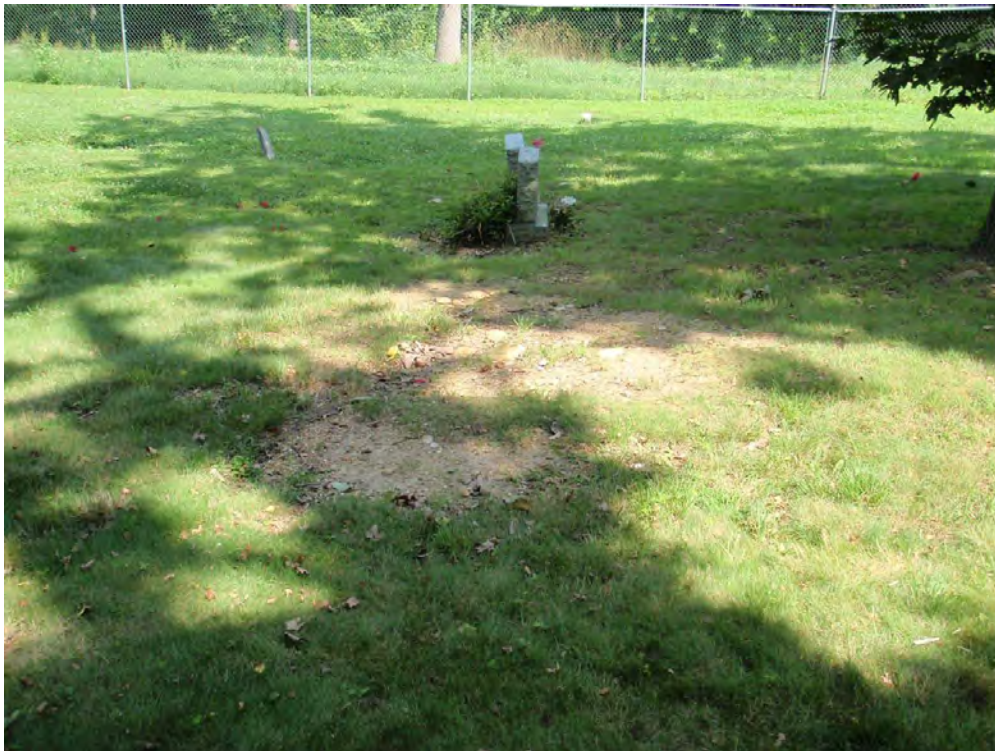
Figure B- 43: Exposed bare ground in the cemetery (Location ID #66)

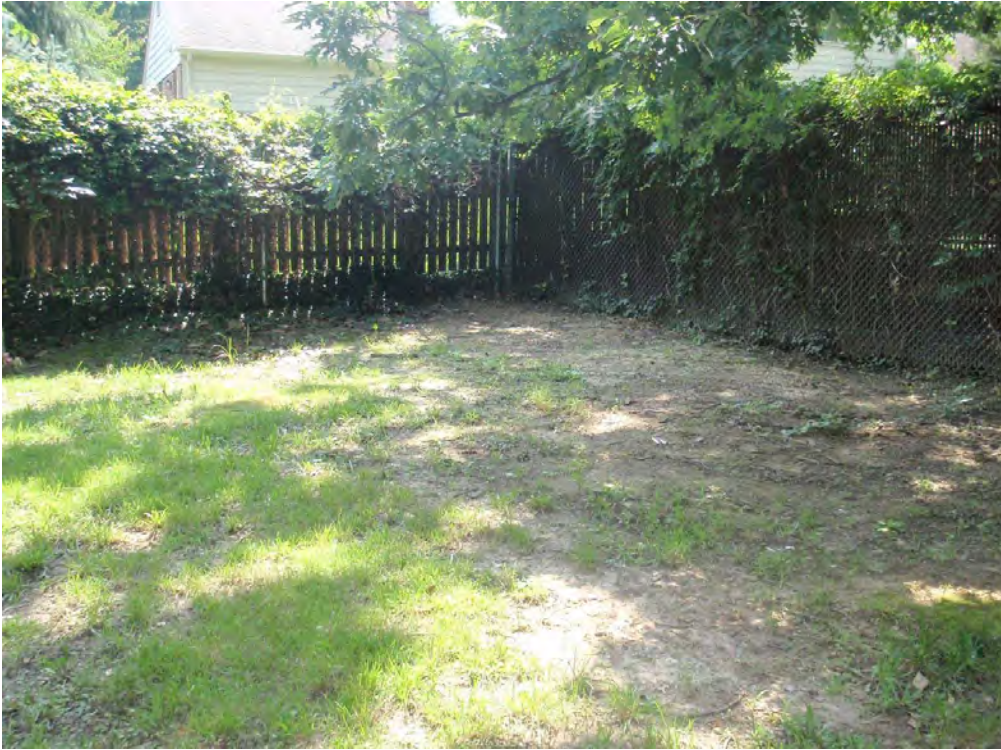
Figure B- 44: Exposed bare ground at southeast corner of the cemetery (Location ID #67)

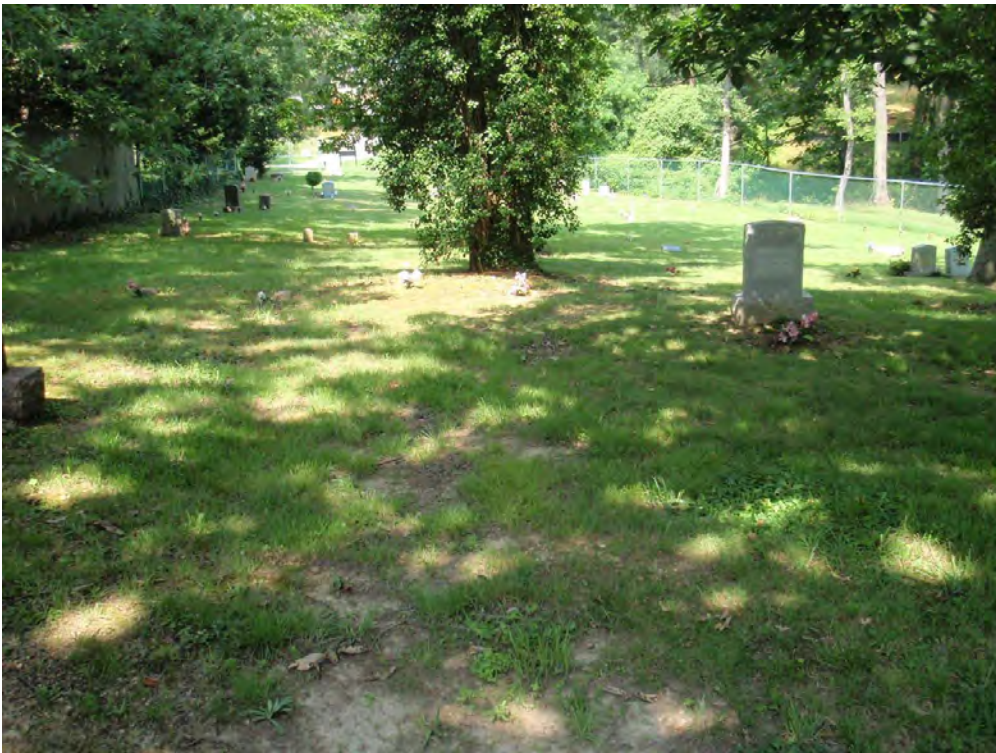
Figure B- 45: Exposed bare ground at southeast corner facing west (Location ID #68)

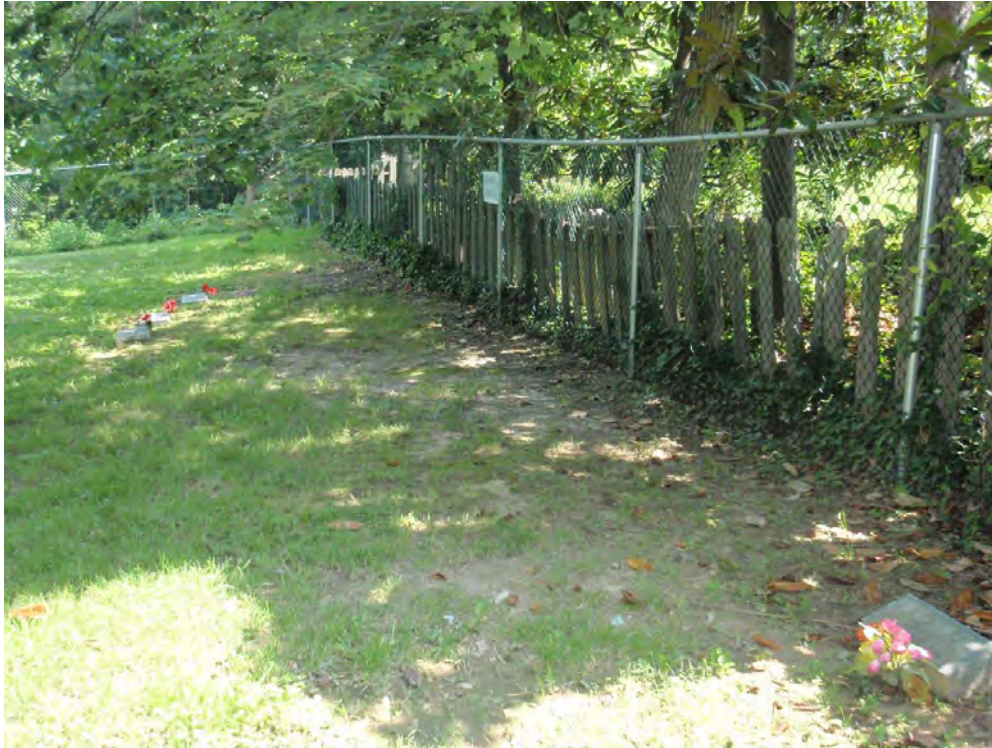
Figure B- 46: Exposed bare ground along the property fence (Location ID #69)

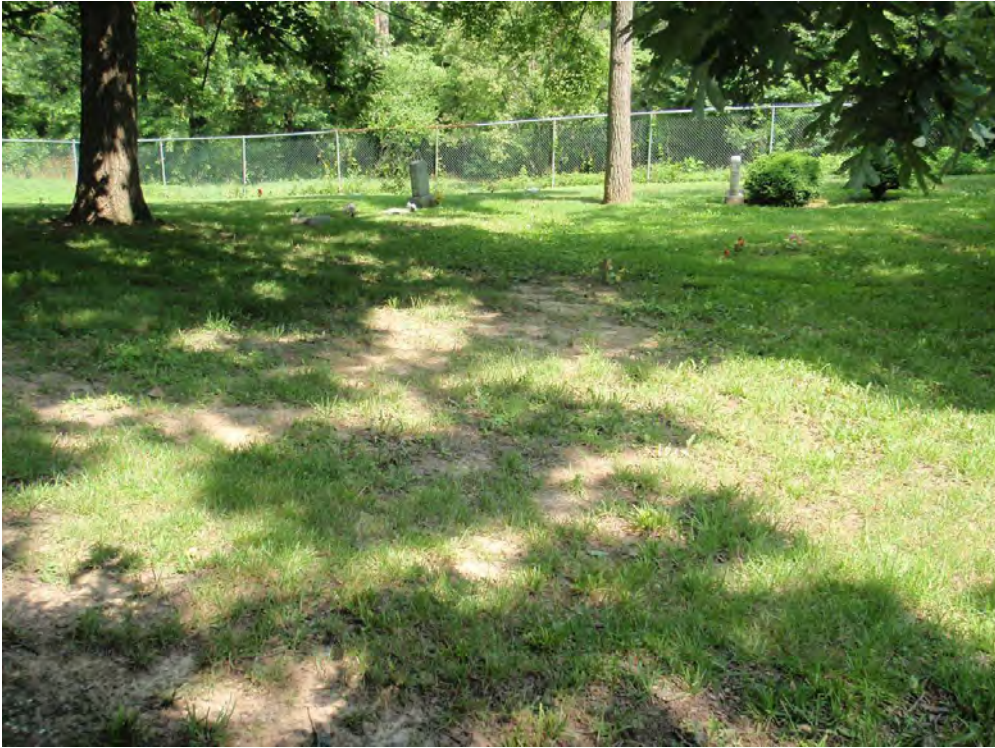
Figure B- 48: Exposed bare ground at southeast corner facing northwest (Location ID #71)

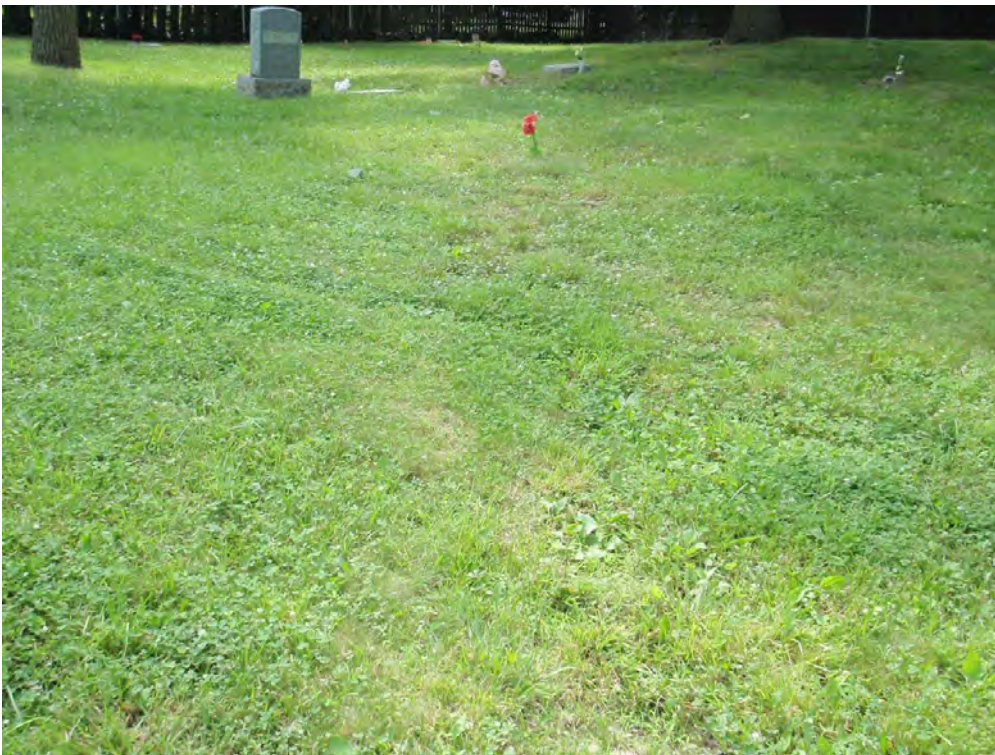
Figure B- 49: Upstream of the swale outfall in the cemetery (Location ID #72)

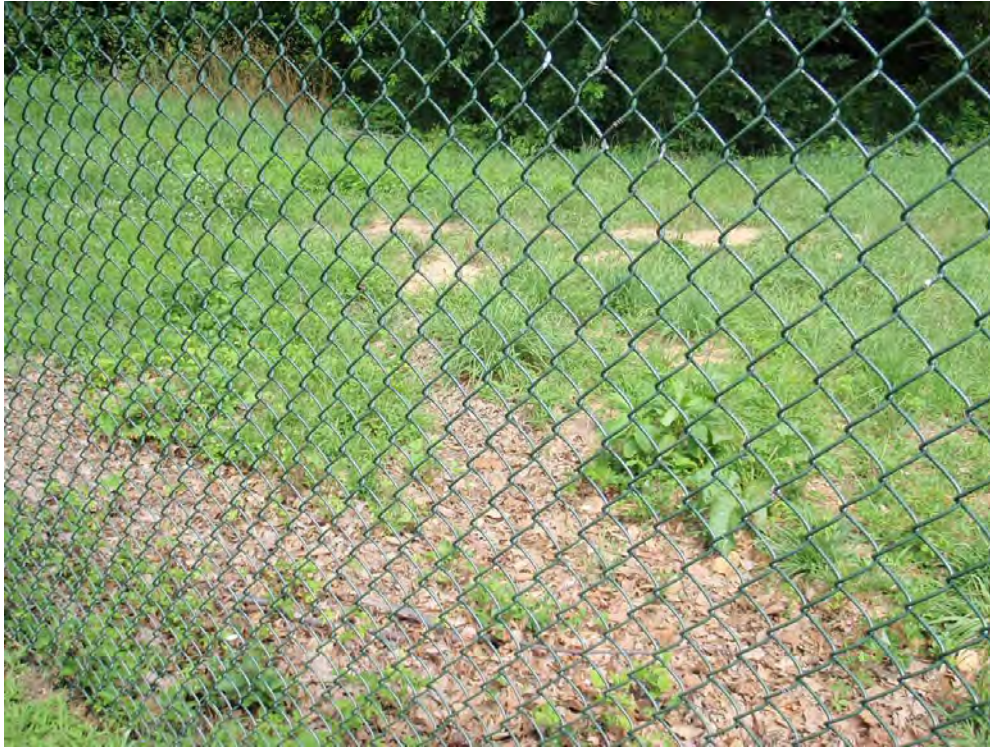
Figure B- 50: Downstream of the swale outfall in the cemetery (Location ID #73)

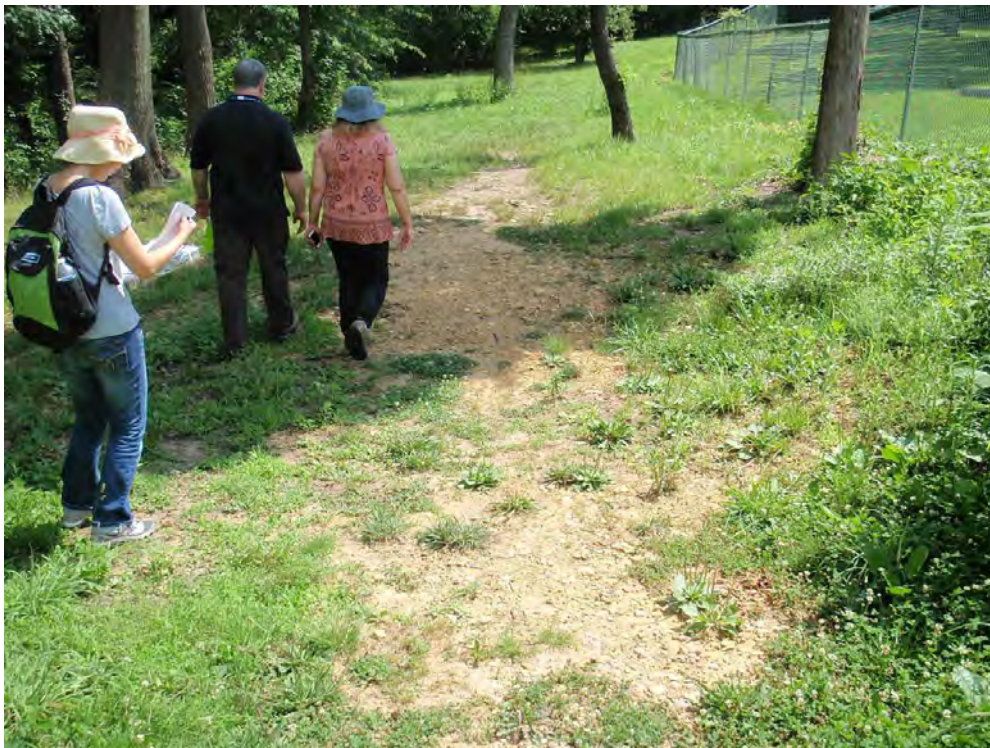
Figure B- 51: Outfall outside the cemetery (Location ID #75)

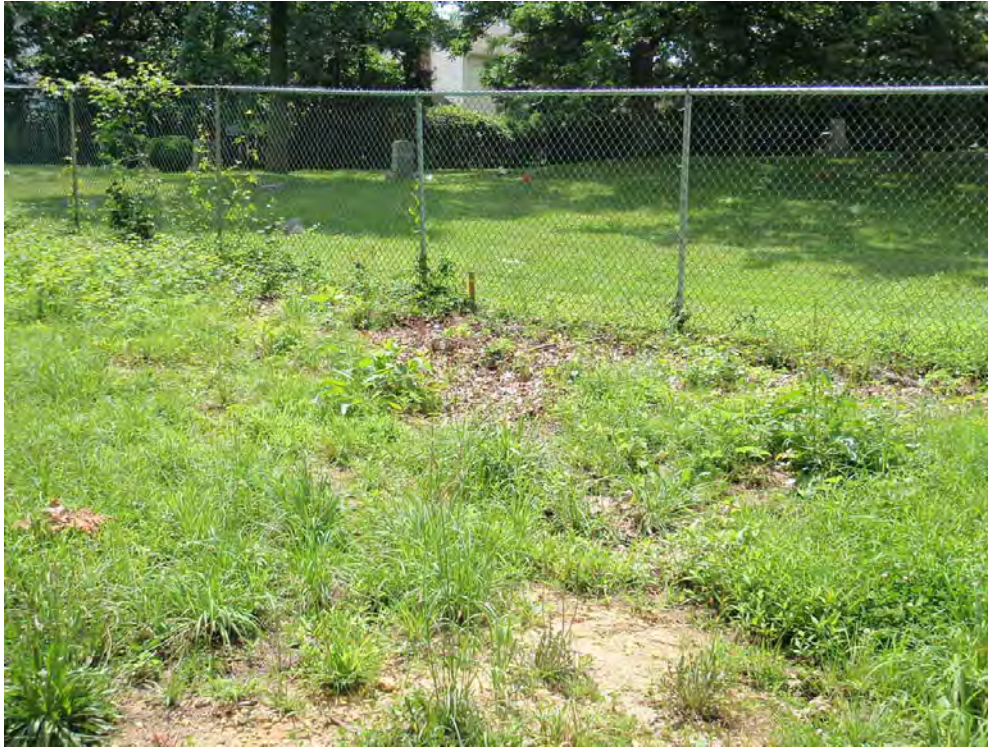
Figure B- 52: Outfall from the cemetery (Location ID #76)

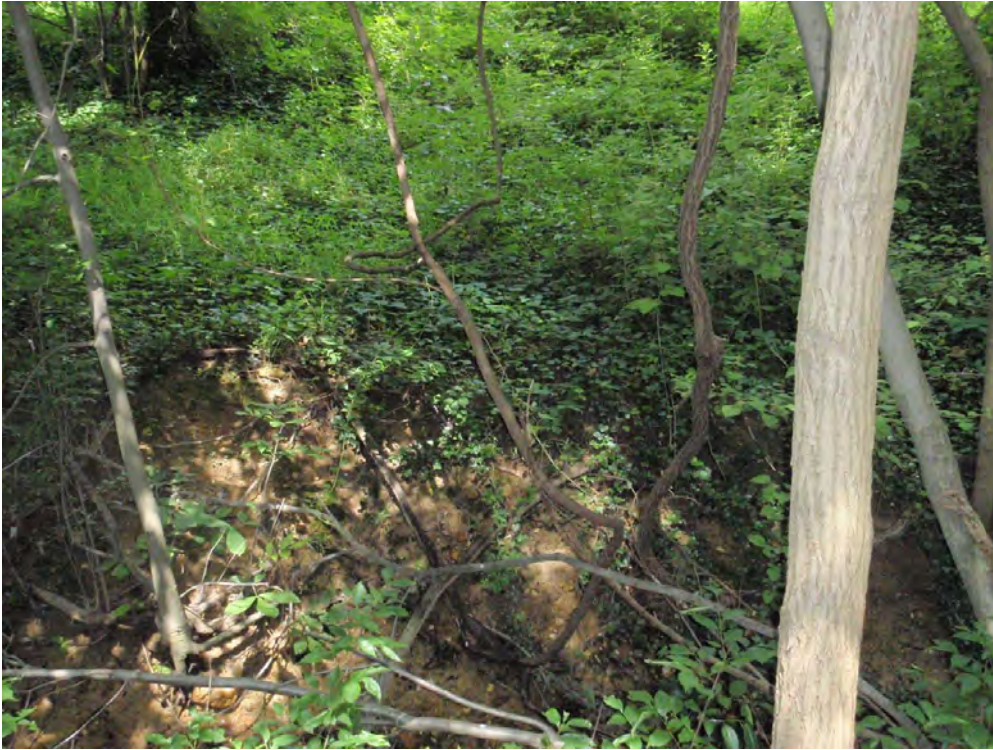
Figure B- 54: Streambed and overbanks (Location ID #78)

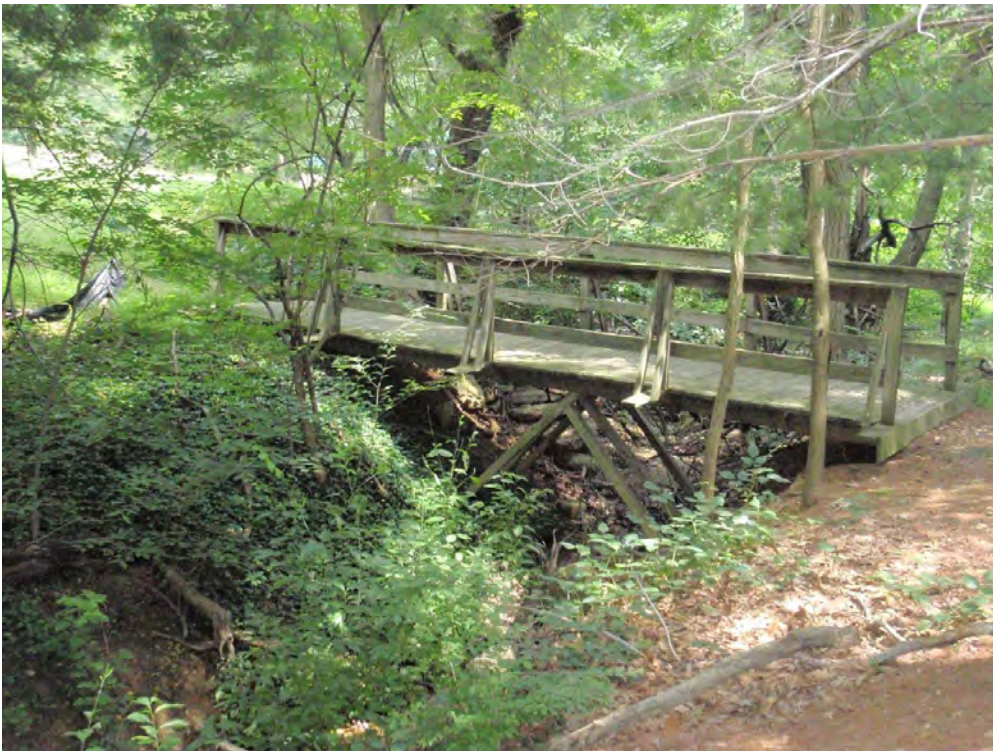
Figure B- 55: Upstream of the foot bridge (Location ID #79)

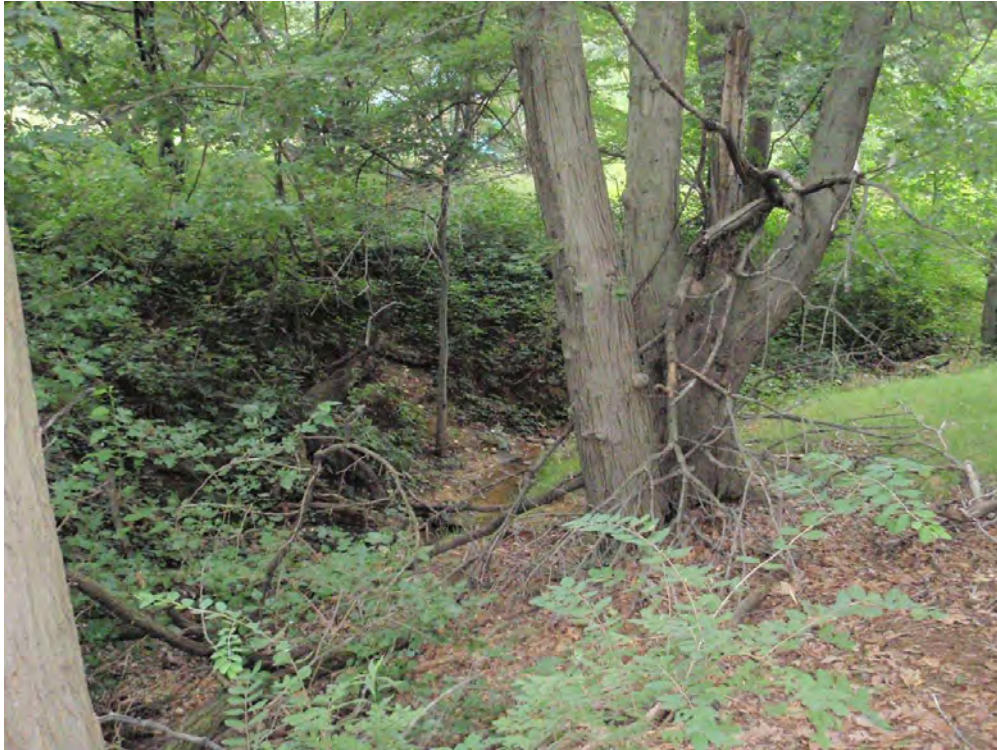
Figure B- 56: Downstream of the foot bridge (Location ID #80)

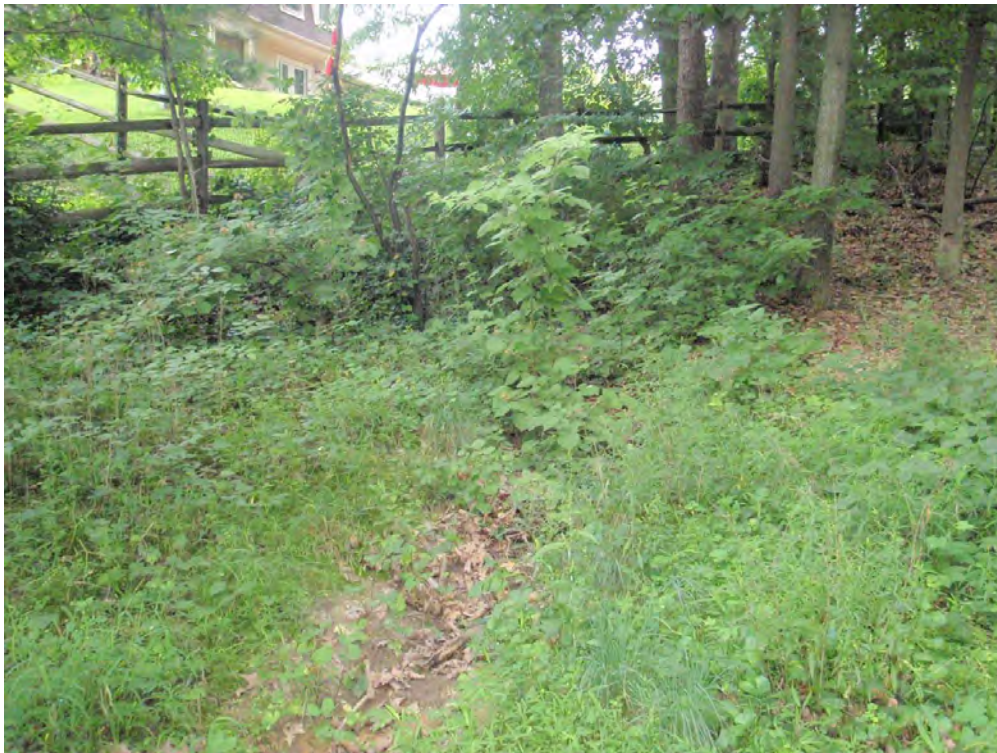
Figure B- 57: Swale from the properties (Location ID 81)

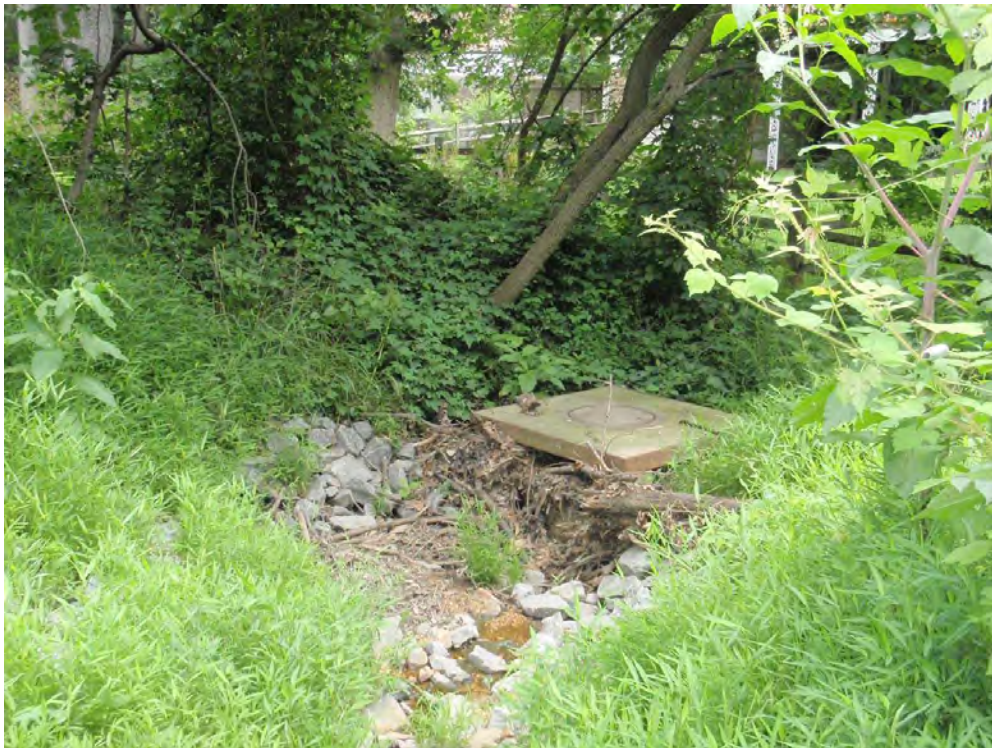
Figure B- 59: Inlet next to the stream (Location ID #83)

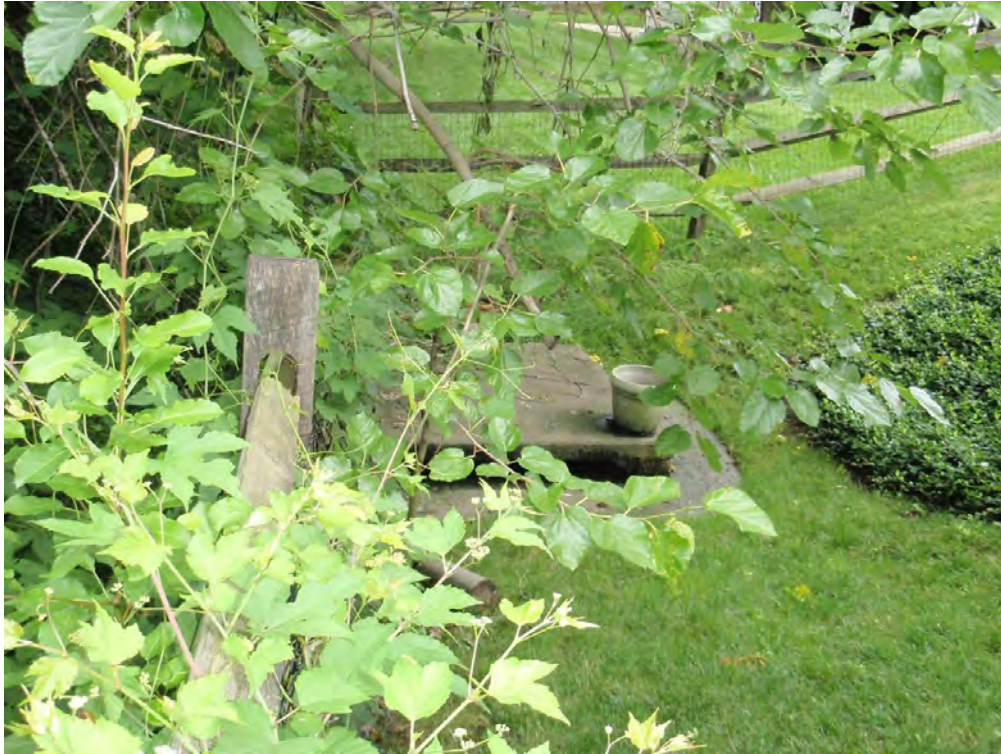
Figure B- 60: Inlet next to the property (Location ID #84)

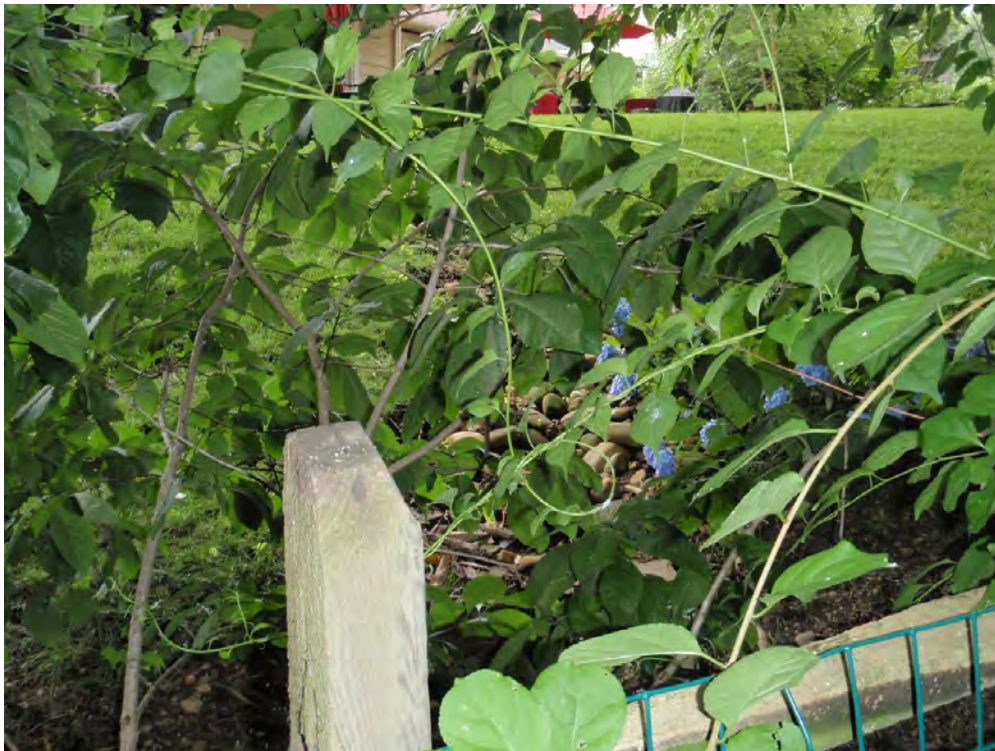
Figure B- 61: Rock channel in the Property upstream of the swale (Location ID #86)

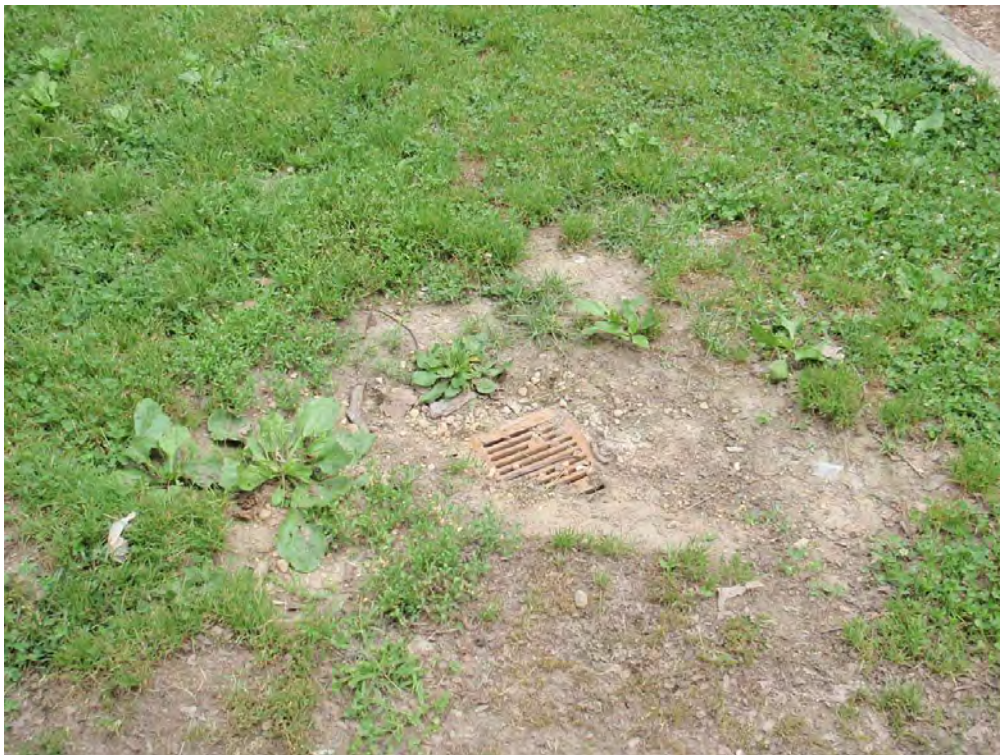
Figure B- 63: Inlet at the playground (Location ID #88)

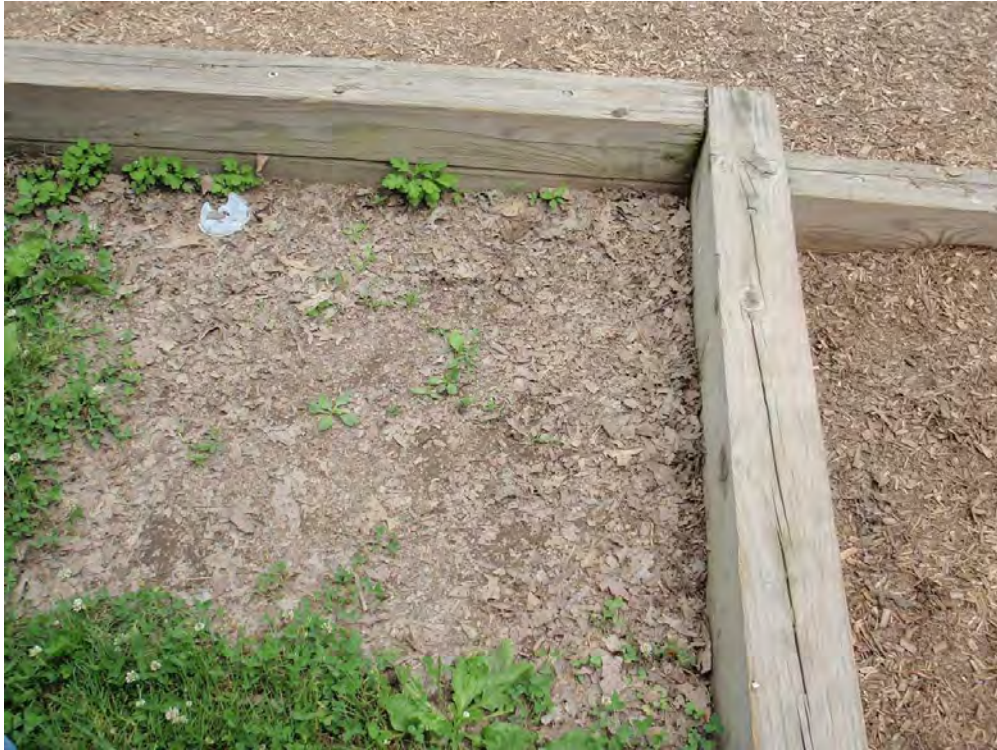
Figure B- 64: Blocked Inlet at the playground (Location ID #89)

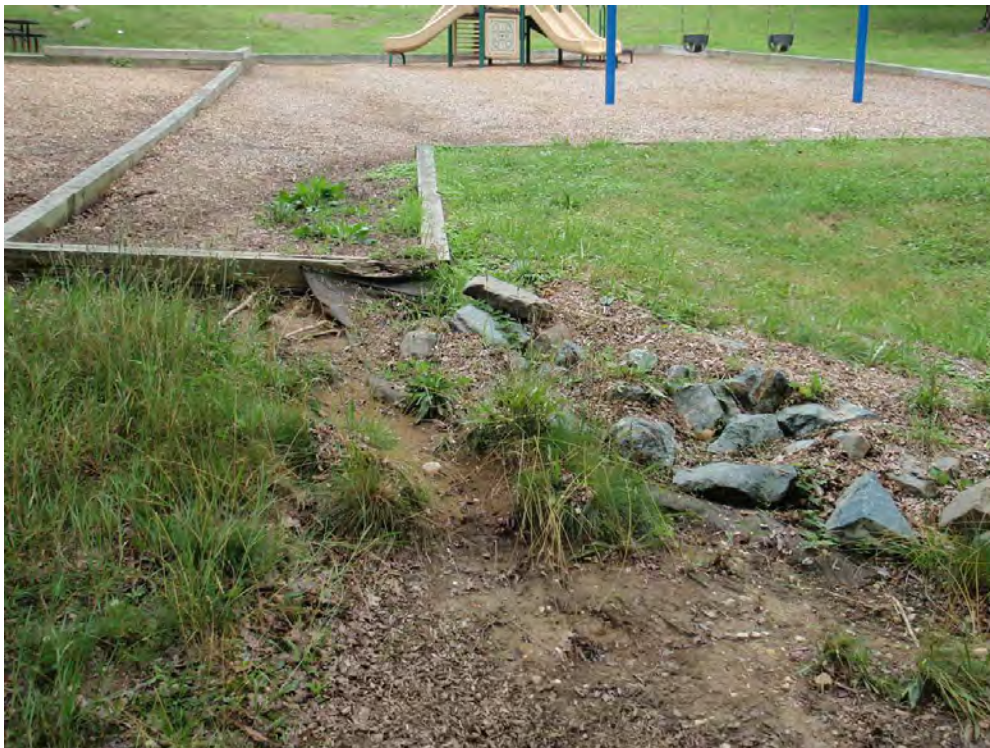
Figure B- 65: Downstream of the playground (Location ID #64)

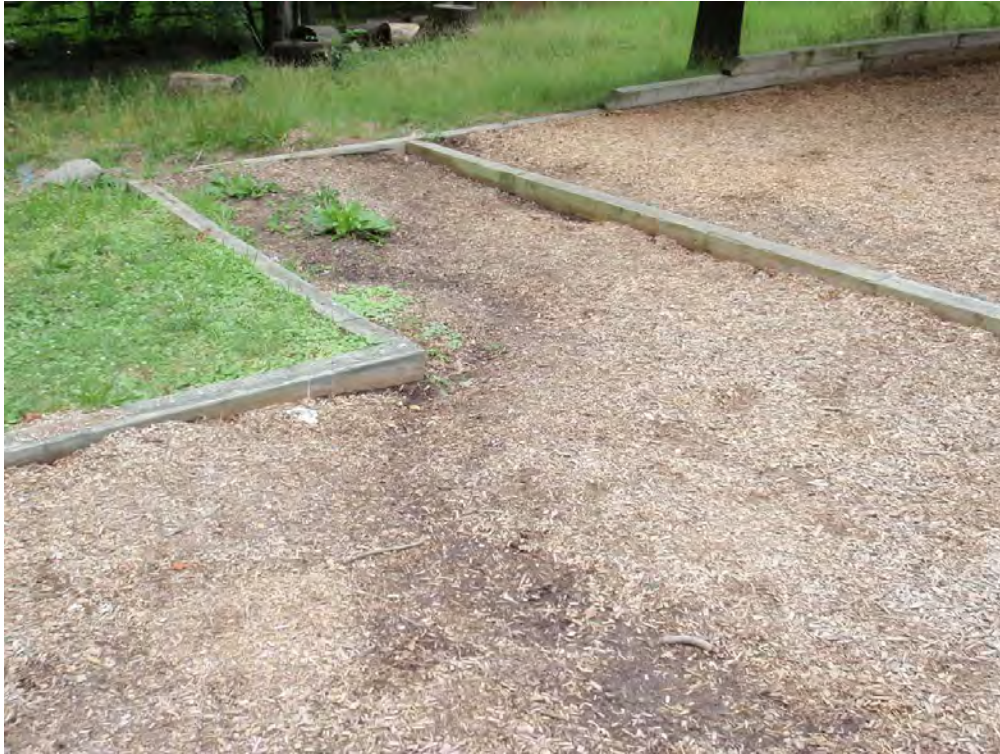
Figure B- 66: Swale in the playground (Location ID #91)

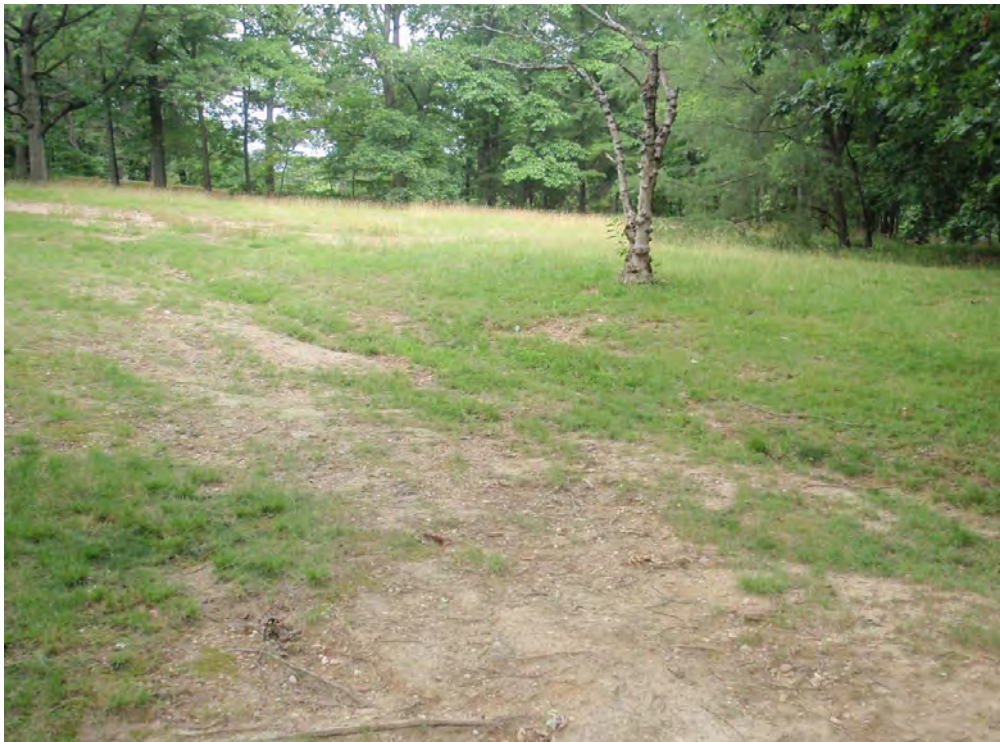
Figure B- 67: Bare ground next to the playground (Location ID #92)

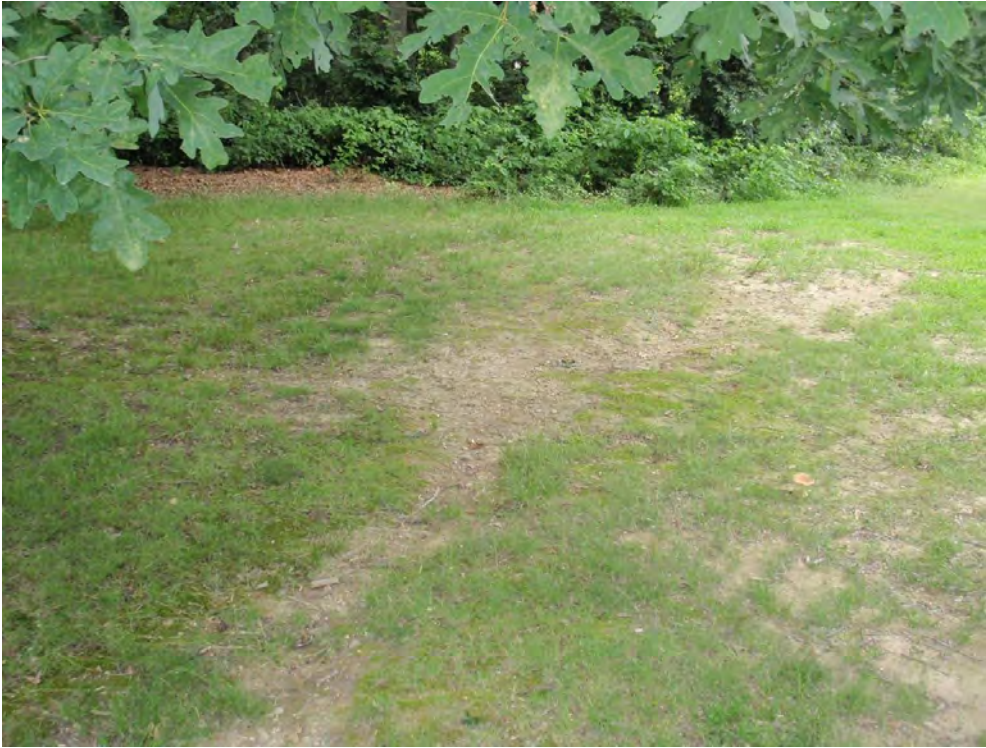
Figure B- 68: Bare ground next to the playground (Location ID #92)

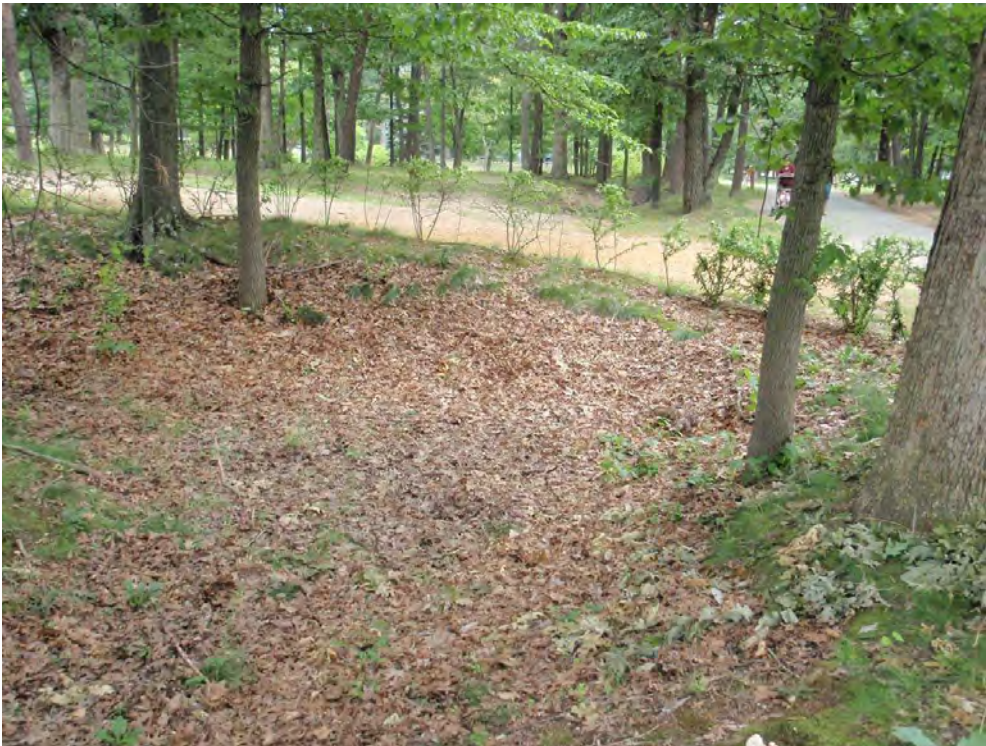
Figure B- 69: Upstream of the drainage inlet (Location ID #96). The inlet appeared to be clogged

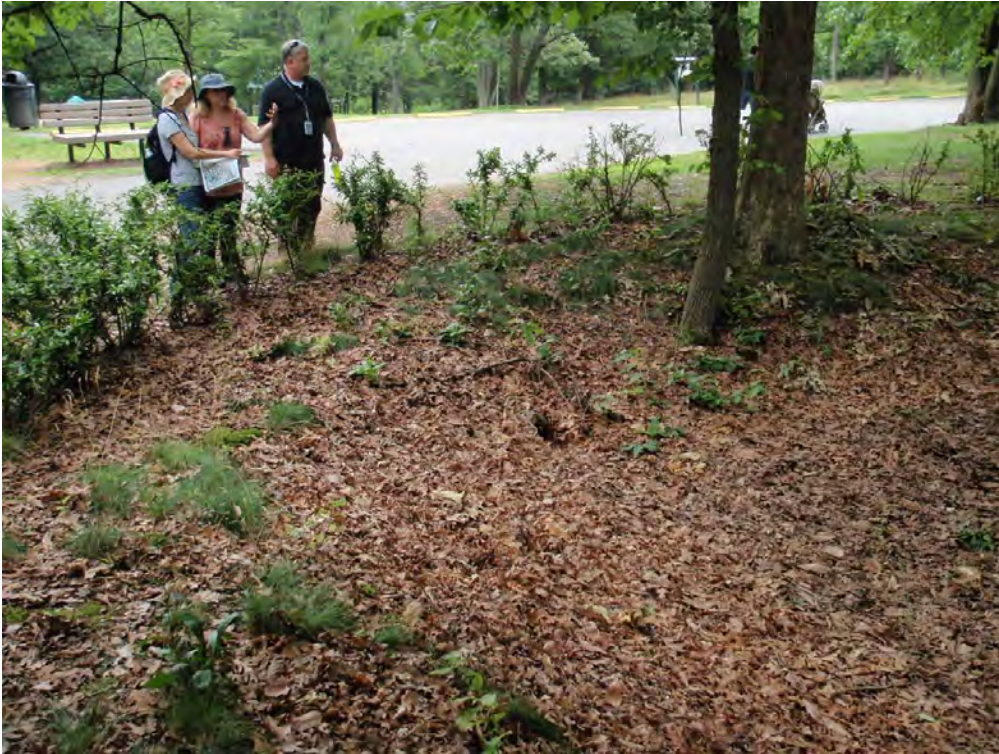
Figure B- 70: Upstream of the Drainage Inlet (Location ID #97)

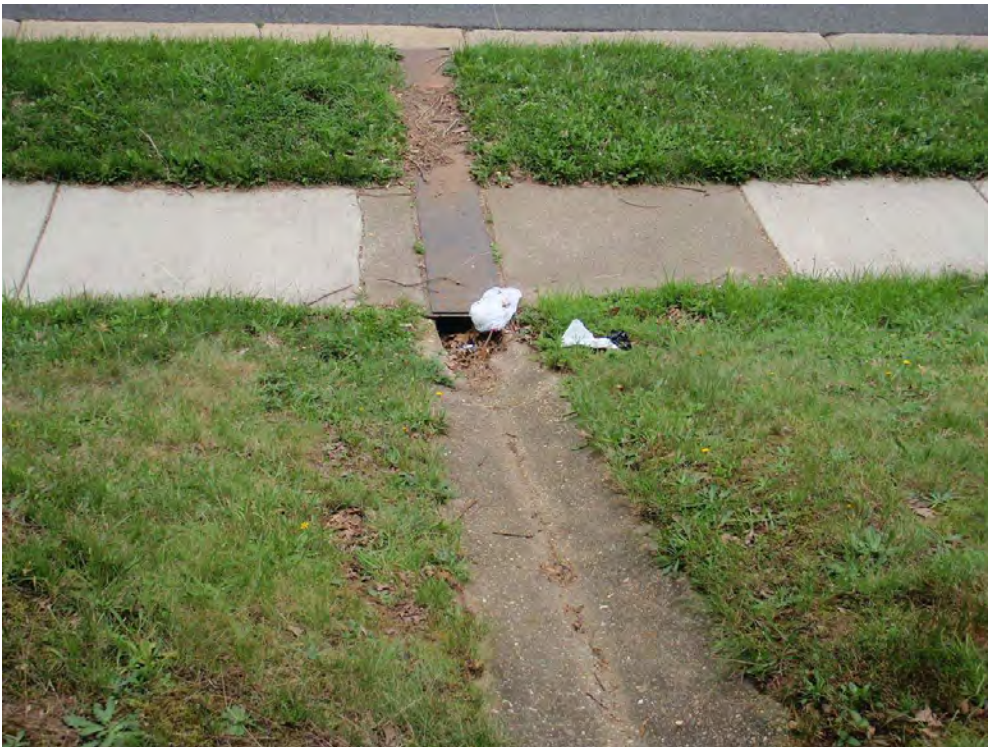
Figure B- 71: Inlet next to the street (Location ID #98)

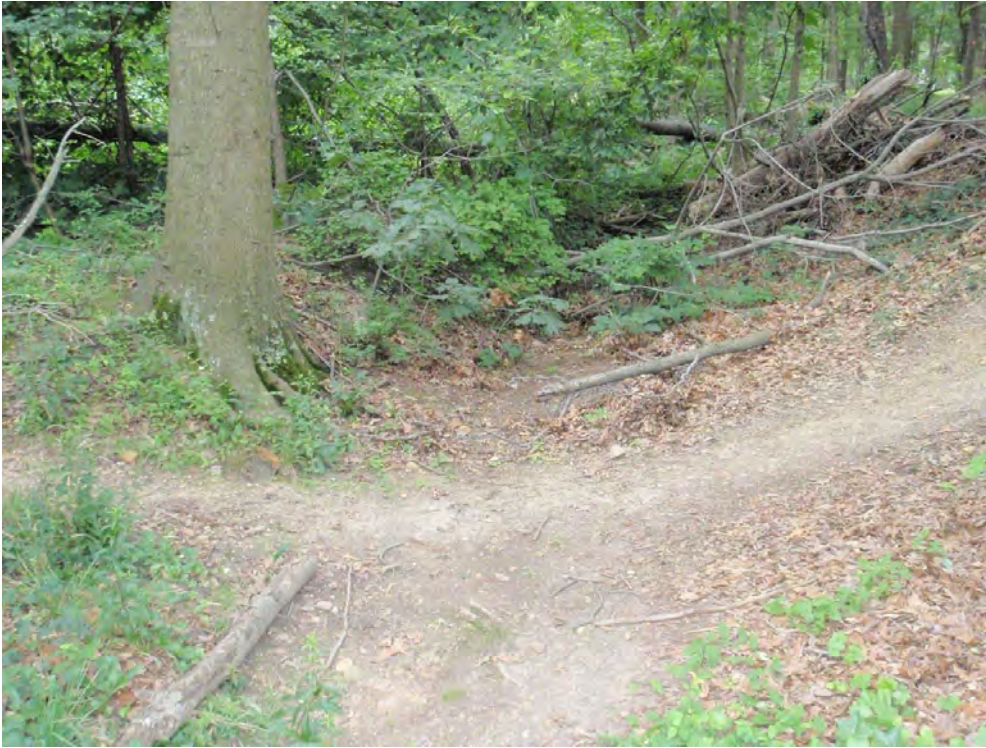
Figure B- 72: Upstream of the inlet (Location ID #99)

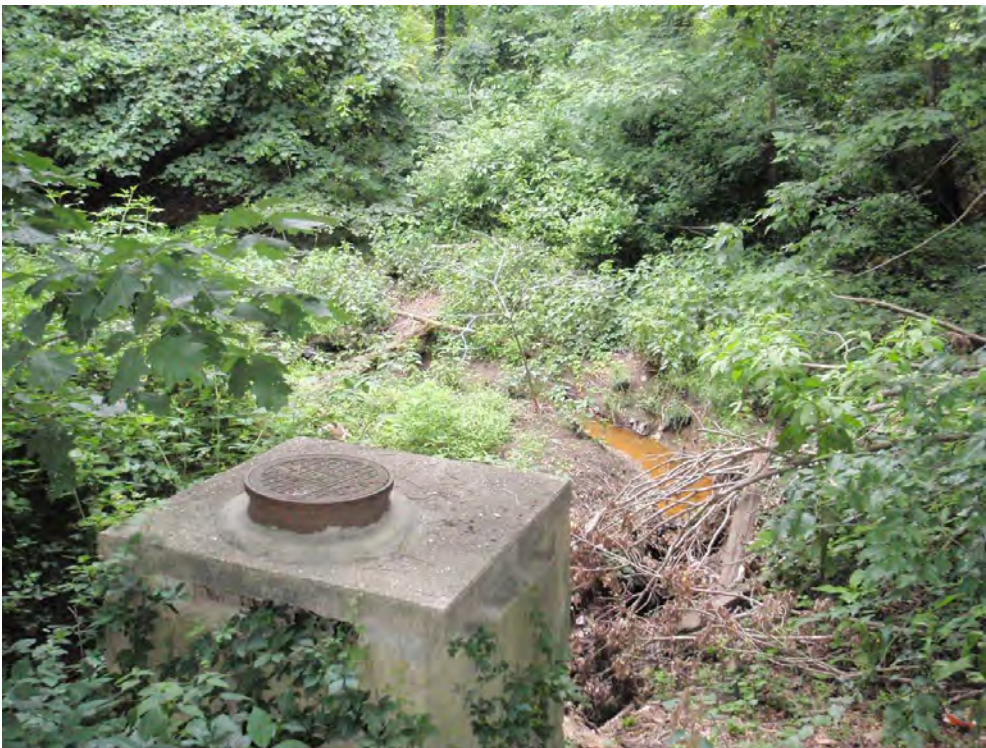
Figure B- 73: Stormwater management (SWM) pond riser (Location ID #100)

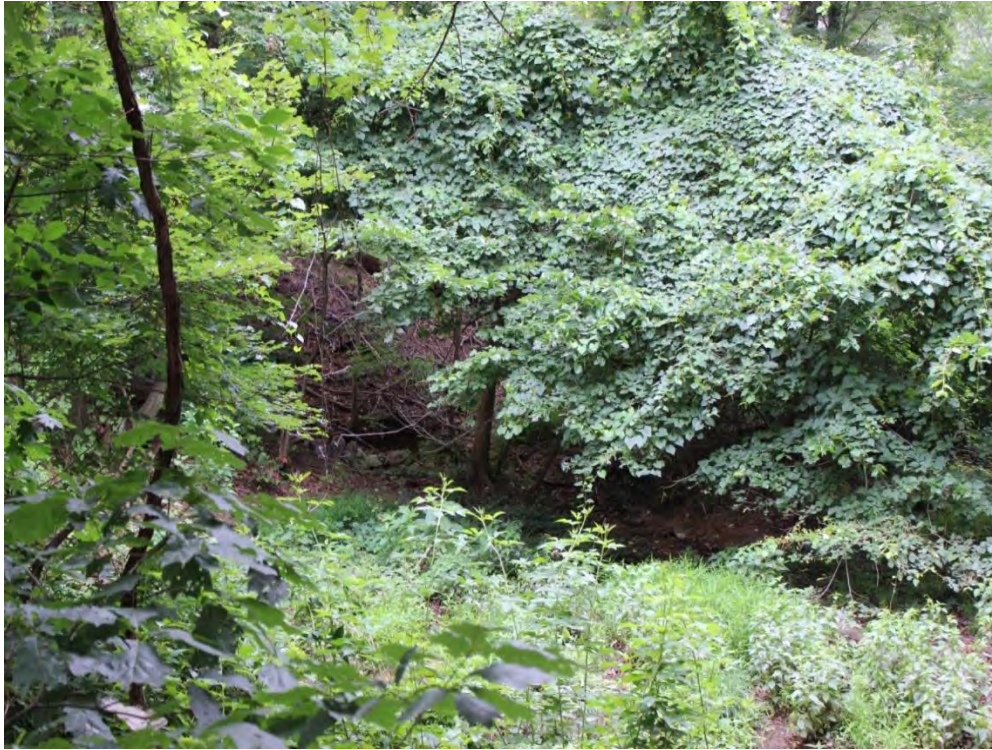
Figure B- 74: Upstream of the SWM facility (Location ID # 101)

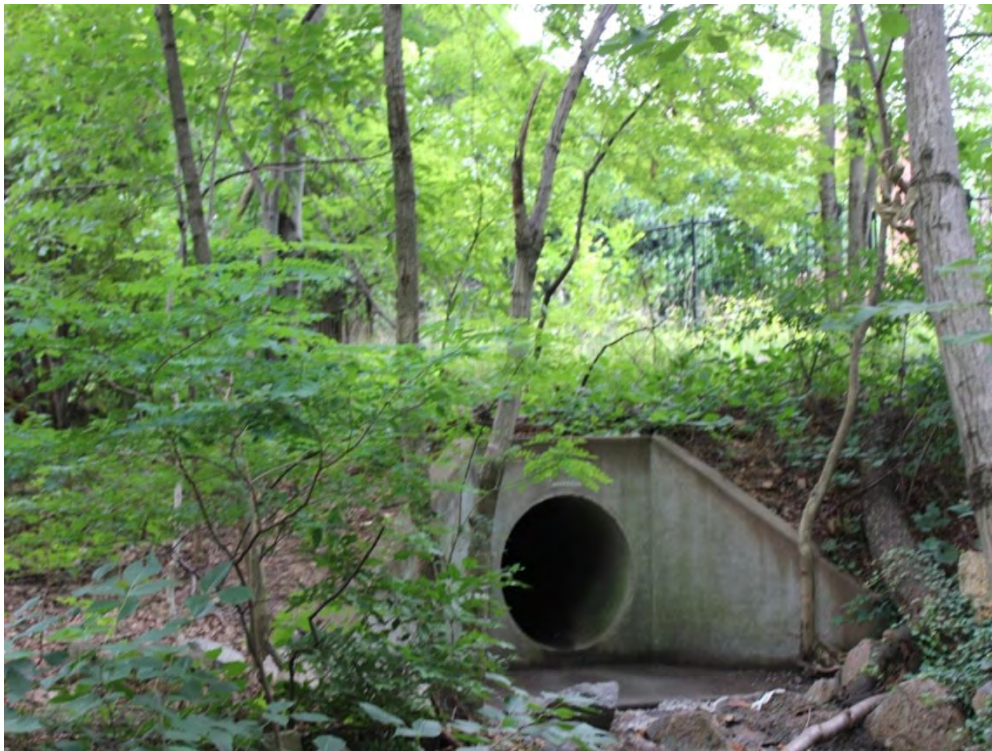
Figure B- 75: Inlet feeding into the SWM pond from the Marlboro properties (Location ID #102)

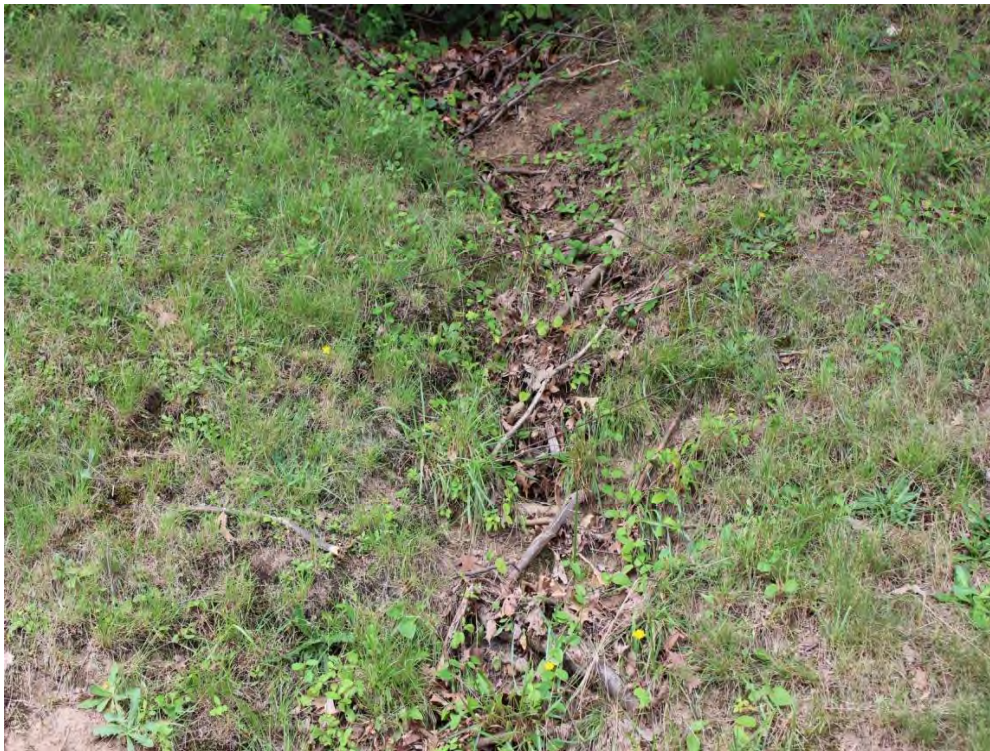
Figure B- 77: Upstream channel of the outfall (Location ID 104)
