Fort Ward Park and Museum Area Management Plan

Appendix I FORT WARD PARK DRAINAGE MASTER PLAN

URS Corporation, 2014

FORT WARD PARK DRAINAGE MASTER PLAN

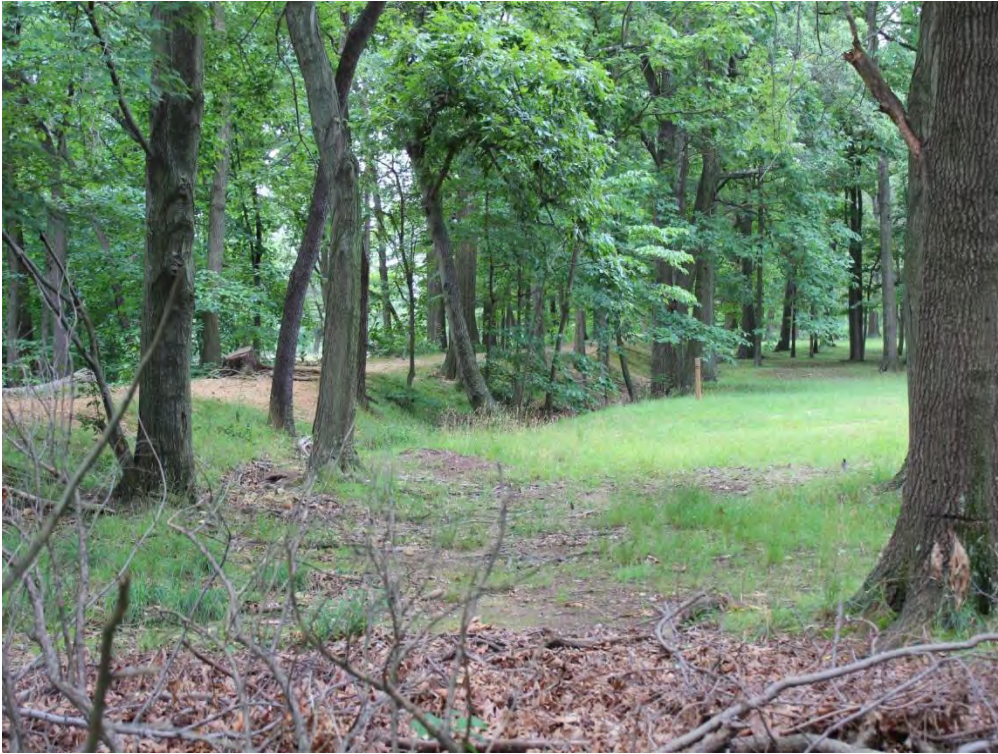
Figure B- 78: Upstream area of the outfall from the Park (Location ID #105)

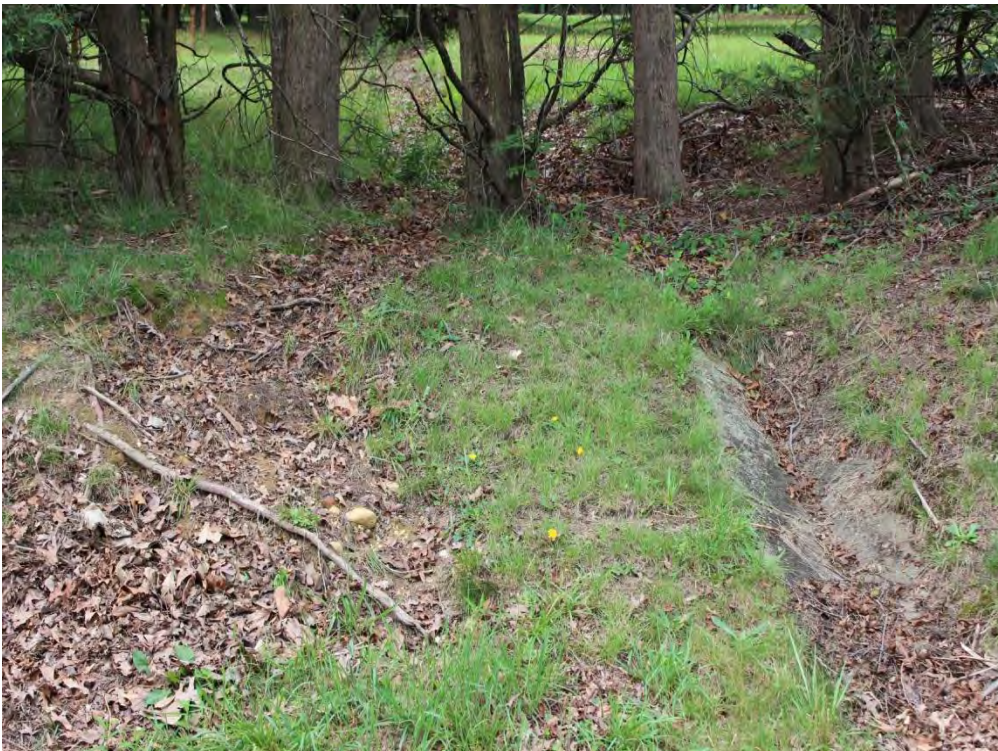
Figure B- 79: Concrete channel in the Park (Location ID #106)

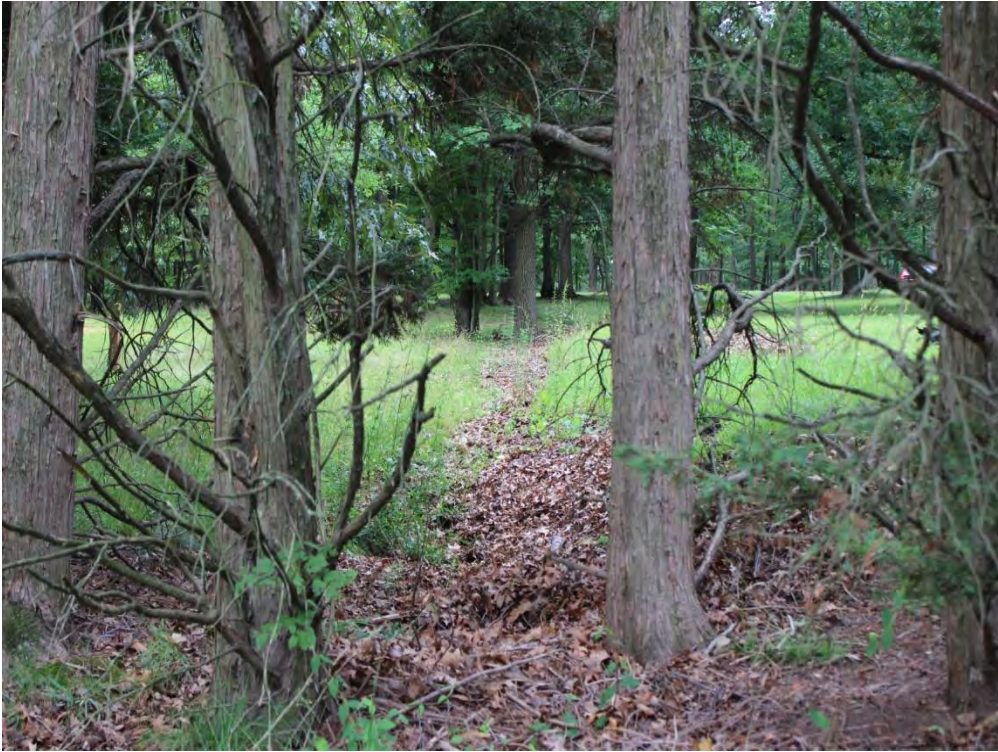
Figure B- 80: Upstream area of the outfall (Location ID #107)

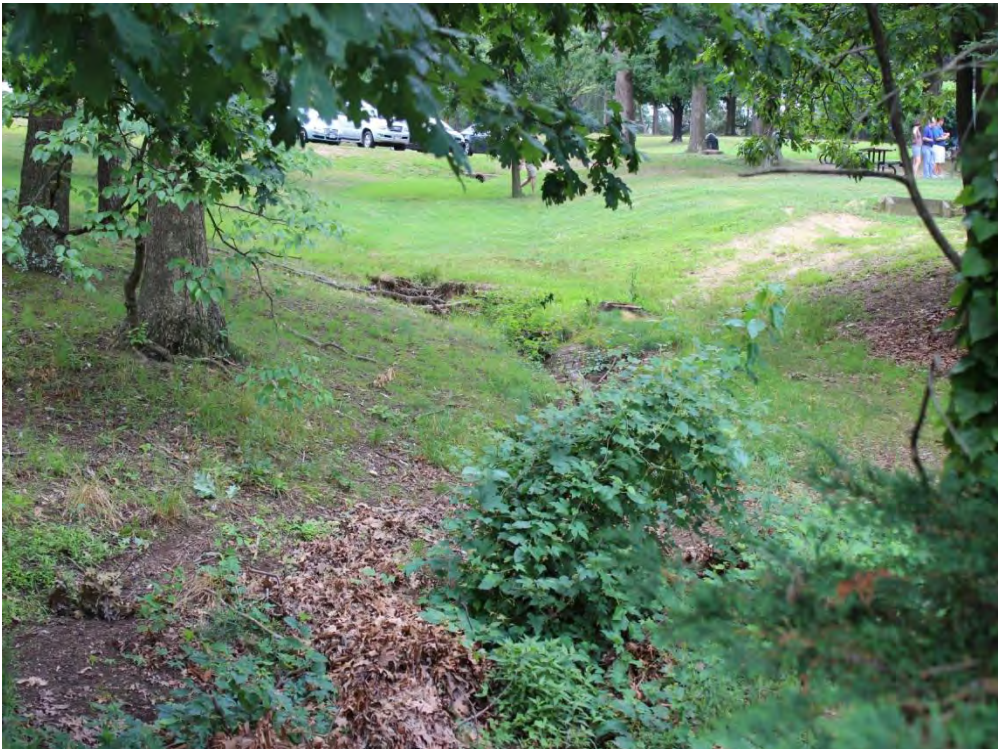
Figure B- 81: Upstream area of the outfall (Location ID #108)

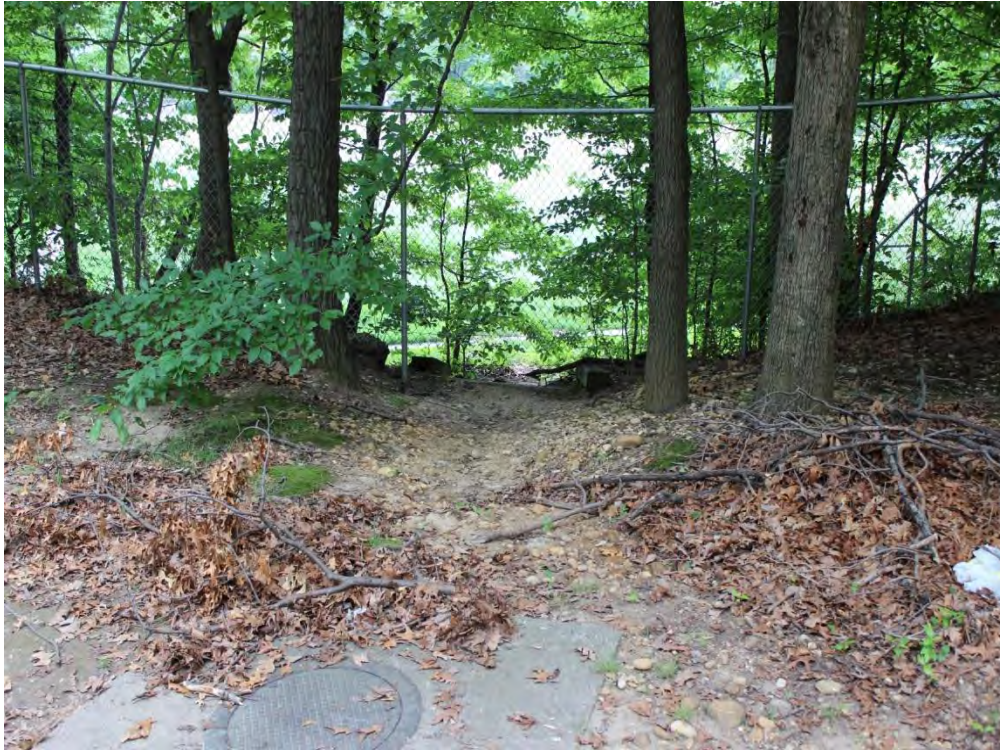
Figure B- 86: Downstream area of the manhole (Location ID #113)

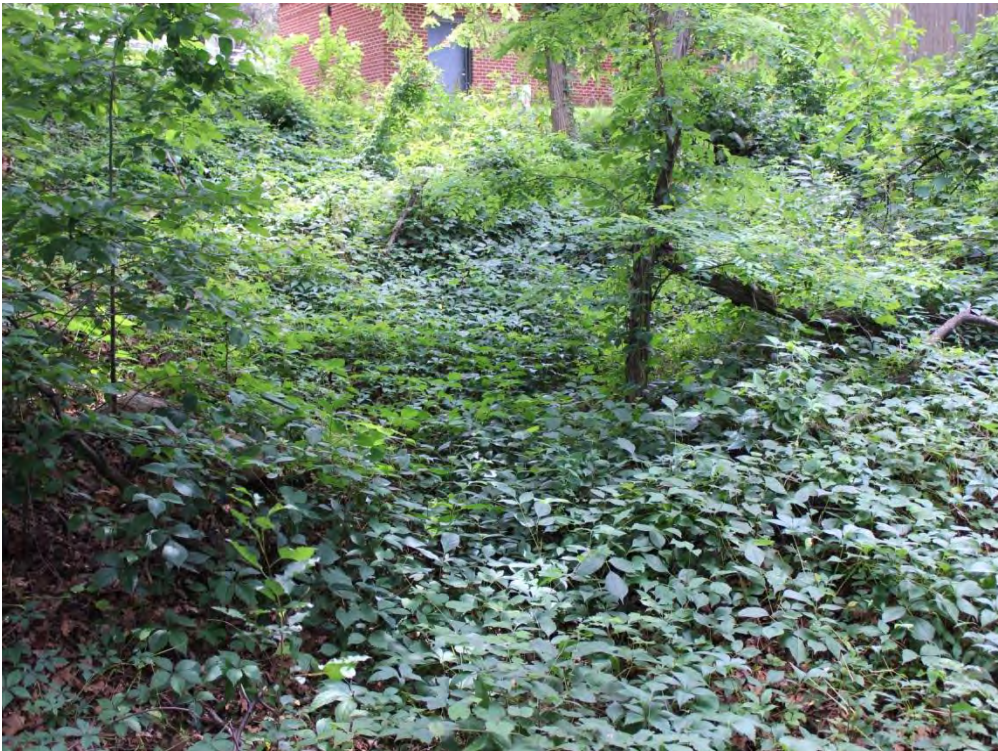
Figure B- 89: Upstream Area of the Inlet (Location ID #116)

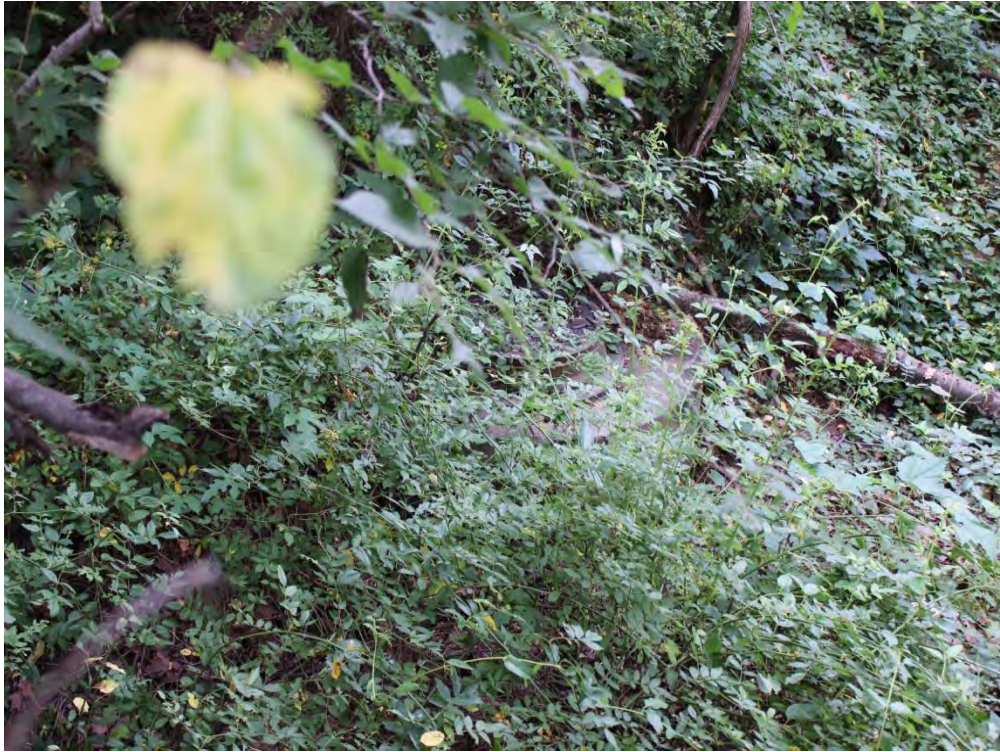
Figure B- 90: Manhole near the soccer field (Location ID #117)

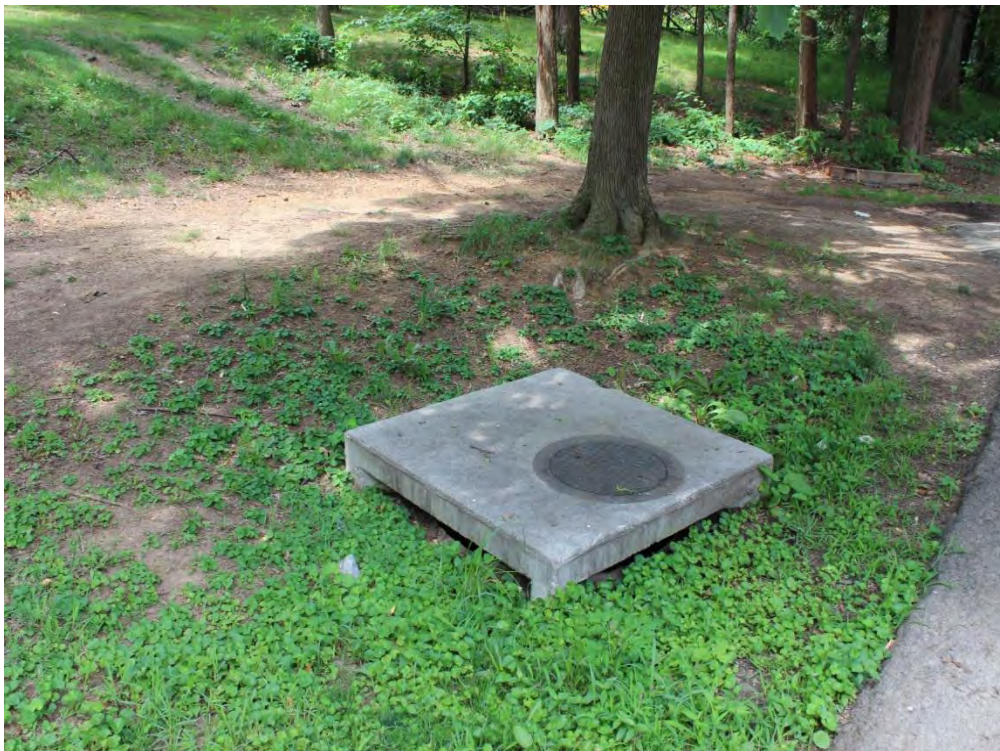
- No problems were observed near the manhole and inlets near soccer field and amphitheater.

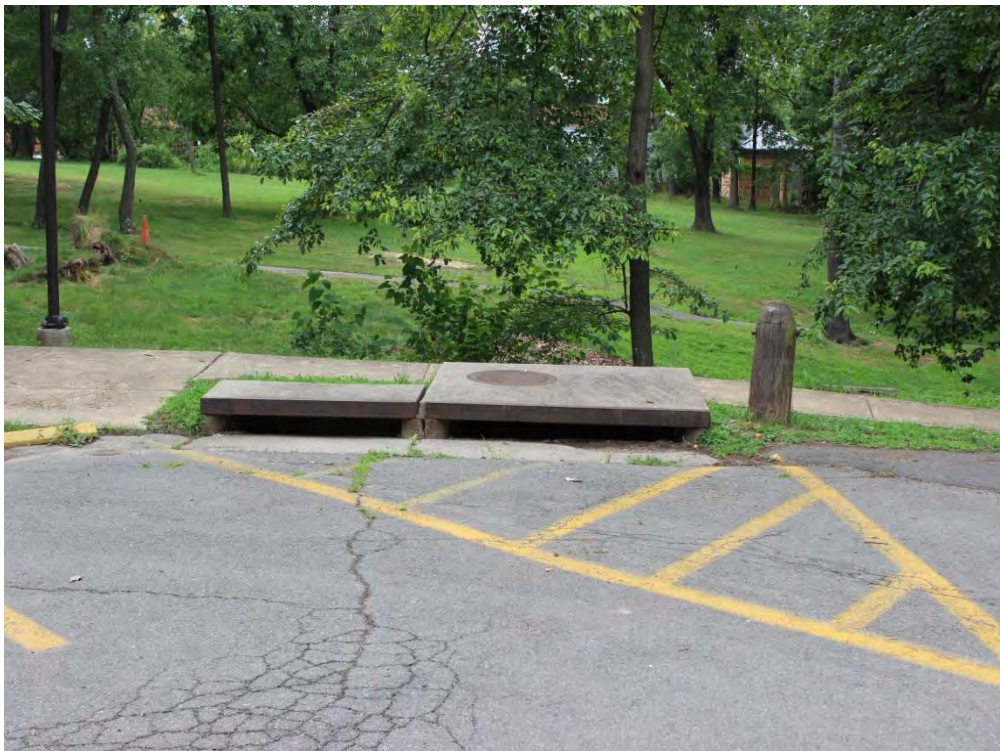
Figure B- 96: Parking lot next to the Inlet (Location ID #126). Observed sedimentation at the parking lot

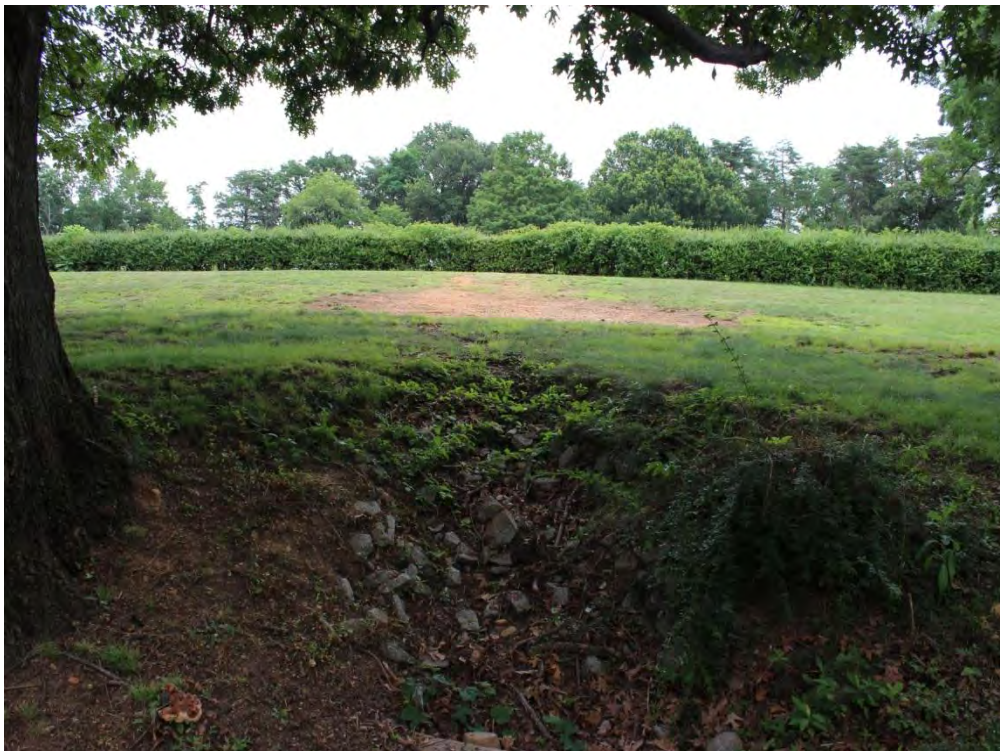
Figure B- 98: Inlet adjacent to the west Side of the fort (Location ID #124). Observed debris at the inlet

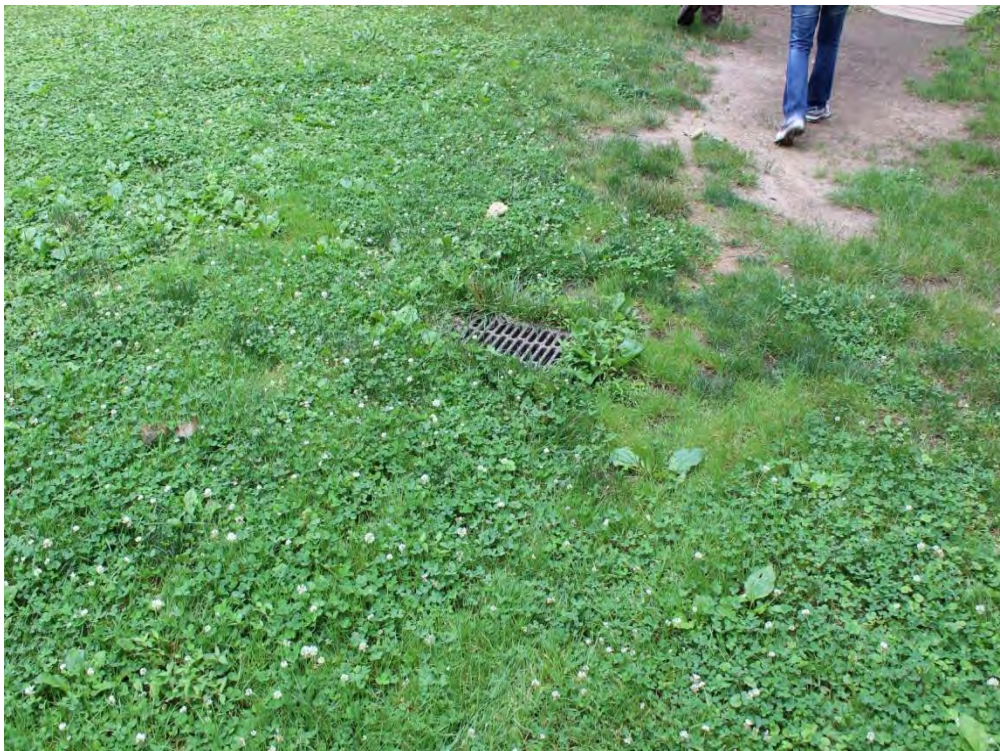
Figure B- 102: Open space (Location ID #129). Observed bare ground near the silt fence

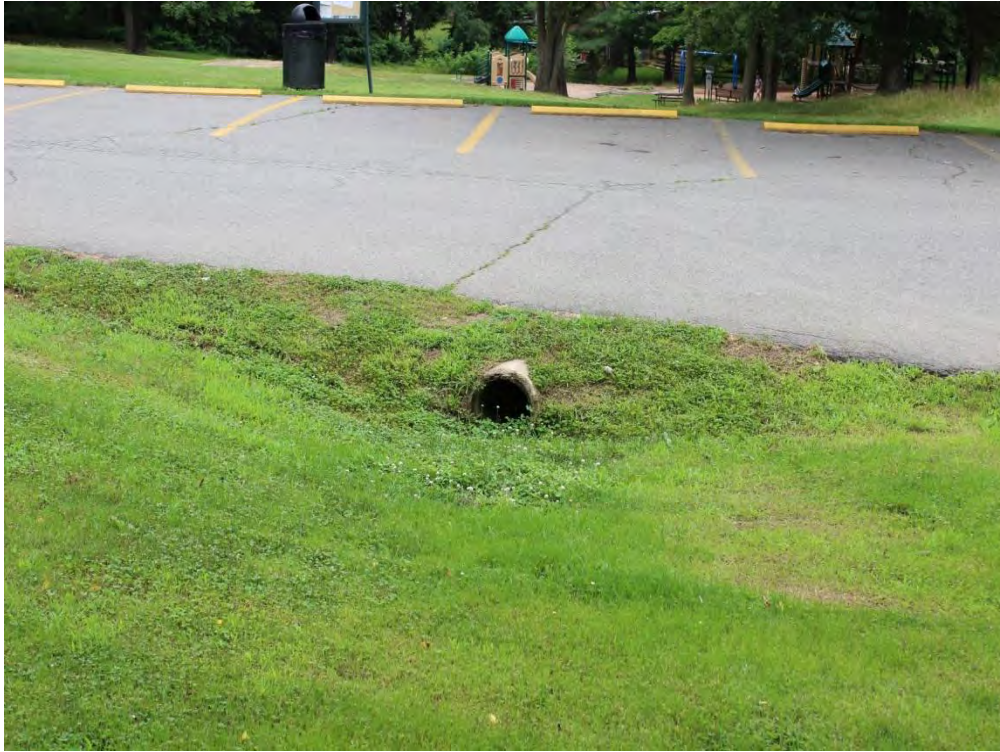
Figure B- 105: PVC Outlet by the footbridge. Observed clogging during previous storm events (Location ID #132)
